Eugene Masonic Cemetery

Condition Assessment and Treatment of the Historic Grave Markers and Mausoleum

October 2013 – May 2014

David Espinosa – Master of Science in Historic Preservation Candidate

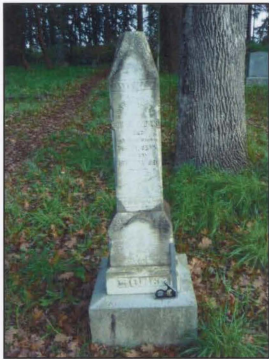
West face of Boren marker pre-treatment

Recommendations: Regular cleaning with clean water and Orvus WA Paste is recommended to deter biological growth and staining. Two cracks are present at the northeast corner of the primary marble element and are liable to contribute to fragmentation in this area. Monitoring of this area and the joint between the two extant marble elements is recommended. The Northwest and Southwest corners at the bottom of the primary marble element are missing and have been filled with Portland cement. In cases where stone loss is present, but does not justify stone replacement (i.e. Dutchman repairs) it can be acceptable to redefine the profile of the stone with mortar. In such a case great care must be taken to match the color, grain size, and permeability of the stone. Furthermore, the mortar infill and the joint should be formed separately. The present repair failed to match color, or grain size. This joint must be monitored and may need to be readdressed in the future.

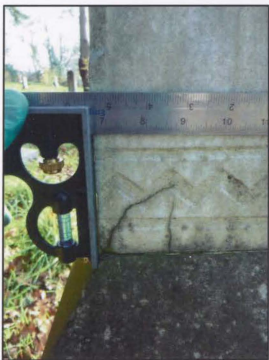
(Left) Detail of cracking at Northeast corner.

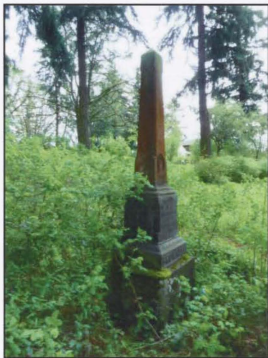
(Above) Brownlee marker pre-treatment
(Below) Graffiti detail

Regular cleaning with clean water and Orvus WA Paste would do well to preserve the natural color of the stone and beautifully carved script and relief. The landscaping of the plot should be evaluated to deter overgrowth of the surrounding plant life and locate any other markers that may be hidden.

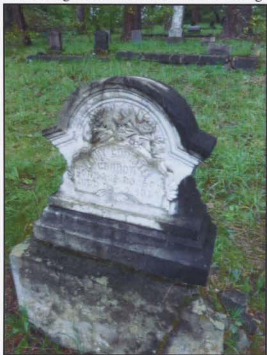
Condon marker pre-treatment

its stability is compromised requiring replacement. The sandstone base, like many others throughout the Eugene Masonic Cemetery is faring poorly against rising damp and biological growth. Options for protective treatments are limited. The best means for preservation of the bases is regular maintenance and monitoring.

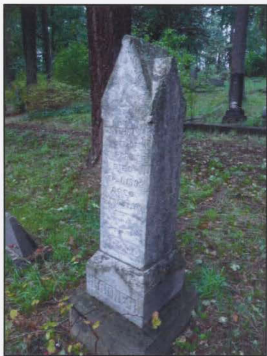
West and South faces of Croner marker pre-treatment

Regular cleaning with Orvus WA Paste and clean water will deter regrowth of lichen and maintain the smooth finish and detailing of the Croner marker. Being highly visible the marker should be well maintained for the aesthetic benefit of the cemetery. As a highly visible marker, exhibiting fine craftsmanship and a naturally beautiful material, this marker can serve as a proponent for support of the Eugene Masonic Cemetery Association for further restoration projects.

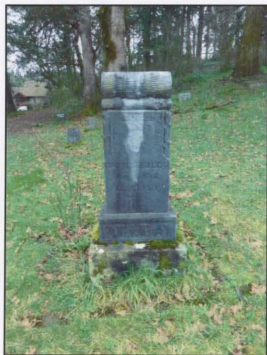
West face of the Holliday marker pre-treatment

It is recommended that the sandstone base be monitored and periodically cleared of lichen and moss. The sandstone is at risk of deterioration through the accumulation of biological growth and vegetation. Simply scraping the base with a plastic scraper and a scrubbing with water and a non-ionic detergent will greatly extend the lifetime of the sandstone.

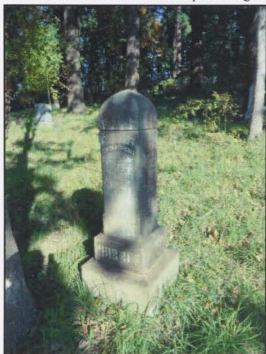
West and South faces pre-treatment

Regular cleaning with clean water and Orvus WA Paste is recommended. The plantings of the enclosure should be assessed as well should future marker instability issues arise. The concrete curb enclosure needs repair along the west edge of the plot.

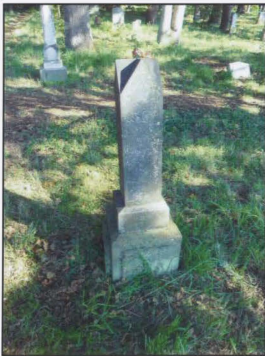
West face pre-treatment

Recommendations: Regular cleaning with Orvus WA Paste and clean water will deter biological growth and soiling. The joint must be monitored and eventually repointed.

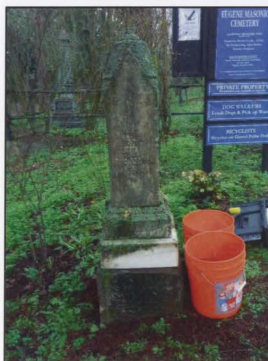
South face pre-treatment

The Lithgow marker holds an important lot in the cemetery as it is the first marker encountered upon entering from the Southeast. Directly adjacent an informational posting board it draws more attention. Regular cleaning is recommended not only to preserve the stone but to

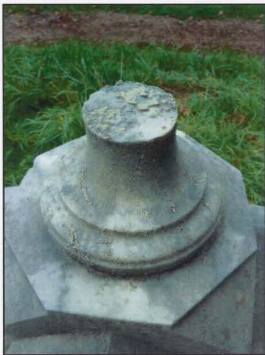
Detail of broken finial

The monument is not experiencing any substantial threat at this point. Regular cleaning with a mild detergent and water is recommended to deter biological growth and maintain inscription legibility. The monument is leaning downhill, but is not in immediate danger of toppling. The joint between the base and primary stone should be monitored, but as of yet repointing is not necessary. Accretions are visible on the ornament fragment and the roof of the. These are products of an interaction between natural inclusions in the stone and the ambient atmosphere. These accretions should not be tampered with as their removal would likely contribute to loss of the historic marble.

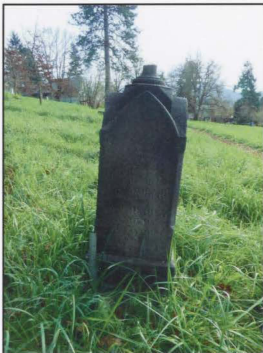
North face pre-treatment (note discolored blotch)

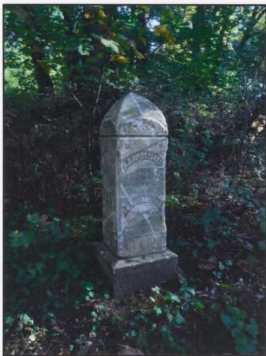
McAlister marker pre-treatment

Recommendations: Regular cleaning with Orvus WA Paste and clean water is recommended to conserve the historic material. The 'base' must receive regular maintenance as marble will deteriorate relatively quickly if left in contact with the soil. Reconstruction of a base consistent with other markers of the period is recommended in order to ensure longevity of the marble's integrity.

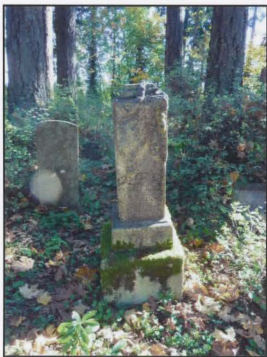
Mary Ellen Noah marker pre-treatment

Given the grave marker's context in the cemetery it must be cleaned and monitored as a point of cemetery advocacy and vandalism deterrence.

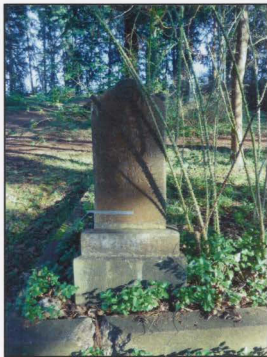
Osburn marker pre-treatment. Note broken curb.

It is recommended that the curb enclosure be repaired so that further work within the plot can be carried out safely. Curb repair should also stabilize the soil and retard or halt tilting of the markers. Regular maintenance with Orvus WA Paste and clean water is recommended.

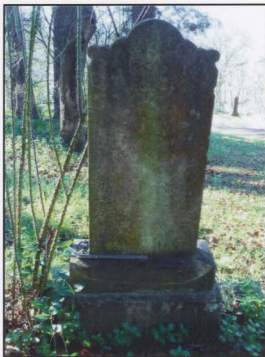
East face of Osburn marker pre-treatment. Note middle element repair.

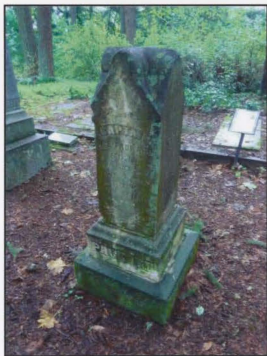
Packard marker pre-treatment, west and south faces

Regular cleaning with Orvus WA Paste and clean water is recommended as the marker occupies a prominent position in a high-traffic area. Monitoring is necessary to note any soil shifting and tilting of the marker.

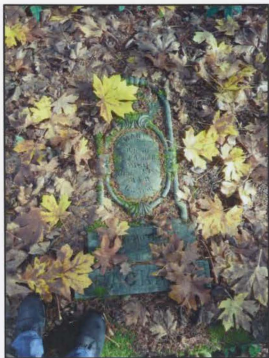
Mary Packard marker pre-treatment

Given the deceased's prominence in local history annual cleaning with Orvus WA Paste and clean water is recommended. This will protect the stone as well as allow visitors to appreciate the beautifully carved marker and better understand Mary's part in the history of Eugene, Oregon.

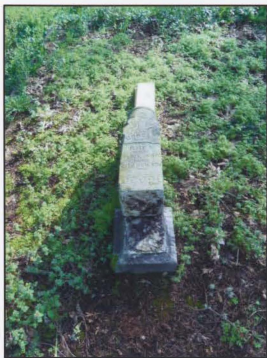
Robert Rhea marker pre-treatment

Reconstruction of a base is recommended to properly level the marker and raise the lower marble element off the concrete pad. Regular cleaning with Orvus WA Paste in clean water is recommended to maintain the stone's natural color and retain the integrity of the incised and carved ornament. Moss and vegetation should be removed from the joint and bonded fractures when encountered to ensure stability of these repairs. This marker is along a high traffic area and is an excellent example of what proper repairs and cleaning can accomplish especially when compared to the untreated markers within its shared plot. It should be utilized for cemetery advocacy.

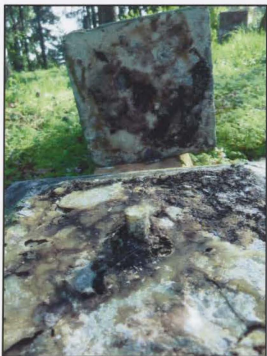
Detail of epoxy, mortar and pin at failed joint

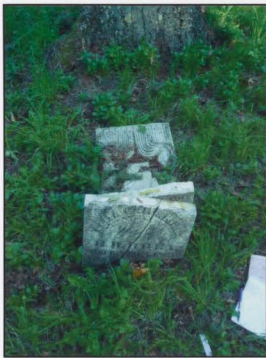
Eliza Rhea marker pre-treatment

Regular cleaning with Orvus WA Paste in clean water is recommended to maintain natural stone color and deter biological growth. Being in a high-traffic area this marker must be monitored and maintained to deter further vandalism.

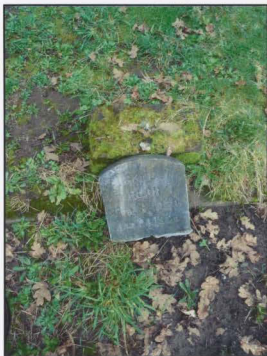
Eugene Rugh marker pre-treatment

Regular cleaning with Orvus WA Paste and clean water is recommended. Removal of moss is necessary in order to retain the stability of the sandstone base. The mortar should be monitored and compared in performance to custom-mixed mortars throughout the cemetery.

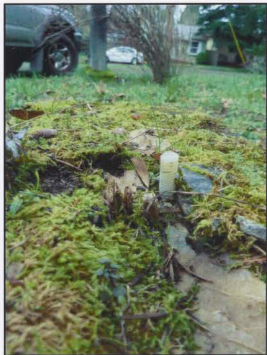
Detail of nylon pin, failed epoxy and mortar

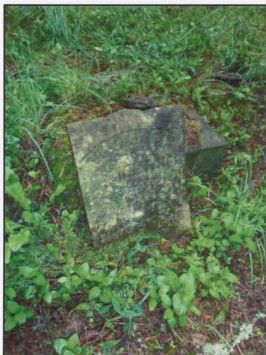
Thomas E. marker pre-treatment

The Thomas marker is in poor condition and requires monitoring to ensure stability. It is situated on a slope and may begin to tilt. If tilting is noticed it should be mitigated as soon as possible. Regular cleaning with Orvus WA Paste in clean water should be executed. If sufficient marble grit is accumulated a void patch should be created. Note: EMCA is in possession of broken marble elements stored in the mausoleum.

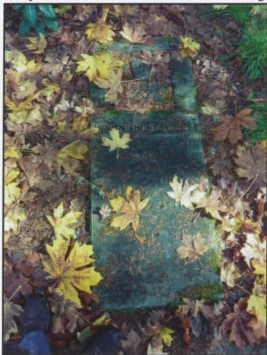
Eugene Skinner marker pre-treatment

Given the marker's importance in the Eugene Masonic Cemetery as well as Eugene Skinner's prominence in the local history an annual maintenance program along Tier 1 guidelines should be adopted. Regular cleaning is necessary to retain the historic material of the Eugene Skinner grave marker. With the inscription and incised ornament now facing skyward they are susceptible to many factors that are detrimental to the integrity of the monument.

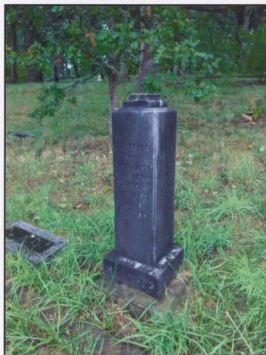
Clifton Stevens marker pre-treatment

Recommendations: Regular cleaning with Orvus WA Paste in clean water is recommended to maintain the color of the stone. More D2 Biological Solution treatments may further lighten the stone and are recommended.

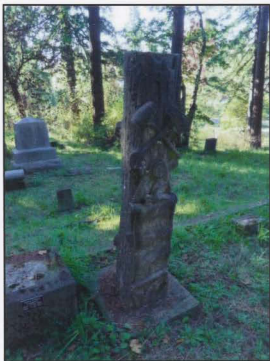
WOW marker South and East façade pre-treatment

As a highlighted site within the cemetery it is recommended that the WOW monument receive an annual or biannual cleaning with Orvus WA Paste and clean water.
