REHABILITATION OF THE STARR HOUSE  
MONROE, OREGON

by  
TADA SUTTITUM

A TERMINAL PROJECT

Presented to the Historic Preservation Program:  
School of Architecture and Allied Arts  
and the Graduate School of the University of Oregon  
for the degree of  
Master of Science  
December 1985

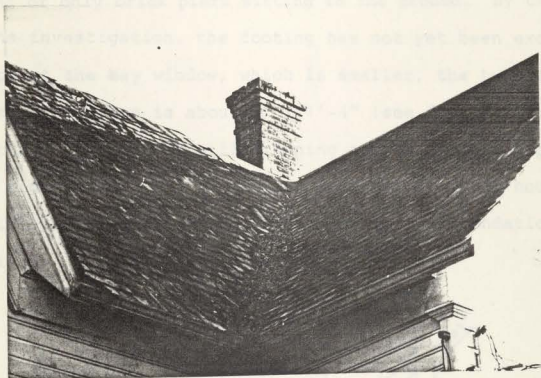
Fig. 36. The roof of the Starr house, at the valley.

Flashing should be installed in the valley and around the chimneys of the main roof, and along the joints where the minor roofs join the siding. Gutters should be considered to be installed along the roof edges.

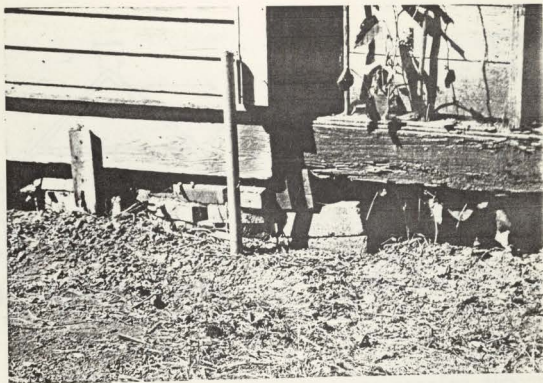
Fig. 39. At the location where the bathroom joins the north-south wing. The original pier and concrete blocks are used for supporting the house.

is missing (see figure 41). This may cause serious damage to the house. Due to the excessive load at that point, the pantry room is gradually separating from the main house body. The excessive bending moment forces toward the south direction on the southeast corner pier of the pantry. The whole house could be tilting toward the south direction. (see figure 40-42).

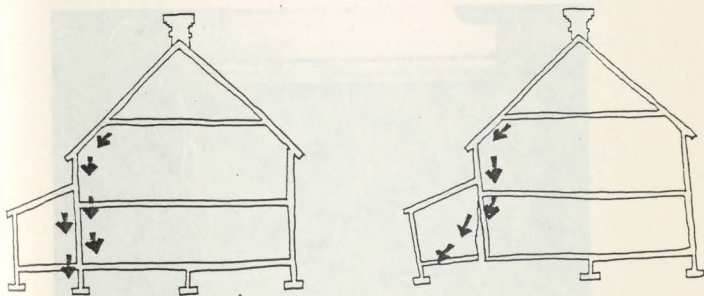
The piers along the back porch were missing and concrete blocks were inserted for replacement. The load appears without sufficient supports therefore causes a sagging in the middle of the back porch structure.

Fig. 40. Distortion of frame dues to missing support; loads pressure on the missing pier, and shift to the left (pier of the pantry). It then suffers from the excessive bending moment.

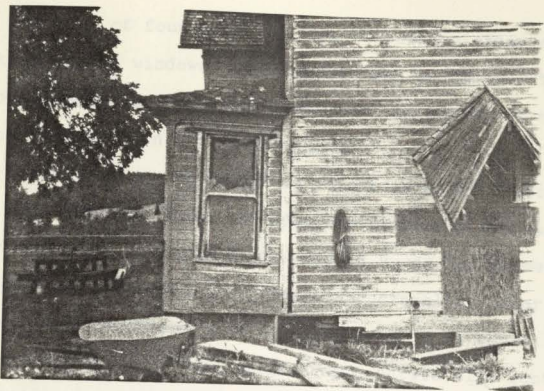
Most piers are deteriorated due to their age and a lack of maintenance. The deterioration of mortar between brick courses make bricks fall off and piers collapse, which affect the body of the house. An attempt to strengthen the pier supports happened around the 1960s.(see figure 39). Concrete blocks in trapezoidal shape were inserted to cushion the house body either near or replacing the original piers. A stack of wood is found at the front gable north elevation which provides a temporary cushion to the east corner. At the present, most piers are partly or totally damaged, bricks are spalling or broken and the mortar are loose. A pier support on the east elevation at the location between the pantry and the kitchen

Fig. 41. The location between the kitchen and the pantry indicates the missing pier.

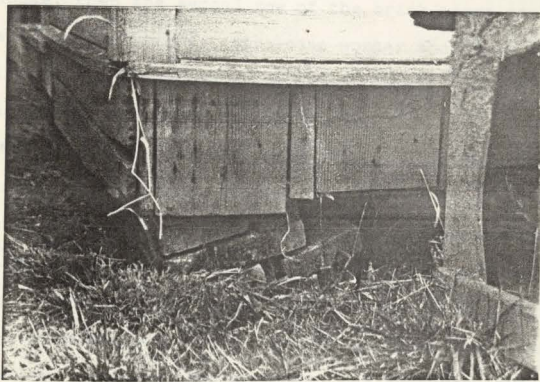
Fig. 42. The pier of the pantry.

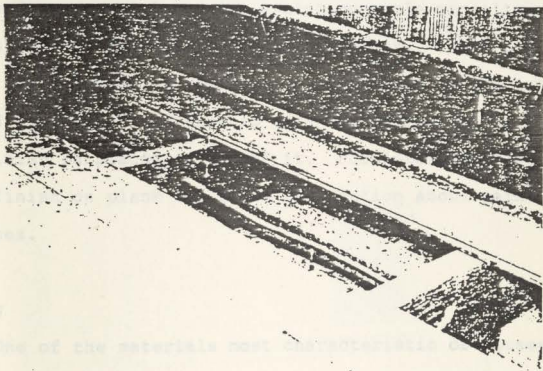
On the second floor, floors are in good condition. The only problem is the stain from organic substances (see figure 47). They need cleaning, using the same method as for the first floor.

Fig. 47. Floor boards of the second floor.

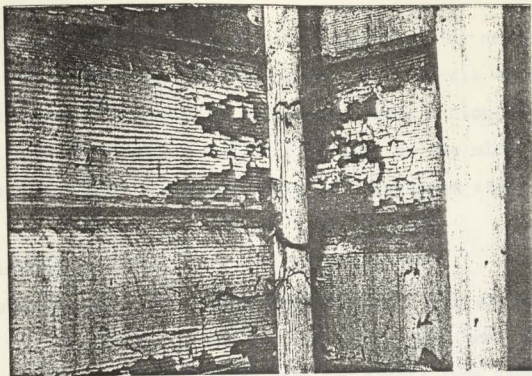
Fig. 48. Paint on the siding has been peeling off.

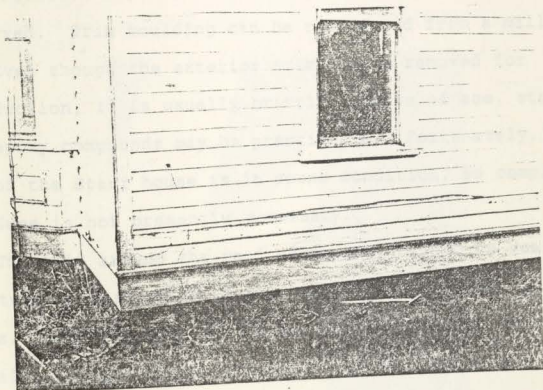
Large cracks or splits are hard to seal by coats of paint and still allow water to enter through it. Siding that

Fig. 49. A large on the siding should be replaced by a new piece.

is badly cracked or split should be replaced by new pieces of board which match the old (see figure 49). Small cracks can be filled by using a caulking compound. Loose siding should be renailed using new nails similar in size to the old, which should be rust resistant, galvanized iron or stainless steel nails.

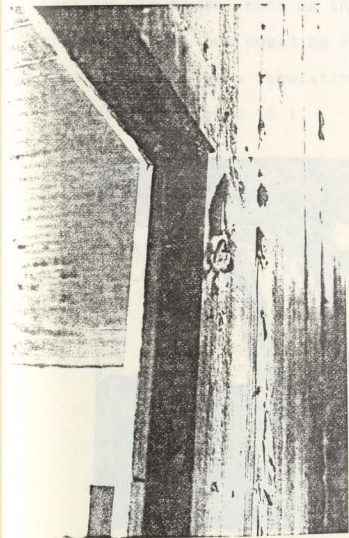
Fig. 54. Missing door trim in the entrance hall

The baseboards in the dining room are new. The original may have been removed when the wall was refinished with the plaster boards. Baseboards in all rooms on the first floor are painted. Paints on baseboards in the north-south wing and dining room, perhaps around 1970s. The original finish on the baseboards in the parlor, back parlor and dining room is believed to be varnish, as in the rooms upstairs. Only the baseboard in the kitchen may be painted in black. Baseboards in the pantry room are missing and should be reinstated.

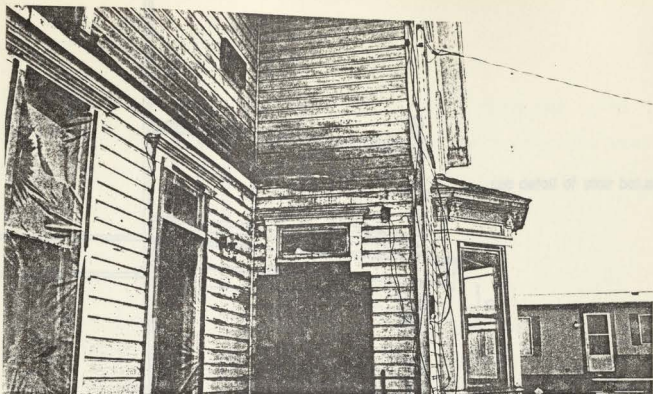
Fig. 70. The stain profile on the wall indicates the front porch's character
