The F.E. Company Industrial Site:
Historic Resources and Preservation
Potential

Matthew Reckard

August, 1993

A final report on a Terminal Project performed as partial fulfillment of the requirements for the degree of Master of Science in Historic Preservation from the School of Architecture and Allied Arts at the University of Oregon, Eugene, Oregon.

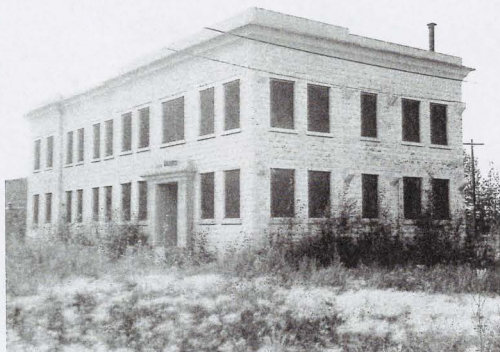
Figure 13. Office Building, 1992. Brackets on the north facade, on the right, were to support beams for an addition. Photo by the author.

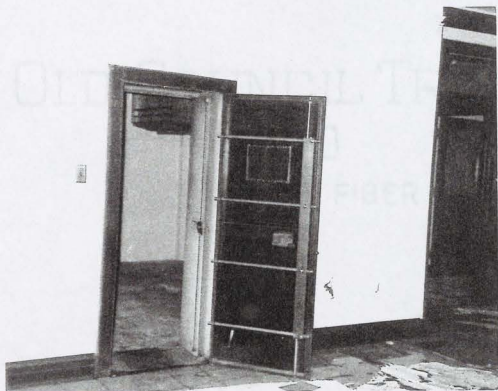
Figure 14. Office Building, 1992. Door to second floor vault. Photo by the author.

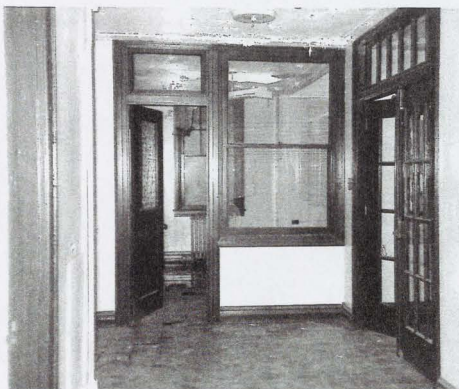
Figure 15. Office Building, 1992. First floor corridor, with doors to the front vestibule on the right. Photo by the author.

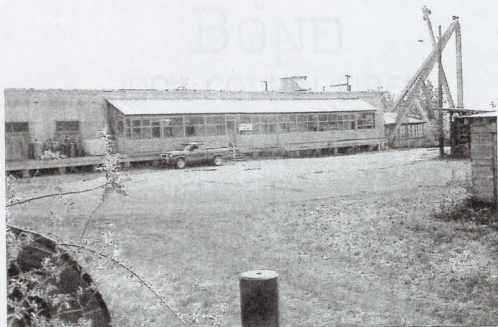
Figure 17. Warehouse 1, looking across the warehouse yard from the north. 1992 photo by the author.

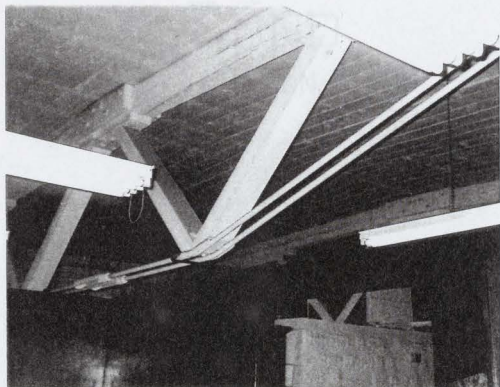
Figure 18. Warehouse 1 roof truss. Part of the vault is visible in the background. 1992 photo by the author.

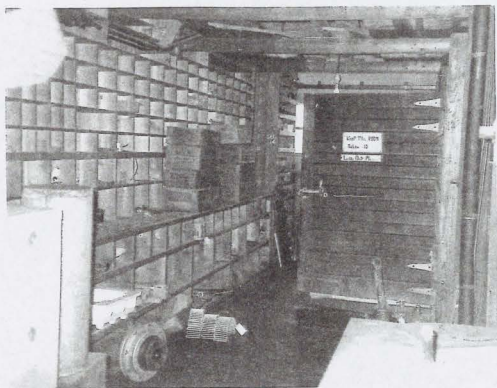
Figure 19. Warehouse 1 interior. Shelves on the left are typical of many in the F.E. warehouses. The door on the right leads to the meat locker. 1992 photo by the author.

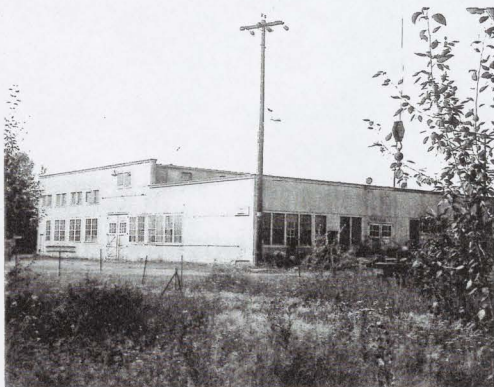
Figure 21. Machine shop from the east. Most of the taller section on the left is a 1941 addition. The derrick's lower pulley block can be seen to the right. 1992 photo by the author.

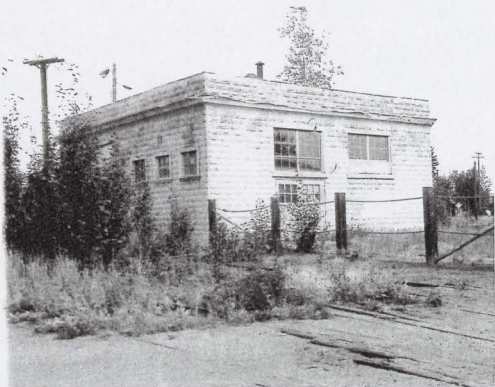
Figure 22. The Retort Building or "Gold Room" from the southwest. 1992 photo by the author.

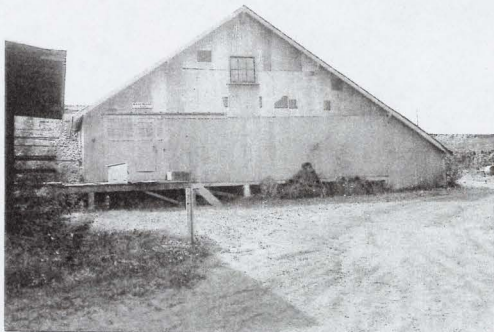
Figure 23. Warehouse 2 from the yard. The loading dock extended to the left within reach of the derrick. 1992 photo by the author.

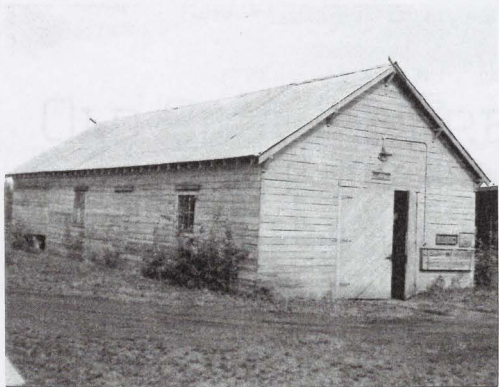
Figure 24. Warehouse 3 from the south. The rack to the right of the doors stored fire hose. 1992 photo by the author.

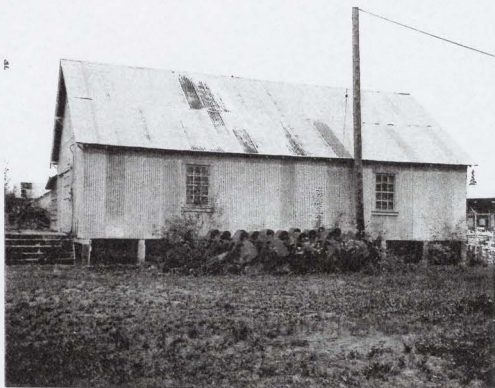
Figure 25. Warehouse 12 from the southeast. Stored dredge buckets are visible next to the building. 1992 photo by the author.

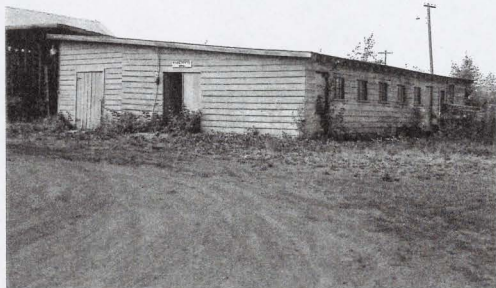
Figure 26. Warehouse 6 from the east, with Warehouse 5 attached at the extreme right. Part of one of the steel racks is visible to the left; the warehouse yard is in the foreground. 1992 photo by the author.

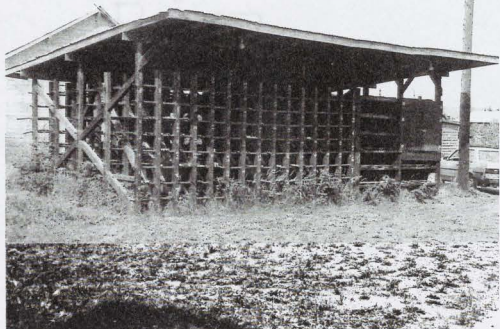
Figure 27. One of the steel racks ("W" in Figure 12) from the south. 1992 photo by the author.

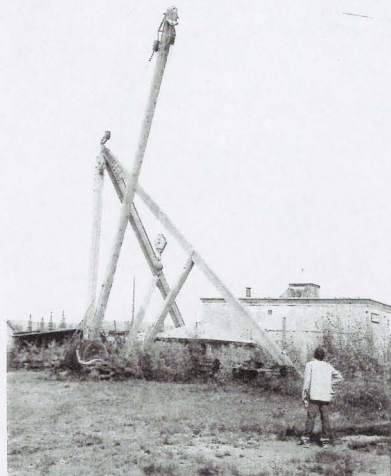
Figure 28 Stiff-leg derrick, from the south, with Warehouse 1 beyond it. The hipped roof under the derrick is the winch house. 1992 Photo by the author.
