ANALYSIS AND REHABILITATION
OF THE COZINE HOUSE
McMINNVILLE, OREGON

A TERMINAL PROJECT

| CHAPTER III. ANALYSIS OF EXISTING CONDITIONS AND RECOMMENDATIONS FOR REHABILITATION/RESTORATION | 20 |

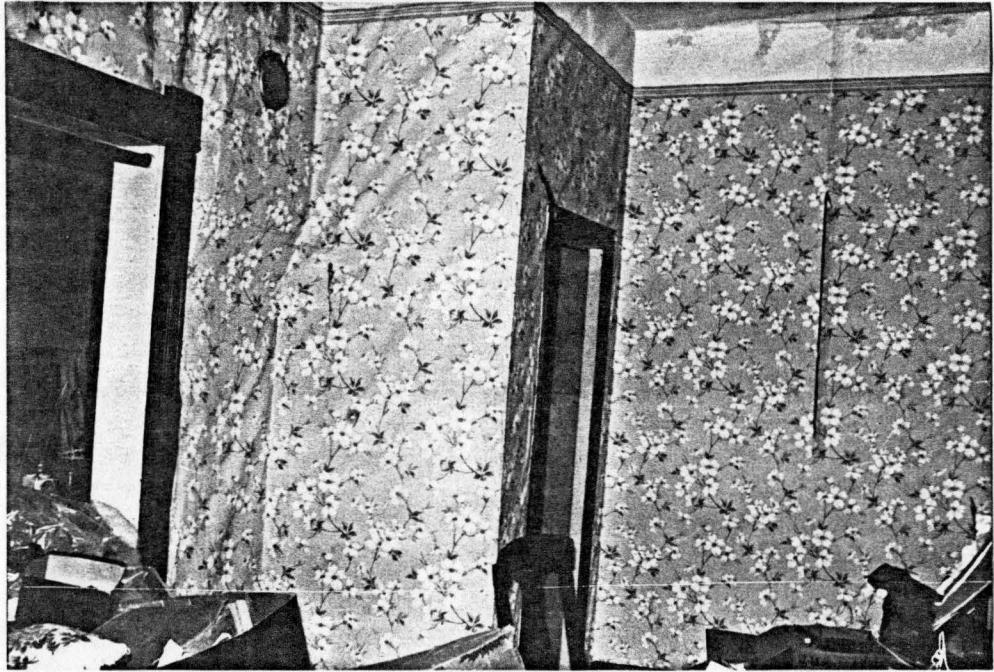
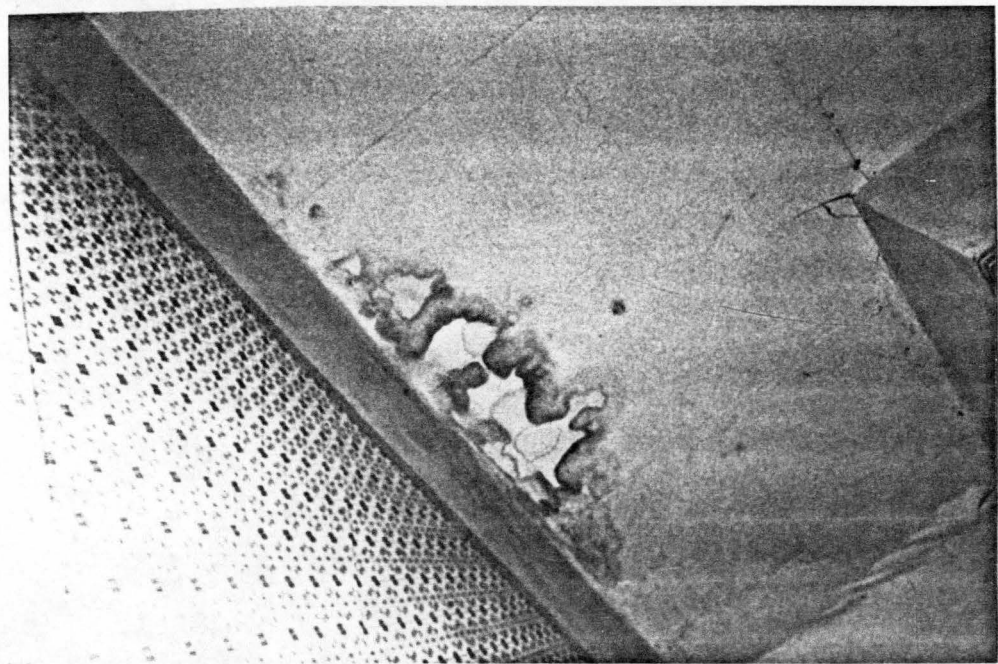
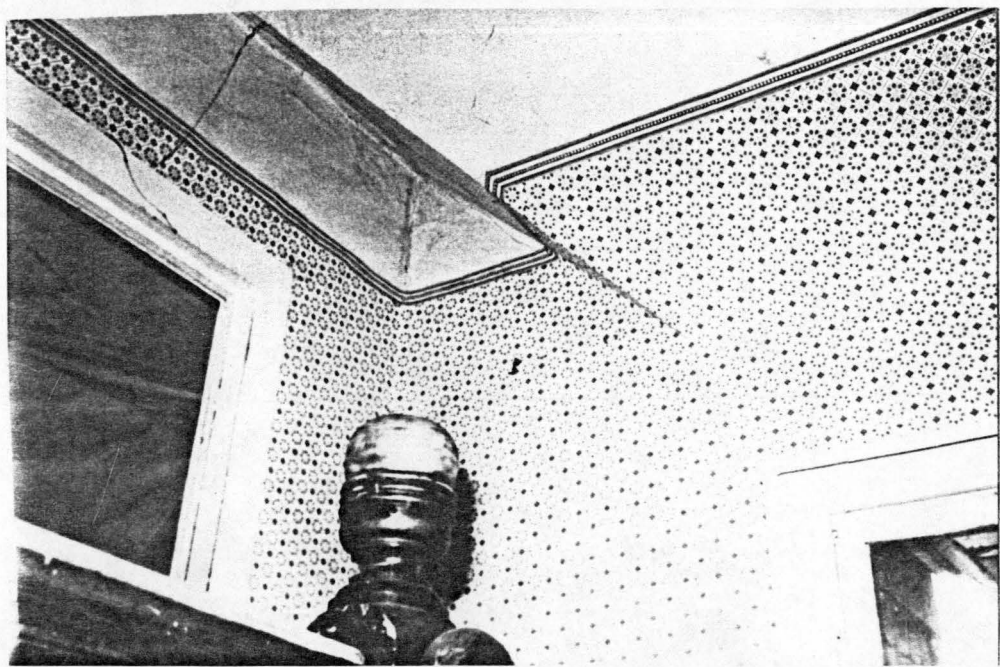
The ceilings in the Cozine House are the same materials as the walls, board covered with wallpaper. The ceilings on the first floor are in fair to good condition and should be retained. The second floor ceilings are in poor condition as water has leaked through the roof. In many places the paper has fallen off the ceiling and the wood has remained wet for long periods of time. Some of the board may need to be replaced. If an entire room needs a new ceiling, sheetrock may replace the original boards. However, it is important to determine the extent of damage to the ceiling and to avoid total removal unless absolutely necessary. Ceilings should be papered with the same care for selecting papers as was done for the walls. Examine the ceiling paper to determine if it is an extension of the wall pattern separated only by the border paper or if it is a different but complementary pattern (Appendix A, Figs. 20, 41, 43).

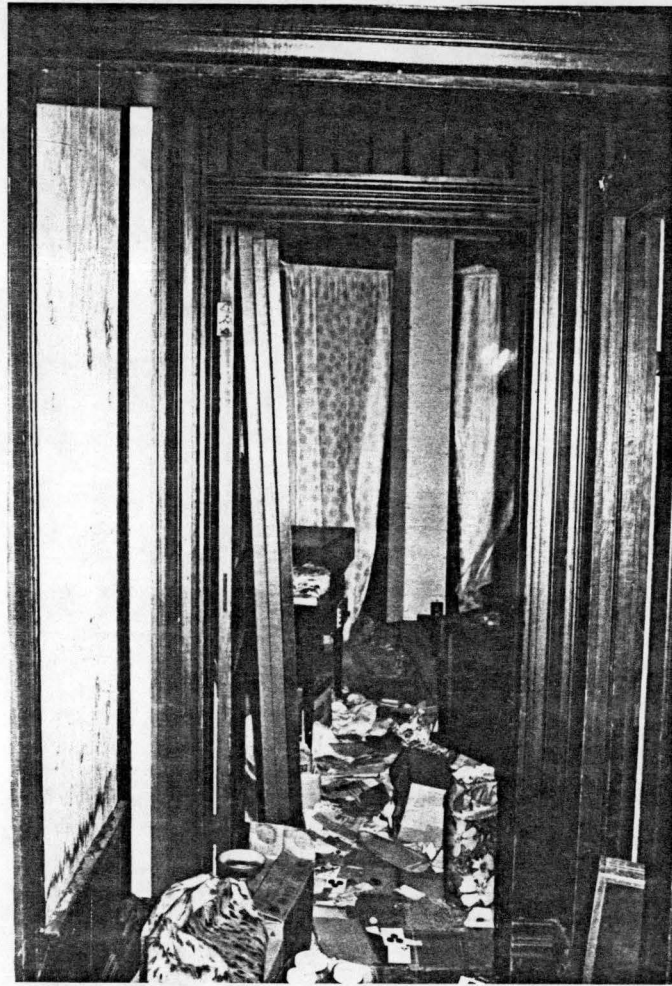
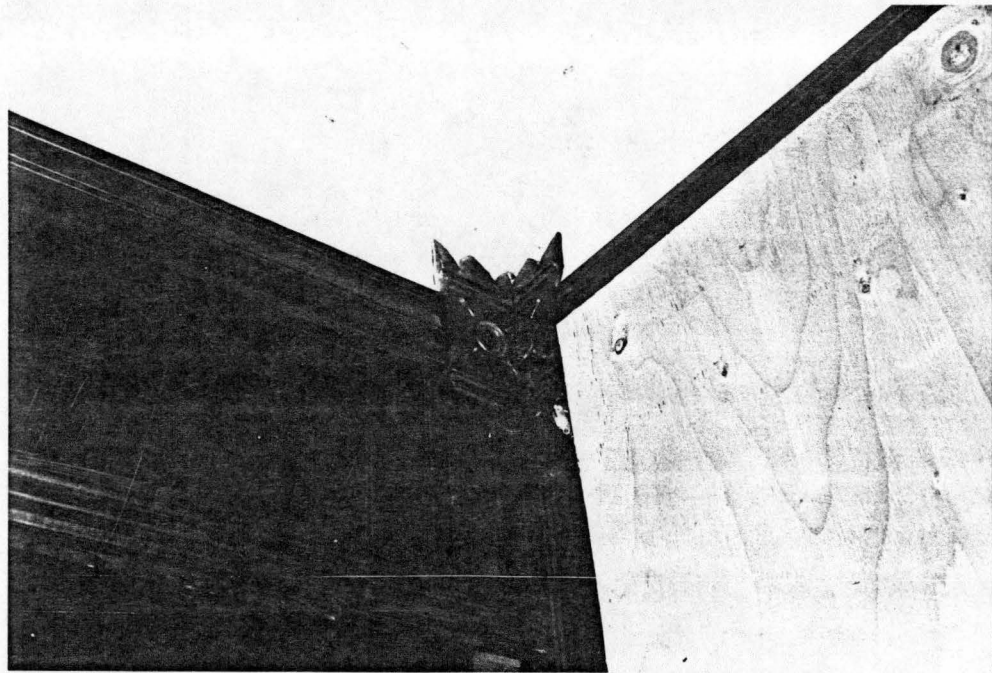
Most of the wood trim throughout the house is in good condition. There are missing base blocks on the first floor, and it will be necessary to have replacements made or purchased from a salvage shop. The wood transoms above the doors on the first floor should be exposed and the door trim should be duplicated as per the original configuration which can be seen in the first floor hall between the parlor and the living room (Appendix A, Figs. 22, 23).

Since it may be necessary to dismantle the trim while restoring and repairing the walls, all pieces should be numbered and identified so they can be replaced in their original locations. If it is not possible to locate identical replacement base blocks in a salvage store, these blocks should be reproduced by a carpenter or craftsman. The wood wainscoting below each window should also be exposed by removing the wallpaper which now conceals it. It is recommended that all the painted trim be dismantled and hand stripped (dipping raises the grain and creates an unnatural appearance) as there is not a large amount of painted woodwork on the first floor. The trim on the second floor is painted and should remain painted. The second floor trim is quite plain so that replacing it should not present problems. However, it should only be replaced where it is beyond repair. The simple wood trim on the second floor is a typical characteristic of the Queen Anne cottage. Elaborate trim should not be duplicated on the second floor. This may be difficult to explain to potential renters who would like the second floor offices to look like the first floor. An elegant appearance can
