COLORS OF THE WESTERN MINING FRONTIER
PAINTED FINISHES IN VIRGINIA CITY,
MONTANA

A THESIS

Presented to the Interdisciplinary Studies Program: Historic Preservation
and the Graduate School of the University of Oregon
in partial fulfillment of the requirements
for the degree of
Master of Science

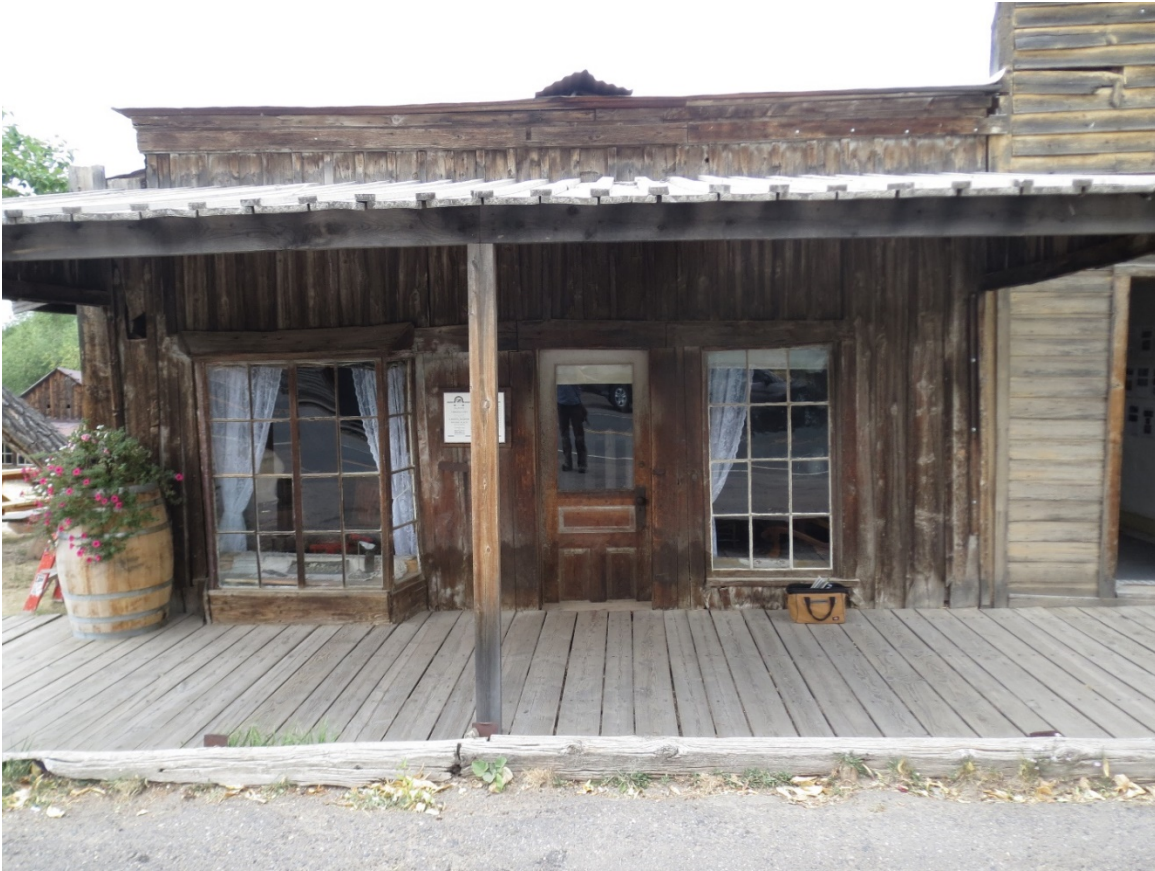
Figure 2.7. Kraemer Dress Shop, August 30, 2016. (Photographed by K. Geraghty)

The Kraemer Dress Shop is one of the oldest buildings in town and the oldest in this case study group. (Figure 2.7) It began as a gable fronted, v-notched log structure with a sod roof.³⁹ It faces Wallace Street, though in 1863 central planned streets were disregarded and structures were built ad hoc, even on Wallace Street, until the town was re-platted in 1868.⁴⁰ The first owner was Augustus Griffith, a local blacksmith who owned and operated a smith out of the property. A 70-inch opening on the Wallace Street-facing façade would have facilitated getting stock animals in and out of the blacksmith for shipping goods and shoeing animals. According to a Condition Assessment Report, the 70-inch opening was only present during the blacksmith period.⁴¹ Griffith sold to Julius Kraemer Sr. in 1870 for \$8, suggesting that Augustus sold the building with no improvements.⁴²

By this time, buildings were in orderly blocks and lots along Wallace Street, and Kraemer's new shop bordered the Chinese district of town to the west. Sometime before Kraemer Sr. sold the shop, a large bay window was installed in the front of the property. It is likely that the board-and-batten false front was also applied at this time. Kraemer Sr. operated a saddlery at this location.

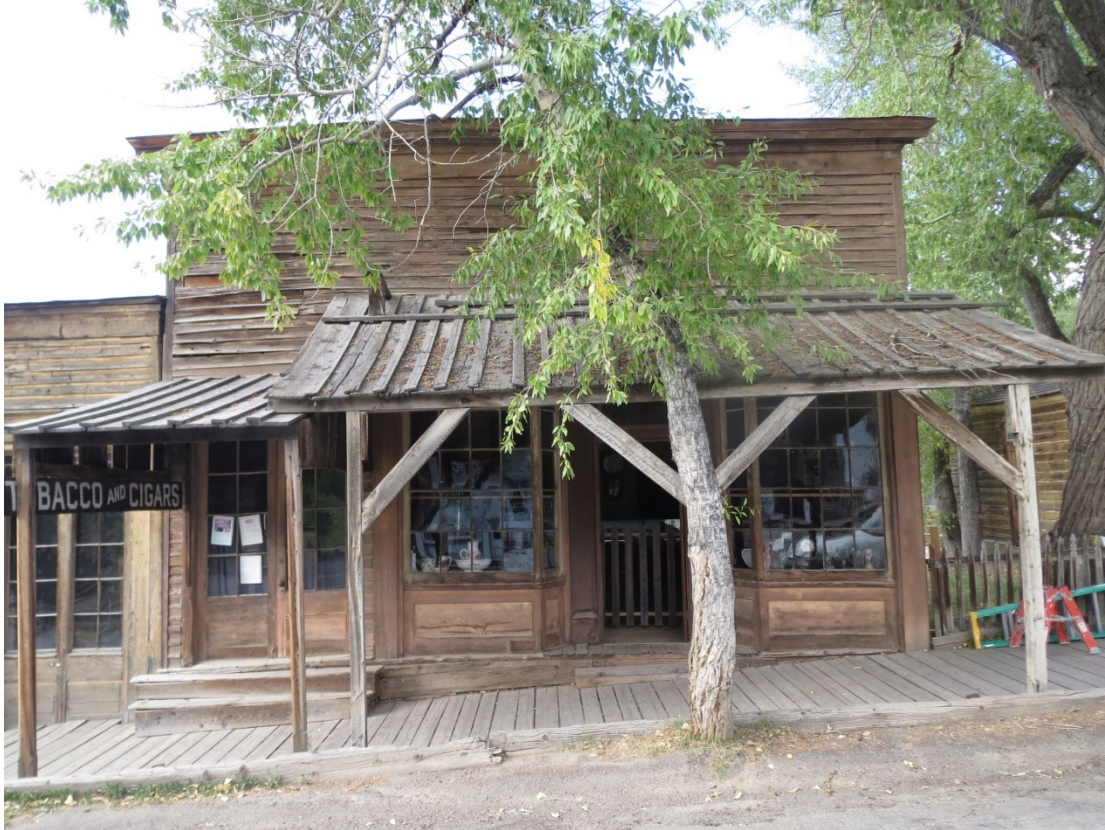
Figure 2.11. Strasburger Colorado Store (right), Brendlinger cigar store (left), August 29, 2016 (Photographed by K. Geraghty)

Like its neighbors, the Strasburger Colorado store began as a single-pen, gable-ended log cabin with an applied false front. Between the store and the McGovern-Goldberg store is a shed-roofed building known as a cigar store that is little more than a hallway leading away from Wallace Street. (Figure 2.11) The first recorded owner on the lot is Hiram J. Brendlinger. Brendlinger was a cigar dealer from Denver, Colorado who concurrently owned cigar shops in Cheyenne and later, Deadwood.⁶⁵ Brendlinger sold the

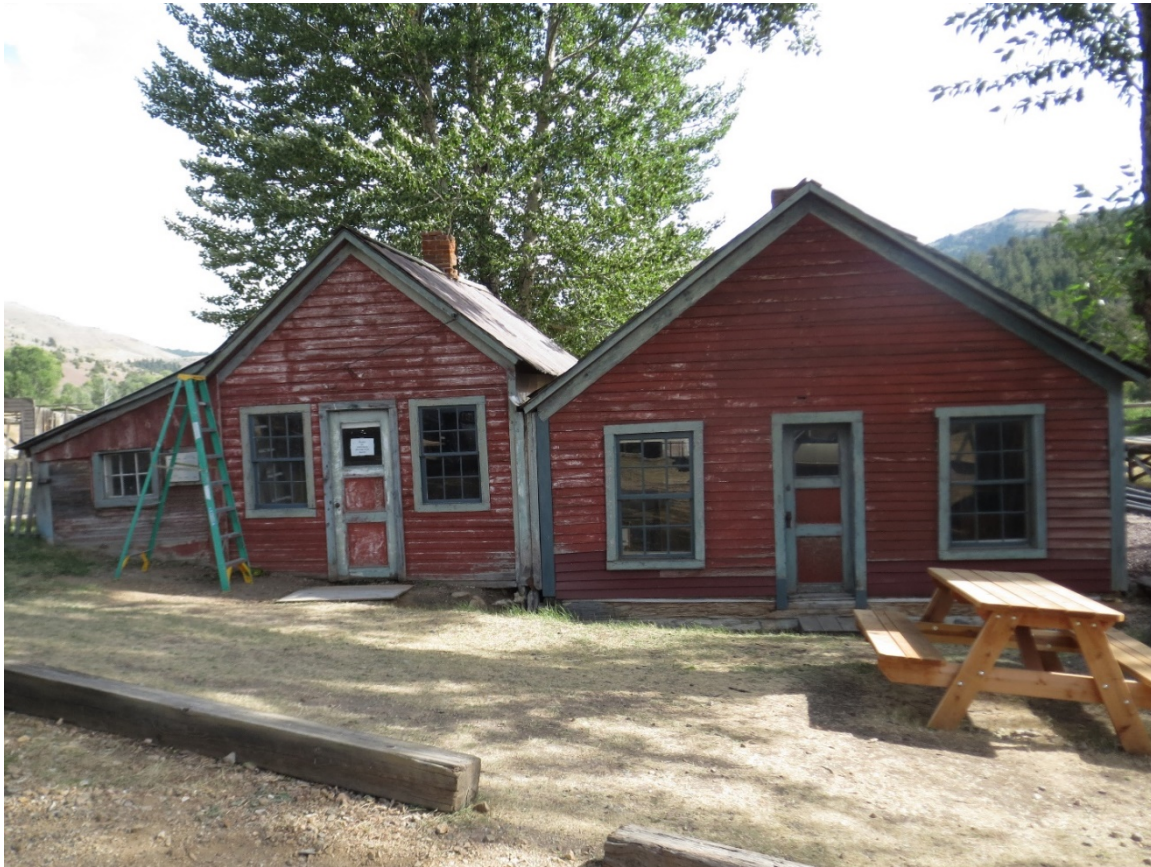
Figure 2.14. Green Fronts Boarding house. 1868 encased log cabin (right), light framed 1878 building (left), August 27, 2016 (Photographed by K. Geraghty)

The Green Fronts consists of two adjoined gable ended structures at the west end of Wallace, just after the bend in the road on the south side of the street. (Figure 2.14) Today it is situated beside Charles Bovey's 1964-introduced shortline railroad that currently runs tourists between Nevada City and Virginia City. The railroad and depot building are an anachronism and are moved from Harrison, Montana.⁸² Originally, this block would have been the Chinese neighborhood of Virginia City, below the sawmill and above the tailing ponds.

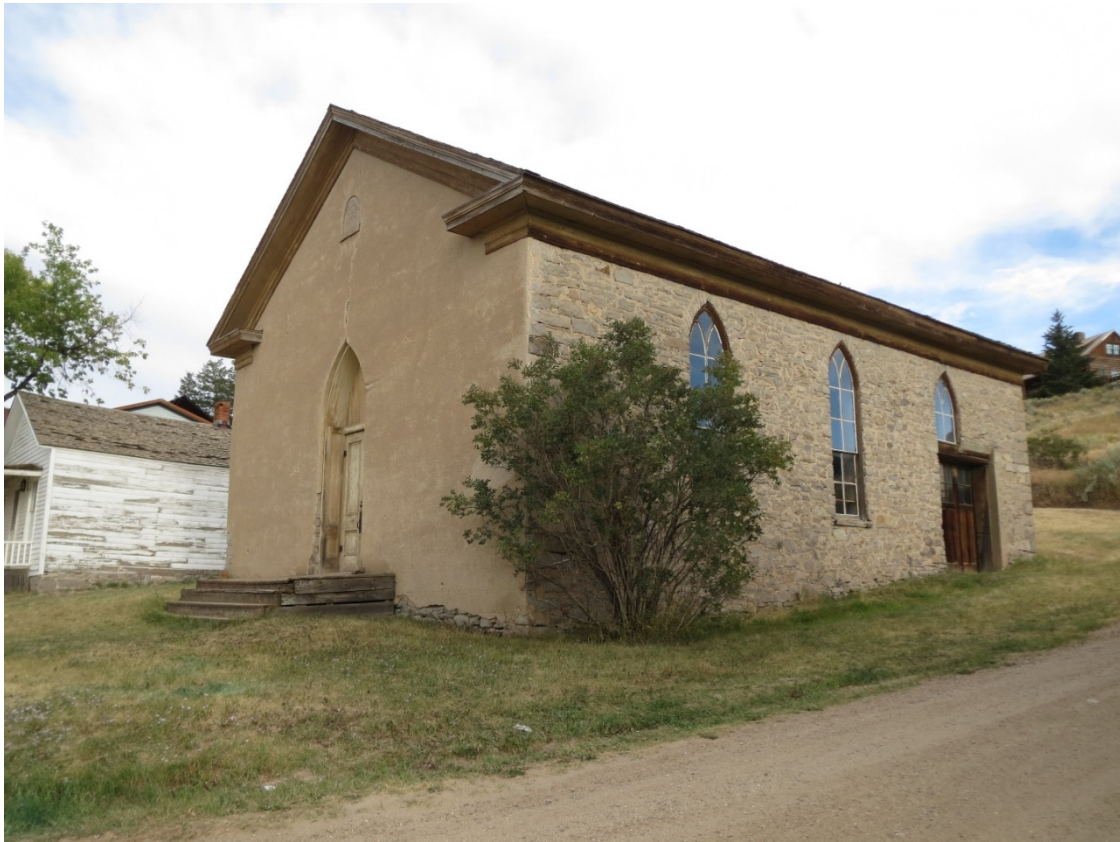
Figure 2.16. Methodist Church with Daems-Corbett House in background, August 25, 2016 (Photographed by K. Geraghty)

In 1875, John Spencer, a lumber dealer sold the land at the corner of Idaho and Van Buren Street to the Methodist congregation. The congregation was formed in 1874 under Reverend A. M. Hough. D.C. Farwell built the church building. It was constructed of rubble rock and covered in stucco scored to look like dressed ashlar for \$4,650.⁹⁹ (Figure 2.16) It was used as a church until sometime in the 1920s, when it became a

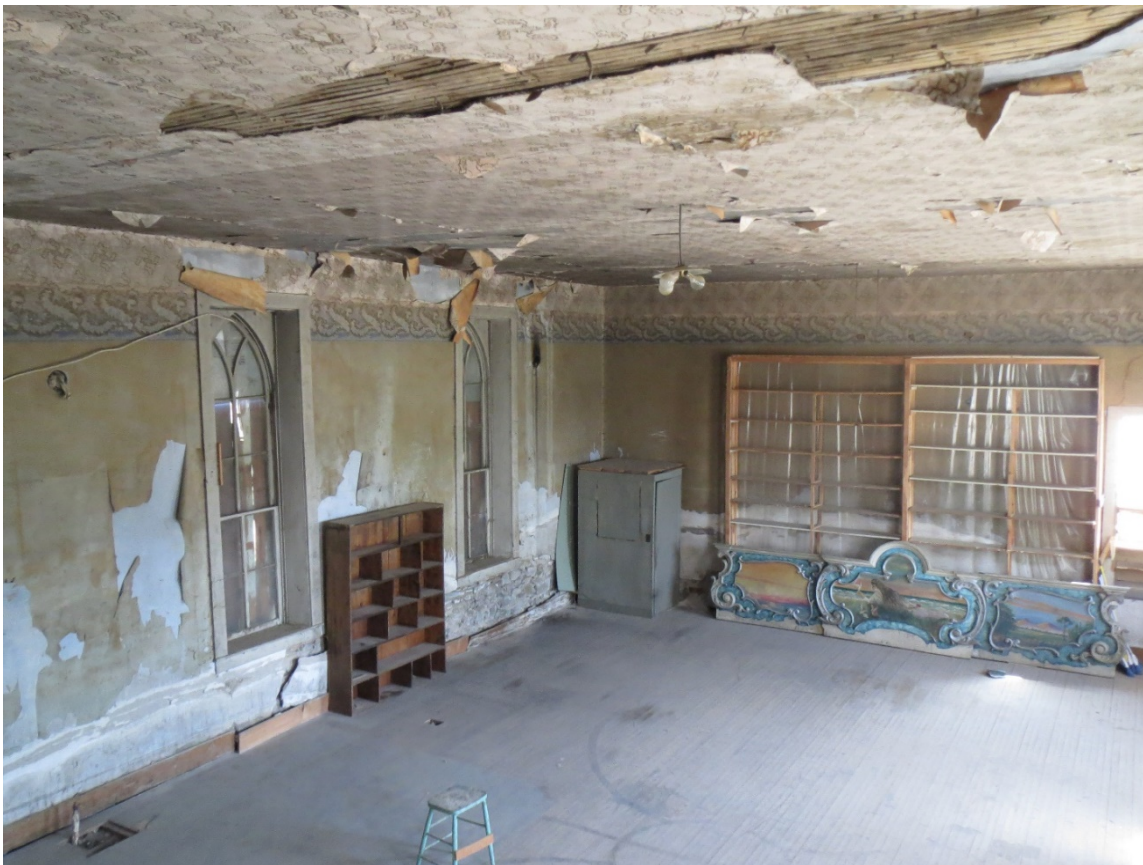
Figure 2.17. Methodist Church interior. Note the painted gymnasium floor and intricate wallpaper of lath plaster ceiling, August 25, 2016. (Photographed by K. Geraghty)

gymnasium. (Figure 2.17) The north, south, and east exterior elevations are completely unaltered except for window mothballing. The west elevation has had a three-part, eight feet wide, wood folding door cut into the rubble stone wall.

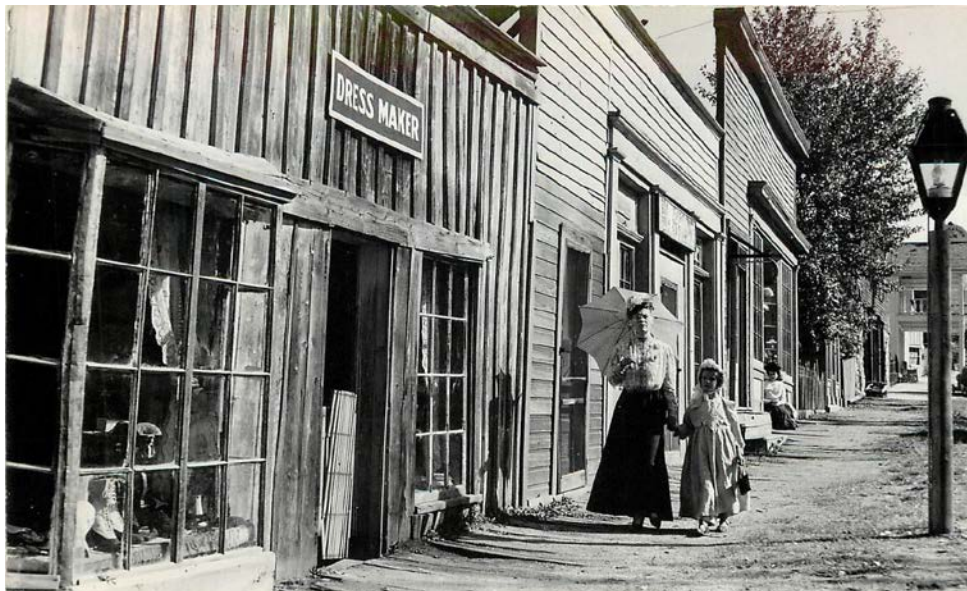
Figure 5.3. A posed 1952 postcard, despite the women in "period dress." Kraemer store is board-and-batten storefront with "Dress Shop" sign.

Kraemer Store have been found, to show at what periods it may or may not have had paint. A postcard from 1952 shows the building to have a weathered, unpainted wood exterior, as well as the trappings of the Bovey-era: barriers and shoe displays, but predate the added wood and corrugated metal awnings added later. (Figure 5.3)

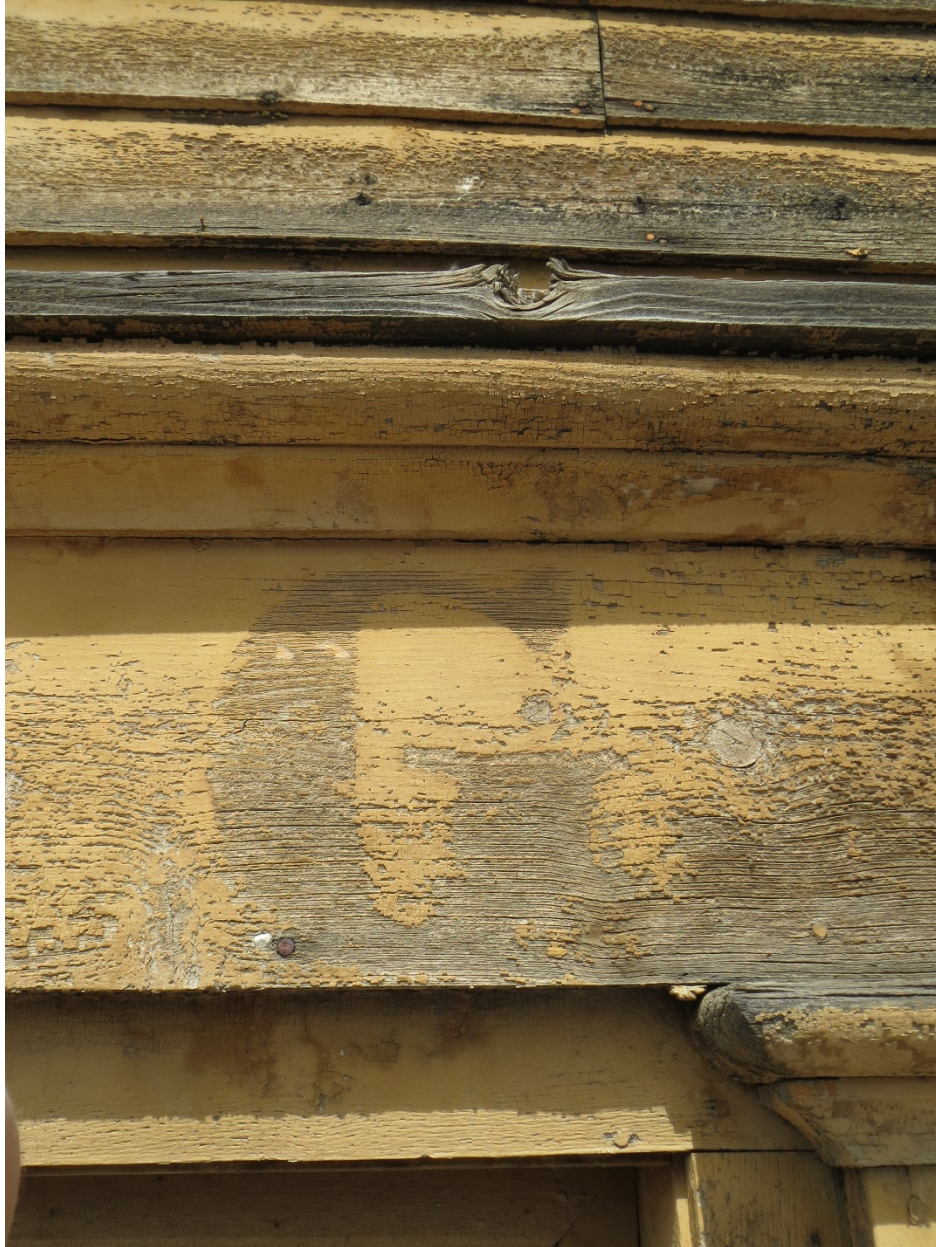
Figure 5.5. Paint Shadow of the "G" in Goldberg. Photographer: K. Geraghty, August 30, 2016

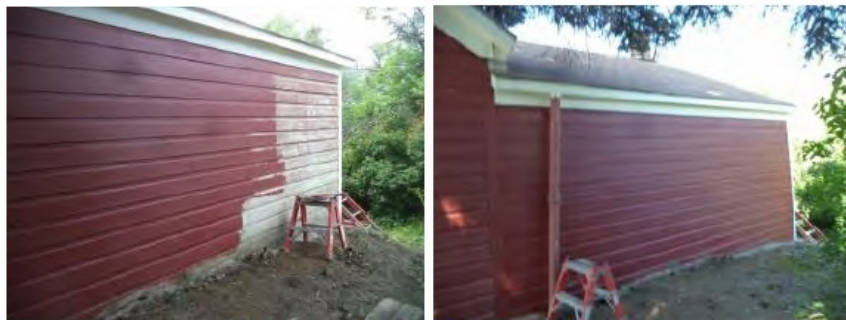
The east side is scraped, primed, and painted.

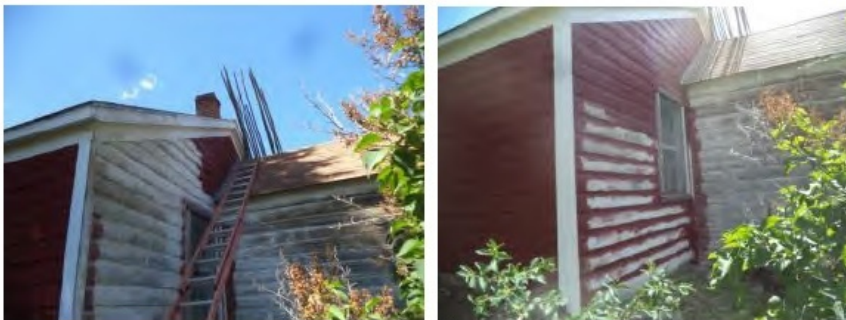
The northeast side is scraped, primed, and painted.

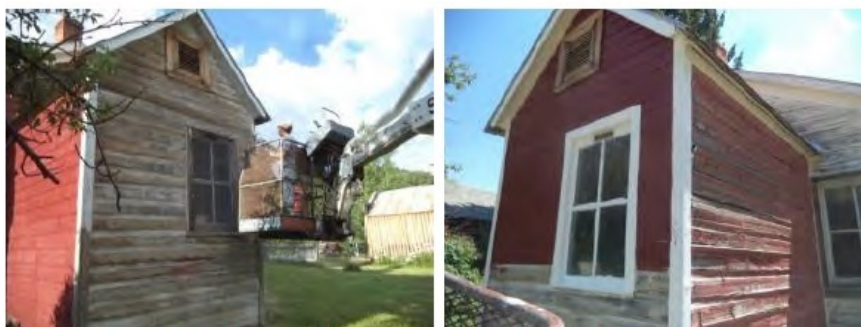
The north side is scraped, primed, and painted using the man lift.

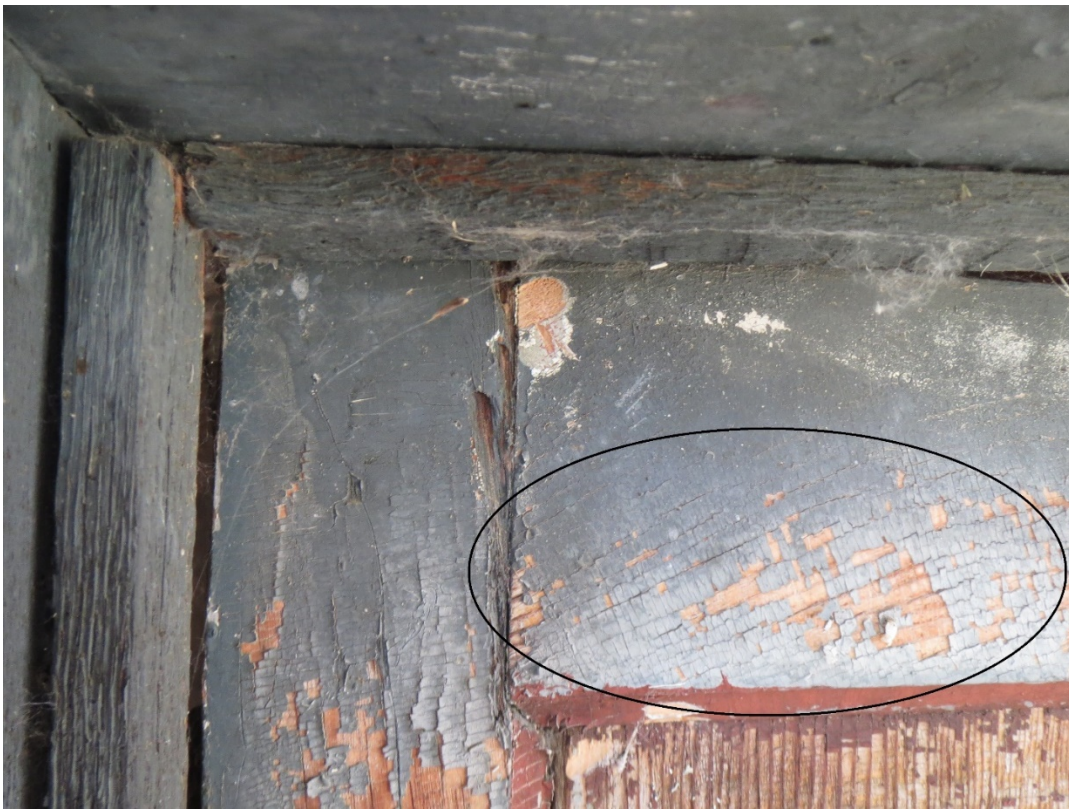
Figure 6.2. Example of "alligatoring" at Green Fronts. Photo by K. Geraghty August 24, 2016

Per the Secretary of Interior Rehabilitation Guidelines, undamaged historical paint should not be removed—paint can adhere effectively to both older paint layers and bare wood substrate.¹³ For paint removal execution, another Secretary of the Interior Technical Brief provides excellent solutions for specific problems—*Preservation Briefs 10: Exterior Paint Problems on Historic Woodwork*.¹⁴ While the Guidelines provide a rough outline of what to do and what to avoid, the technical brief addresses condition assessment, paint removal methods, and paint removal safety with specific instructions. The brief breaks down removal treatments by media type (e.g. distemper or oil mediums) and specific condition problems.

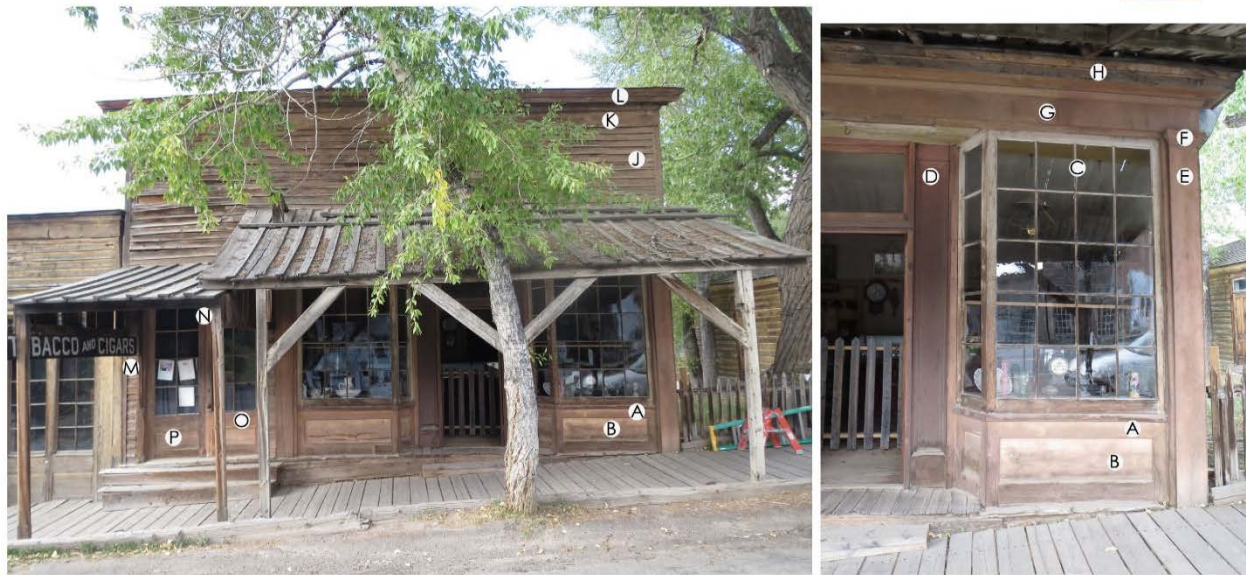
P) First Paint Campaign 5YR 4/1
Second Paint Campaign 7.5YR 5/4

Figure 6.5. Strasburger Colorado Store paint recommendations, keyed by location. Image created by Kate Geraghty, May 2017

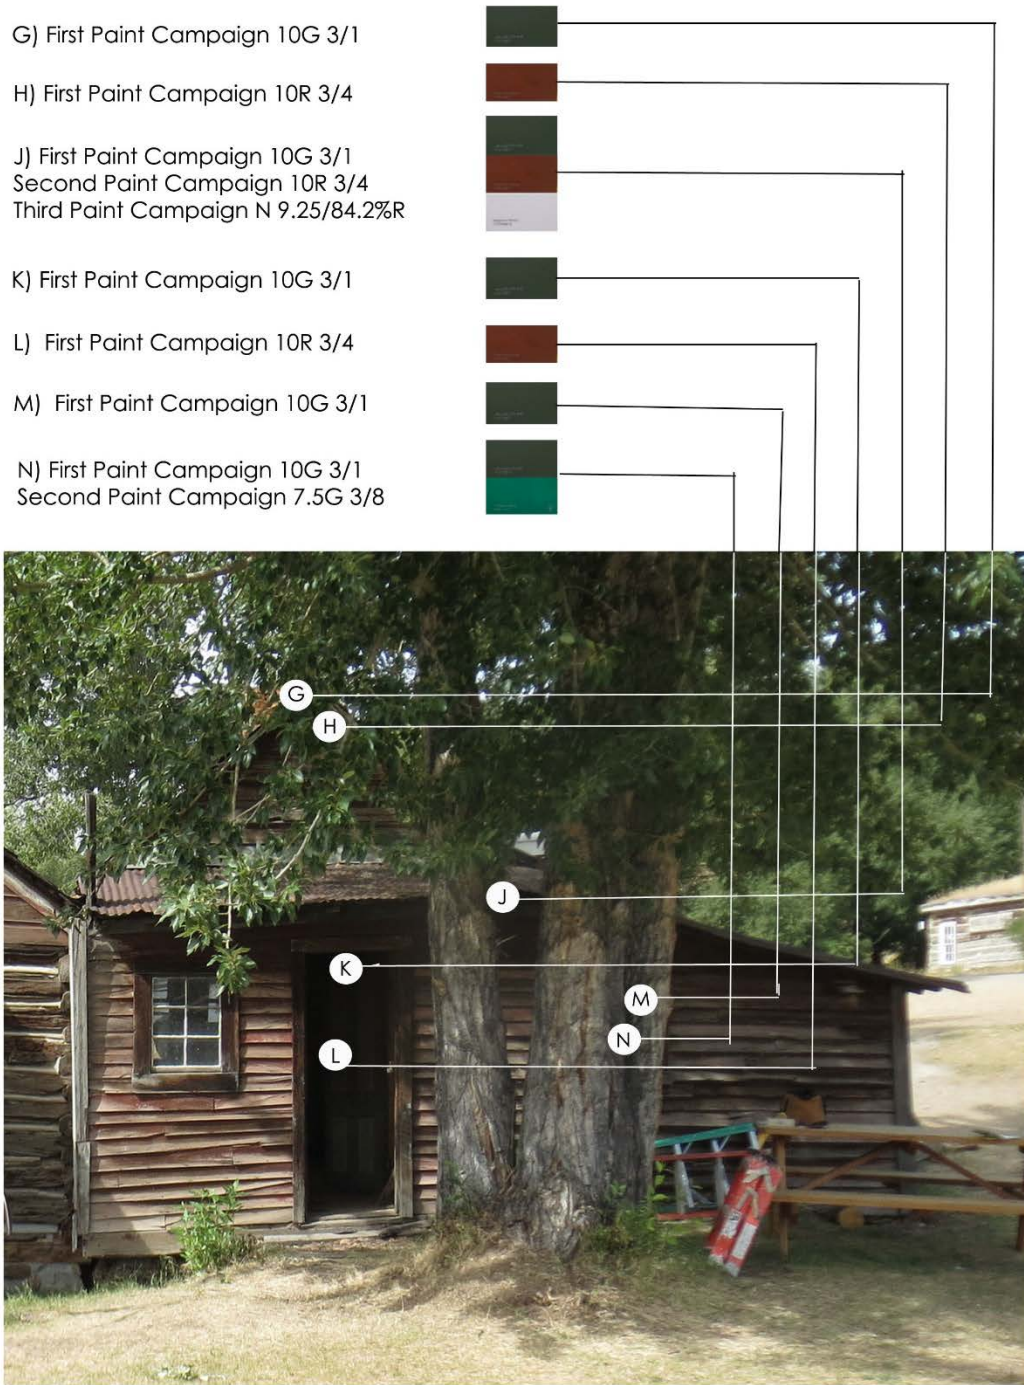
Figure 6.7. Green Fronts East Building South Elevation paint recommendations, keyed by location. Image created by Kate Geraghty, May 2017

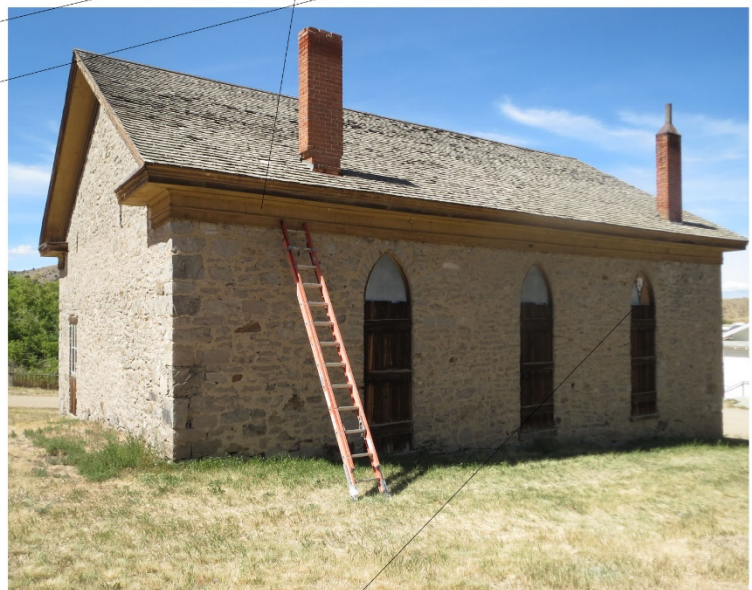
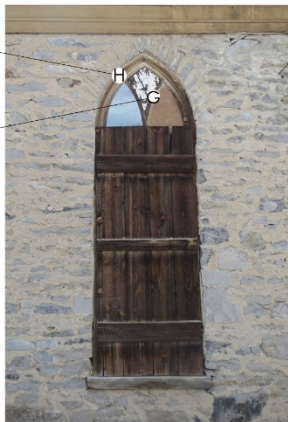
G) First Paint Campaign N9.25 / 84.2% R
Second Paint Campaign 2.5Y 5/4

H) First Paint Campaign 10B 9/1
Second Paint Campaign 2.5Y 5/4

G) First Paint Campaign 10B 9/1
Second Paint Campaign 5Y 5/2

Figure 6.9. Methodist Church Exterior eave and window paint recommendations, keyed by location. Image created by Kate Geraghty, May 2017

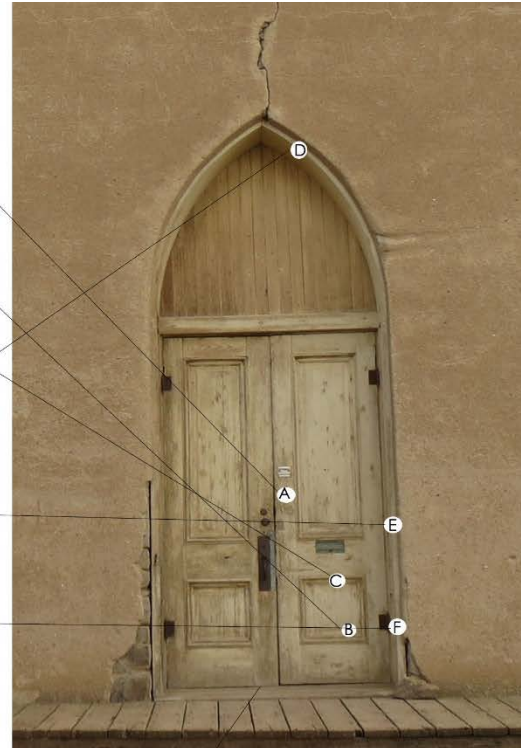
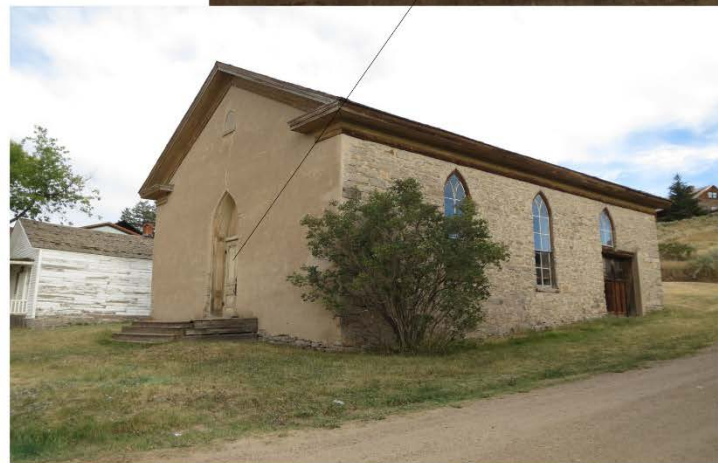
F) First Paint Campaign N 9.25 / 84.2%R
Second Paint Campaign 2.5Y 8/6

Figure 6.10. Methodist Church Exterior Door paint recommendations, keyed by location. Image created by Kate Geraghty, May 2017
