MONITORING AQUATIC HABITAT RESTORATION  
USING MULTISPECTRAL HIGH-RESOLUTION REMOTE SENSING

Presented to the Department of Geography  
and the Graduate School of the University of Oregon  
in partial fulfillment of the requirements  
for the degree of  
Master of Science

June 2019

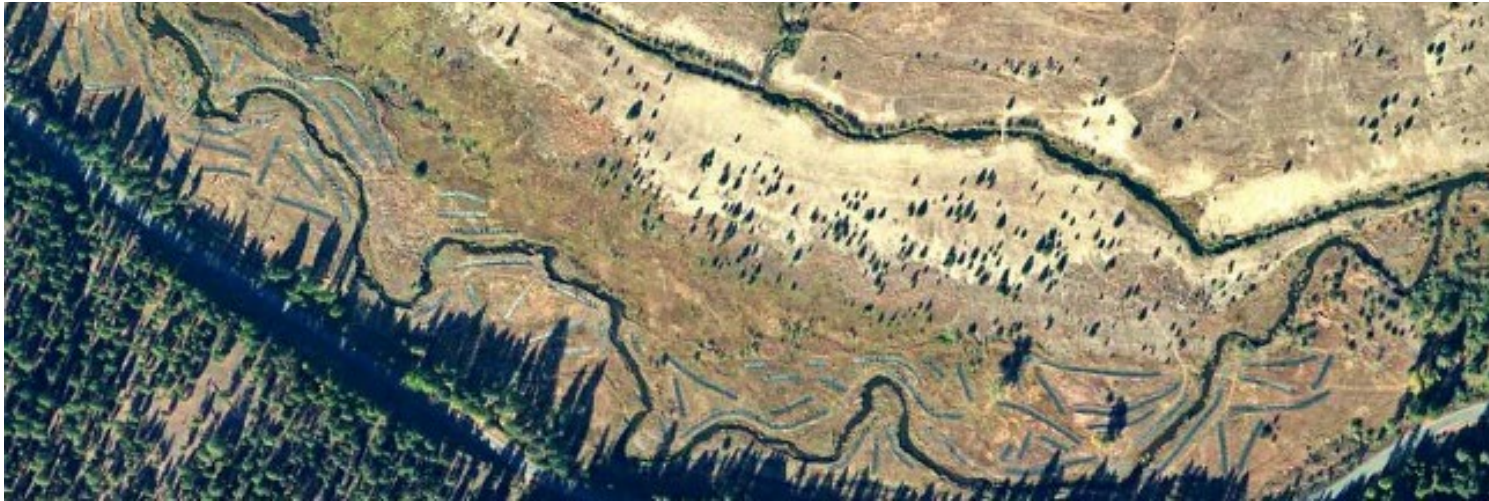
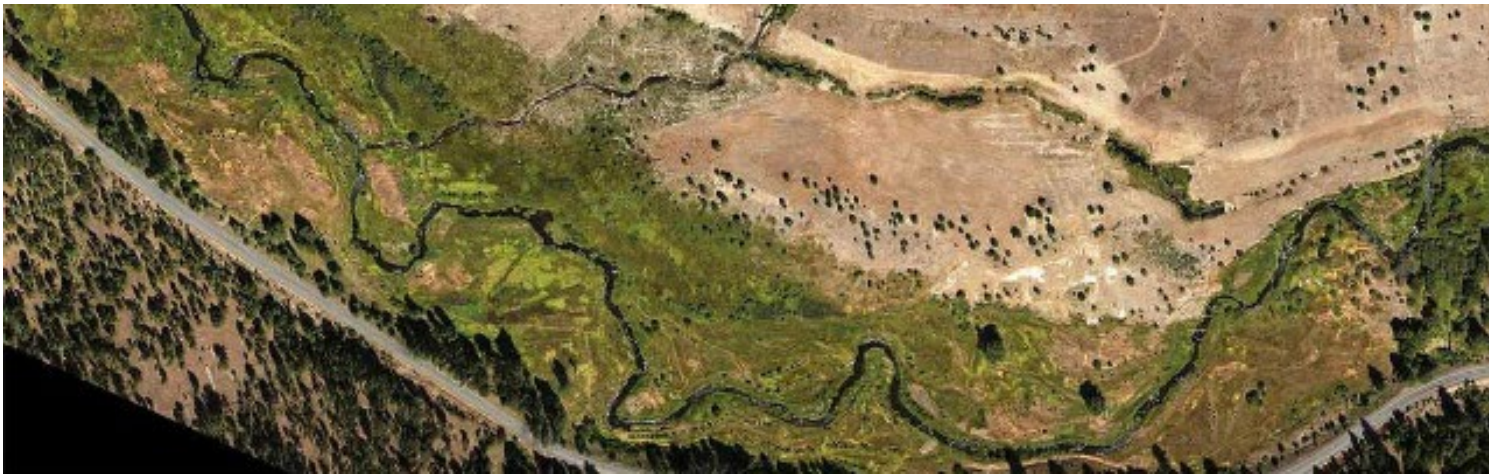
**Figure 2:** Oxbow Conservation Area before restoration (left) and after restoration (right). Following restoration, the northern dredge channel has been eliminated and a new channel has been constructed for Granite Boulder Creek, in addition to multiple grazing exclosures, large woody debris placement, and riparian plantings.

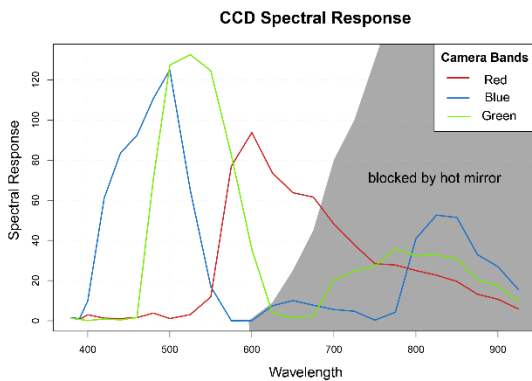
**Figure 3:** Sensitivity curves of a typical CCD array, showing NIR wavelengths blocked by the hot mirror. (Data source: Dan Lewellyn 2018)

Because the camera sensors are not equally sensitive to all wavelengths of light within their band (see Figure 3), producing a weighted average of reflectance is advantageous as it gives a more accurate estimate of the radiation actually being perceived by the sensor. Many studies (e.g., Coburn, 2018) utilize a simple unweighted average of the reflectance across all wavelengths within a respective band (in other words, it assumes the camera records the entire band equally), but this may mask some variation in the sensor that has the potential to affect the final raster output. For example, the red band in Figure 3 shows a strong peak at 500nm, while other wavelengths of light within the red band are far less represented. An unweighted average assumes equal sensitivity to the entire range. For each panel, the reflectance at a given wavelength (Figure 6) was weighted by spectral sensitivity in Figure 3 and summed to produce a “weighted reflectance that is more representative of the camera sensitivity using the equation:

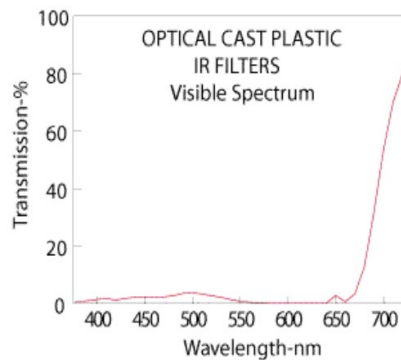
**Figure 4:** Transmissivity of the NIR-Pass Filter. (Figure Source: Edmund Optics, 2018)

Within the range of spectral sensitivity of the Canon camera, the IR filter passes as much as 80% of near infrared light, which is sufficient for the production of aerial imagery under well-lit conditions. Because slightly more near-infrared light is captured on the red band of the Canon camera than the blue or green (Figure 3), I used only the modified red band of the camera to extract NIR data. While other studies utilize the blue band of the camera to minimize interference, the red band records comparatively more near infrared radiation than the blue, making it a practical choice in situations where the IR filter has a steep absorption curve and removes the vast majority of visible red light (see Figure 4). Additionally, the NIR sensitivity peak in the camera's blue band occurs near 850 nanometers. In vegetation applications, the "red edge" between 680nm and 730nm contains the strongest change between visible red and near infrared and is considered to be the best portion of the spectrum to emphasize in terms of spectral

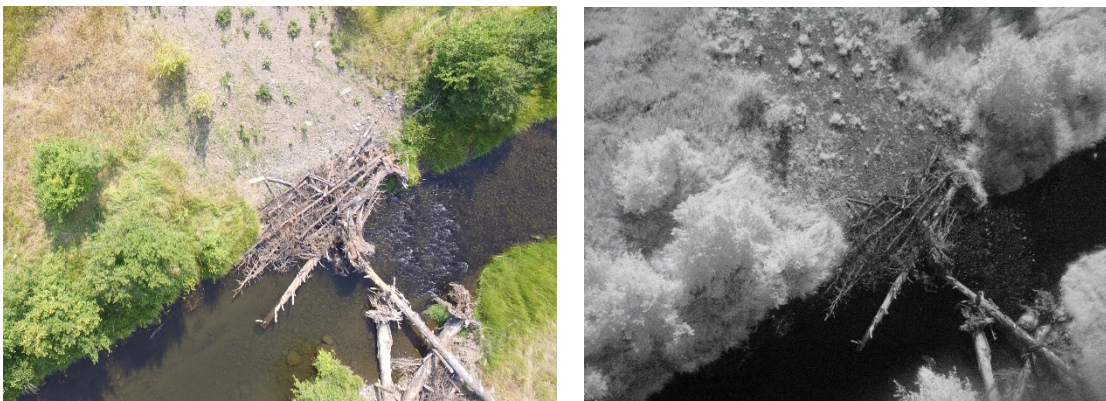
**Figure 5:** Example of unprocessed JPEG images taken with the Phantom III Pro FC300X camera (left) and modified Canon A480 (right). The RGB image at the left can be subsequently broken down into its 3 constituent bands of visible light and merged with the NIR image to produce a 4-band raster stack.

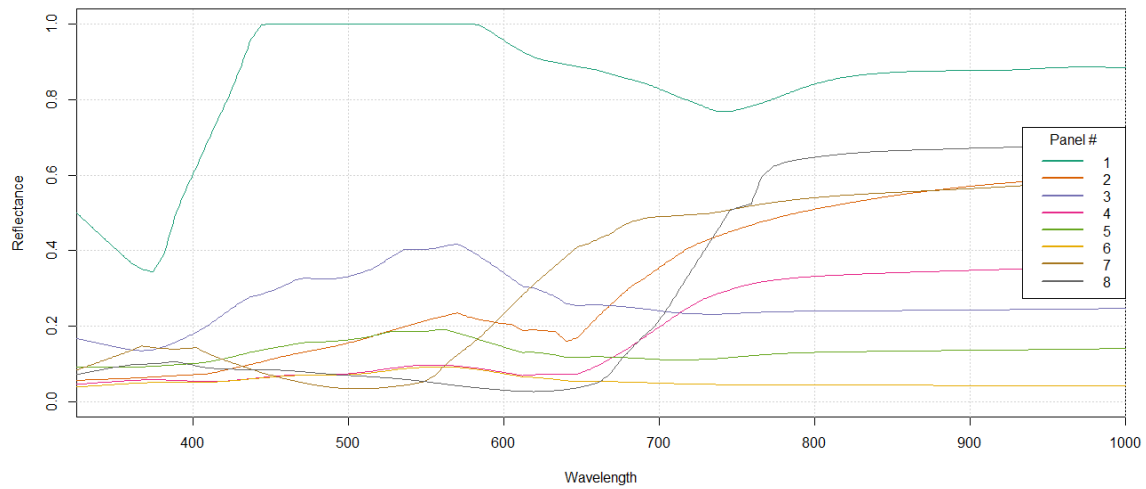
**Figure 6:** Spectral reflectance curve of each calibration panel.

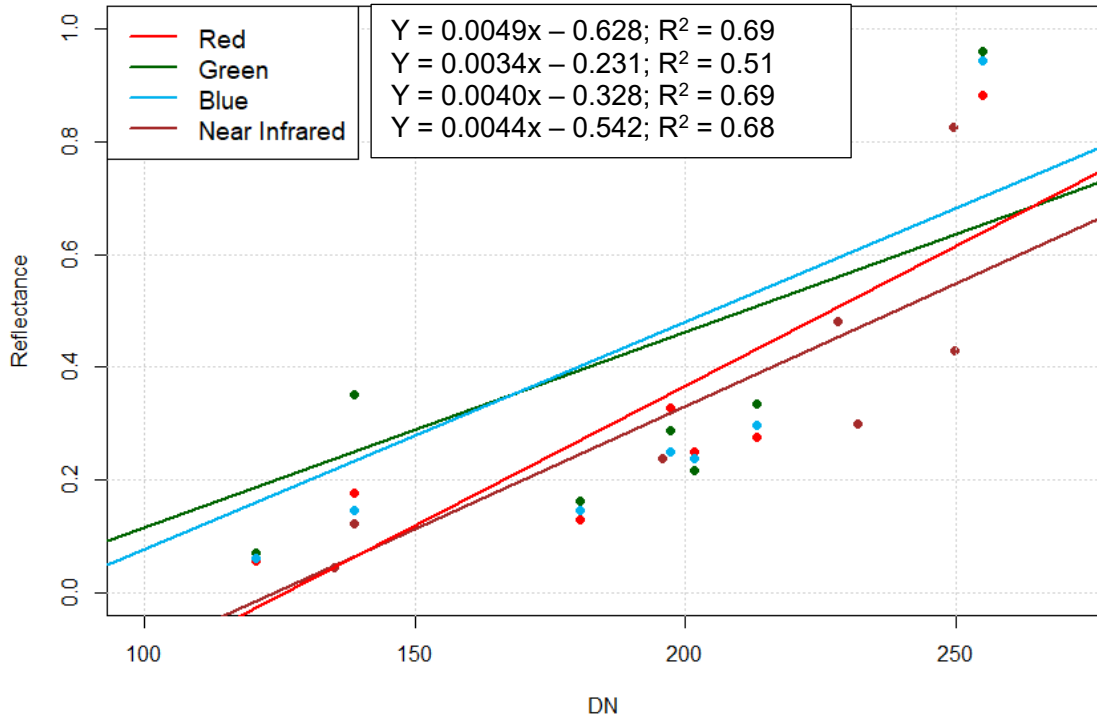
**Figure 7:** Plot of DNs and Reflectance values for each sensor waveband used to generate calibration regression equations.

The  $R^2$  values for each band are relatively low compared to those obtained by Mathews et al., 2015 and Michez et al., 2016 - this is to be expected when prioritizing diverse spectral characteristics during calibration, and highlights the caution one should have when interpreting heterogeneous materials and landscapes. It is additionally important to note that the cameras must theoretically be recalibrated if the settings are to be adjusted - for example, if imaging during cloudy conditions requires a longer shutter speed for adequate brightness, then reference image DNs would need to be re-taken with camera settings used under those conditions, and subsequently plotted against calibration panel spectral curves.

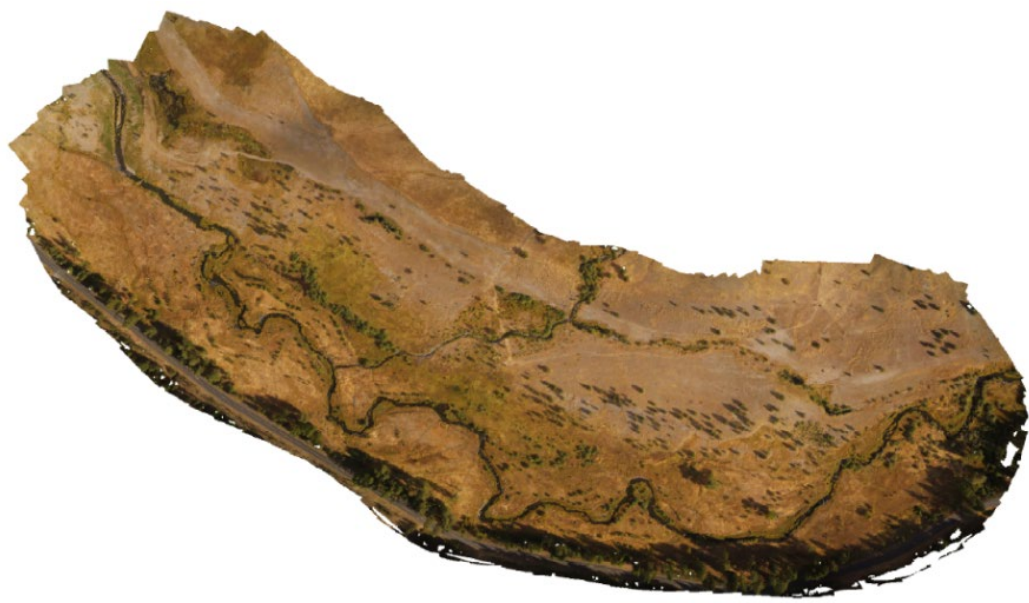
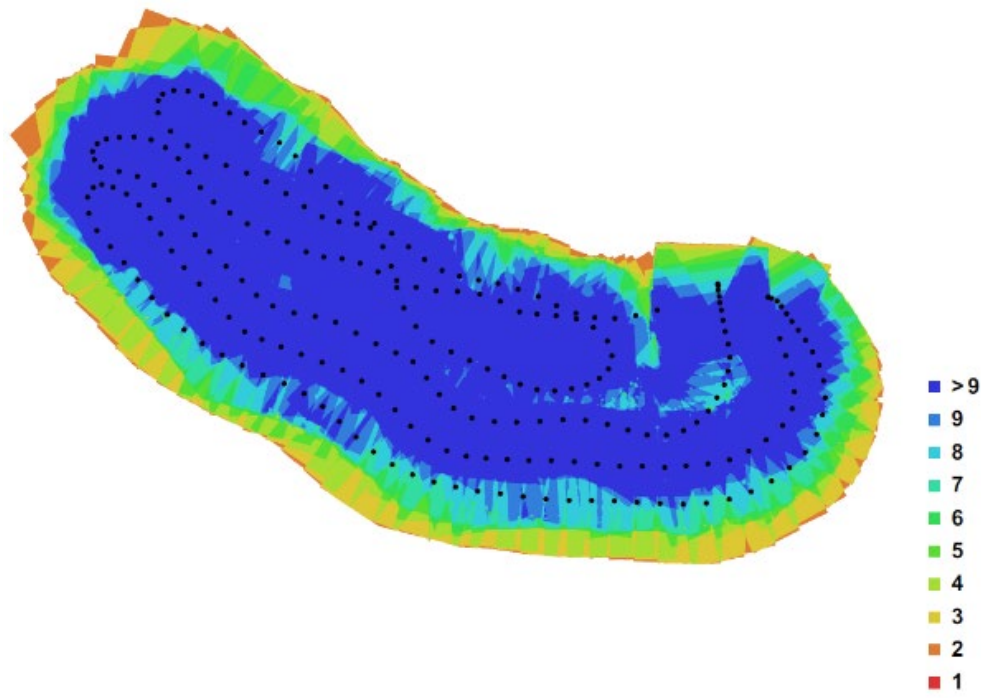
**Figure 8:** Final RGB orthophoto generated for Oxbow Conservation area (top), showing amount of image overlap throughout the study area (bottom). Each dot represents the position of the drone at the time of image capture.

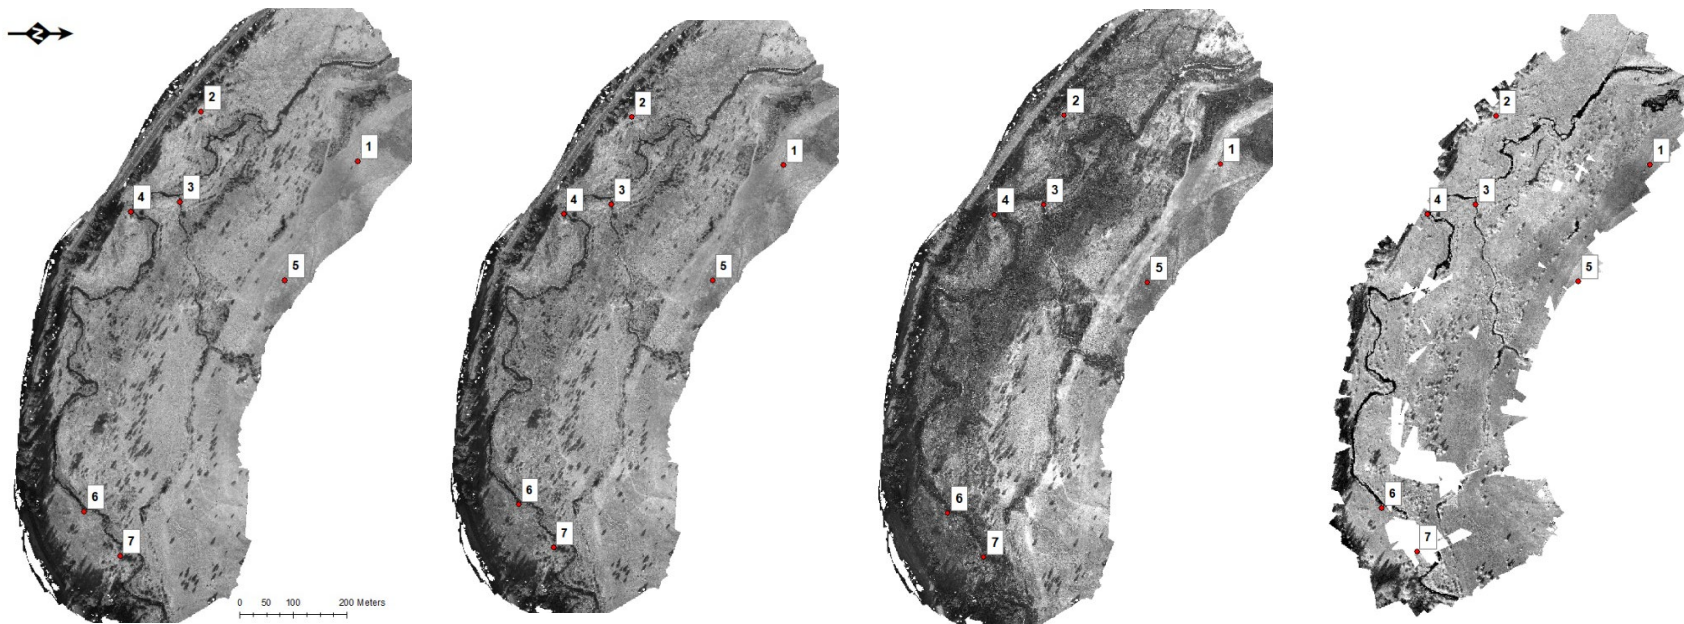
**Figure 9:** Orthophotographs of each band (from left to right: Blue, Green, Red, Near-Infrared) showing ground control points used for georectifying 2018 imagery to 2013 imagery. The gaps in the NIR orthophoto are the result of insufficient overlap in those areas and is partially due to the smaller FOV of the Canon camera in relation to the drone's FC300X.

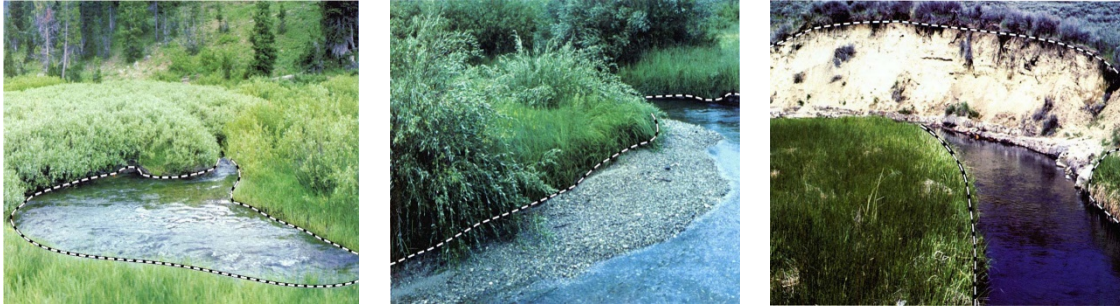
**Figure 10:** Greenline location examples under bankfull conditions (left), low flow conditions (center), and areas of erosion and/or incision (right). Note the inclusion of xeric vegetation in the cut bank greenline in the third image. (Source: Winward, 2000)

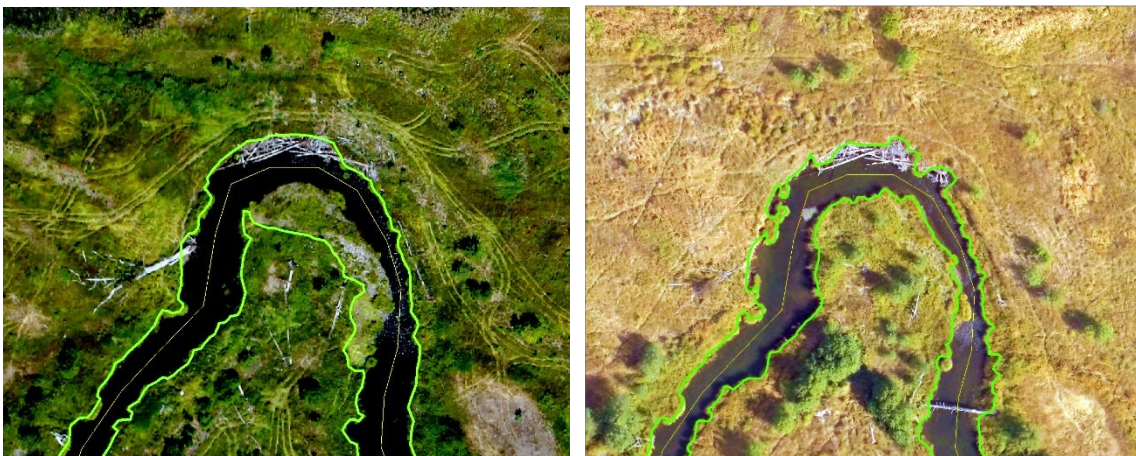
**Figure 11:** Greenline location in 2013 (left) and 2018 (right). While some mixed annual/perennial vegetation is present at the water’s edge in 2013, it is not until 2018 that coverage is continuous enough to place the greenline in that location. Flow is from right to left.

Figure 11 shows an example of the greenline digitized for the same location in two different years – while vegetation is present at the water’s edge in 2013, it does not achieve >60% coverage of continuous perennial vegetation, which pushes the greenline farther from the channel. Figure 12 shows all three digitized greenlines for each bank, with their associated transects generated from the 2013 centerline. With removal of grazing and the restoration of vigorous riparian vegetation, we would expect the distance between greenlines to decrease gradually by year. Results of analysis and subsequent discussion are presented in Chapters V and VI.

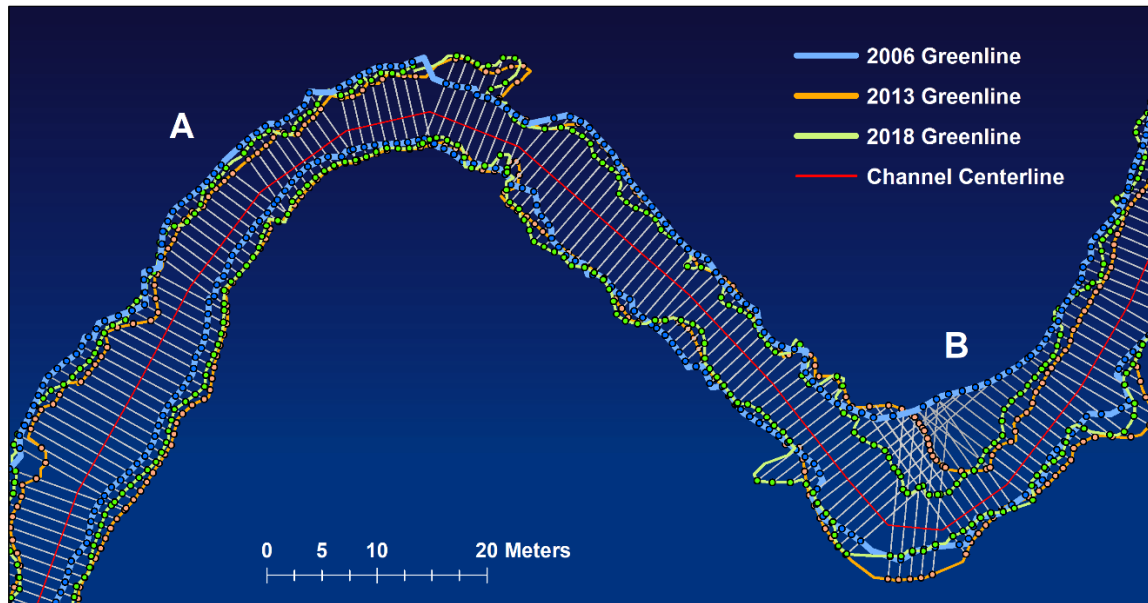
**Figure 12:** Example of fully digitized greenlines showing transects and points of intersection for each year's greenline. At point A, there has been minimal change in the location of the greenline in the 12-year study period. Point B, by contrast, captures perennial vegetation encroachment of nearly 10 meters. Flow in this figure is from right to left. Crossed transects like those present at point B were discarded prior to analysis.

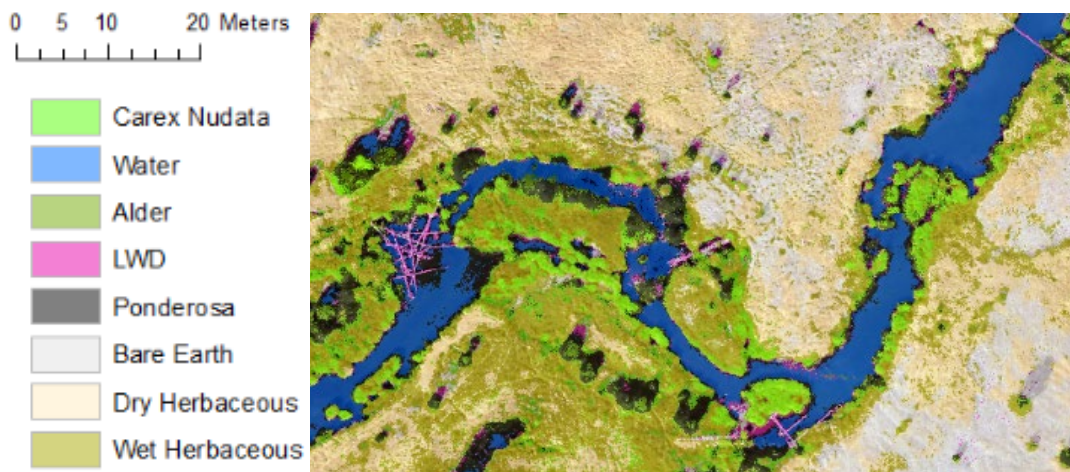
**Figure 13:** Example of classified imagery in Oxbow Conservation Area. The classification performs best for differentiating dry and wet herbaceous material, water, and large woody debris.

To create training classes to identify vegetation groups, I used orthorectified submeter resolution RGB imagery stacked with a DEM for 2006 and for 2018. The 2006 DEM was sourced from highest-hit lidar data, and the 2018 DEM was sourced from SfM processing. Both effectively sample the vegetation height and return those values in a raster format and so are roughly comparable to each other. Figure 13 gives an example of classified imagery.

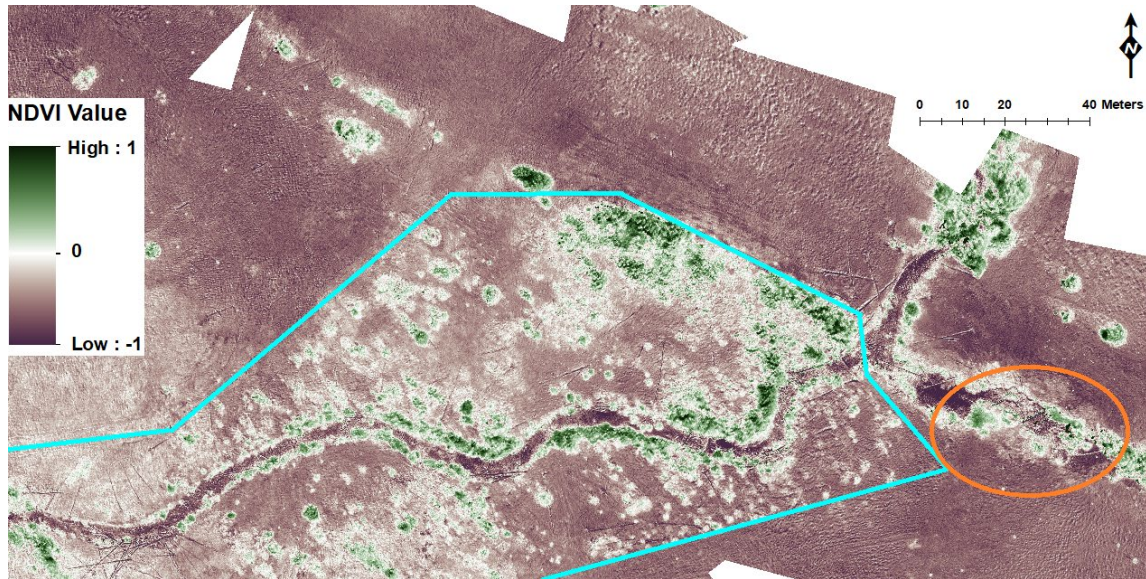
**Figure 14:** Subset of NDVI imagery focusing on restored portion of Granite Boulder Creek. Dark areas show the low values associated with water and mine tailings. Plantings near the channel have the highest NDVI values, while hardwood trees planted farther away are in early fall senescence with accordingly lower values. The fence bordering the restored riparian area of Granite Boulder Creek is outlined in blue, and the alcove formed by a remnant portion of the decommissioned north channel is circled in orange.

I used calibrated red and near infrared orthophotos to produce NDVI maps. Because the 2018 imagery was flown during mid-September, the signal resulting from seasonal precipitation should be at its weakest, and vegetation vigor should correlate with areas of hydrologically connected floodplain with more available groundwater. I then interpreted the NDVI values to assess areas of relatively vigorous vegetation and areas of potential concern, with an emphasis on replanted areas. A portion of the restored floodplain of Granite Boulder Creek is shown below in Figure 14 and shows the area

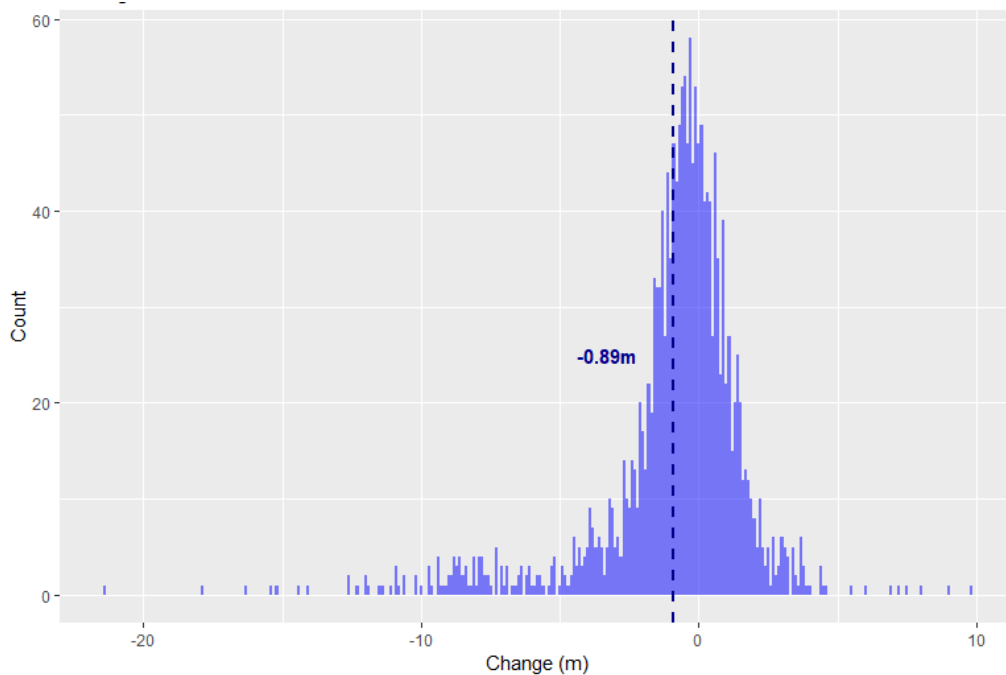
**Figure 15:** Change in greenline to greenline width, 2006 – 2018. The average throughout the study site is indicated by the dark dashed line

The distance between the 2013 channel centerline and the 2018 greenline has generally decreased within Oxbow Conservation Area. Figure 15 shows that the distance between left- and right-bank greenline has generally decreased throughout Oxbow Conservation Area. The values summarized in figure 15 were generated by subtracting the distance from the 2013 centerline-greenline distance from the 2018 distance along the same transect. A negative value shows that the 2018 width was smaller than 2013, indicating narrowing of the greenline. The data are roughly normally distributed with a mode near zero and a slight negative skew, indicating that vegetation has, on average, encroached on the channel by 0.89 meters between 2006 and 2018. It is notable that there far more areas of distinct vegetation encroachment than retreat. Areas of encroachment primarily occur inside meander bends (Figure 16), where areas of gravel bars that were exposed in 2006 that have been rapidly recolonized by riparian vegetation. The greenline additionally tracks well with active channel processes, and captures bank erosion downstream of several large wood structures. The most dramatic change in the greenline occurred between 2006 and 2013, most likely as a result of grazing removal in 2002. The signal captured is primarily due the encroachment of *Salix* and *Carex* species. Woody plantings that do not overhang the channel are not captured by the greenline, but should be increasingly represented through time as canopies become larger and begin to gradually intersect the bank.

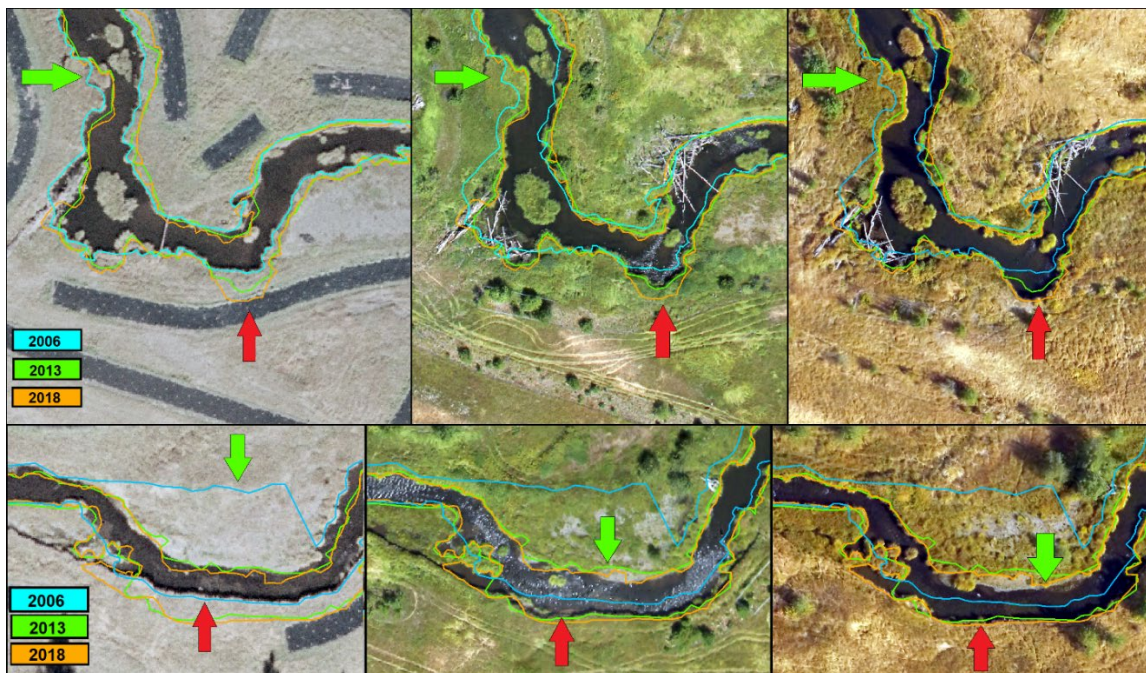
**Figure 16:** Hotspots of greenline change showing all three greenlines across 2006 imagery (left), 2013 imagery (center), and 2018 imagery (right). Red arrows indicate areas of erosion or retreat. Green arrows highlight areas where vegetation has encroached on the channel.

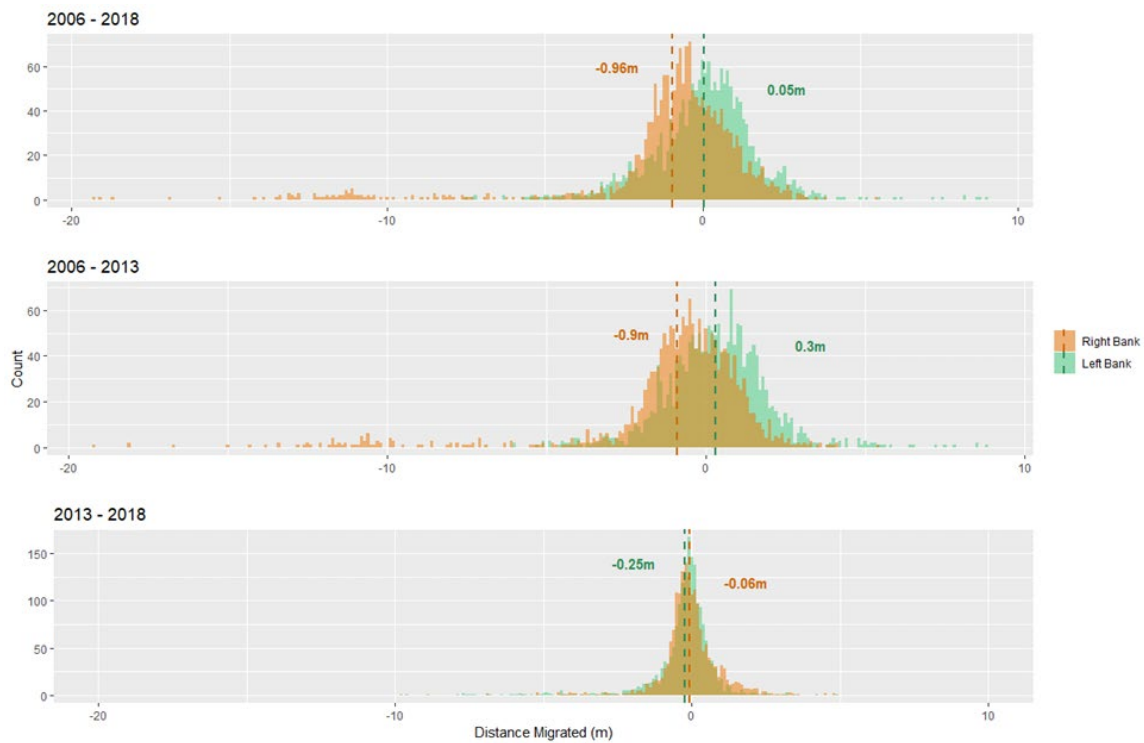
**Figure 17:** Change in distance from greenline to channel centerline separated into left bank (green) and right bank (orange) organized by time interval. The top histogram includes the entire study period, while the second two are broken into two consecutive time intervals. Negative values show movement towards the channel centerline, while positive values indicate greenline movement away from the centerline. The numbers in bold indicate mean change for each bank.

Figure 17 shows the greenline migration for each bank. Of the change visible between 2006 and 2018, the vast majority occurred between 2006 and 2013. Separating migration into right and left banks (facing downstream) additionally reveals that the right bank shows considerably more change than the left bank. Throughout the study period, the left bank was far less mobile than the right, with a total mean change below the RMSE of 12cm. Interestingly, when separated into two time periods, the right bank first widens by 0.3m between 2006 and 2013, and narrows by 0.25 from 2013 to 2018. By contrast, the right bank's greenline moved closer to the centerline throughout the study period, and is the primary cause of the average narrowing in Figure 15.

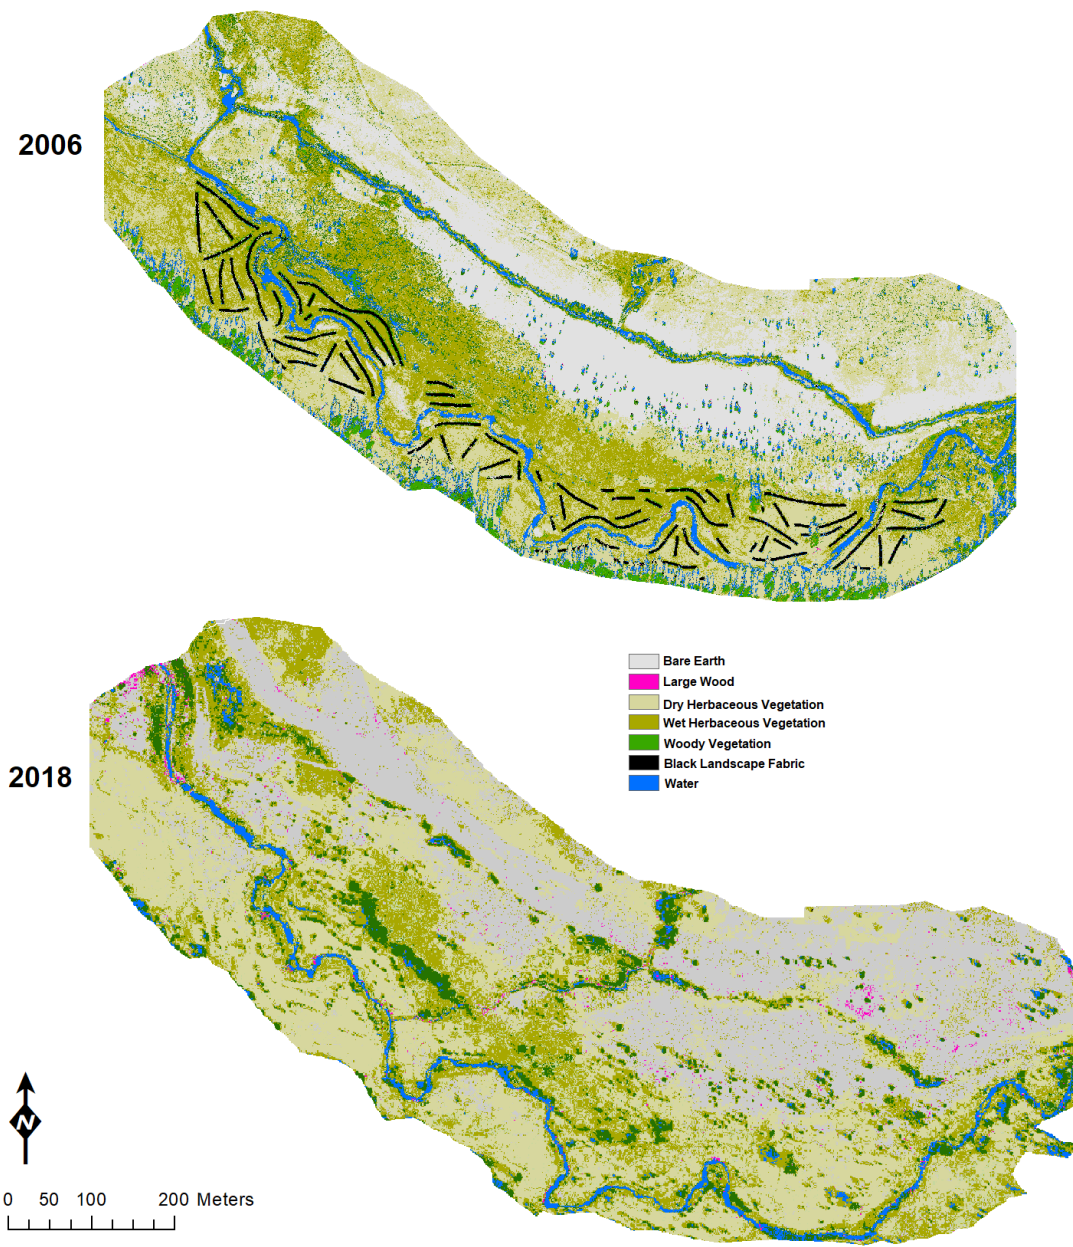
**Figure 18:** Map results of supervised classification within Oxbow Conservation Area

A summary of landcover composition change is provided in Table 7, and the pixels counts used to generate them can be found in Table 8. Between 2006 and 2018, there was an increase in bare earth, large woody debris, dry herbaceous vegetation, and wet herbaceous vegetation. Open water and woody vegetation decreased slightly, and black plastic tarps were no longer visible in 2018. The decrease in water and woody vegetation is primarily due to the decommissioning of the north channel, where landcover has mostly changed to either herbaceous vegetation or reverted to bare earth. Although the overall pixel count of woody vegetation decreased, woody vegetation in 2018 is much less intermixed with bare earth and dry herbaceous vegetation, indicating that woody riparian plants are filling in and becoming more established.

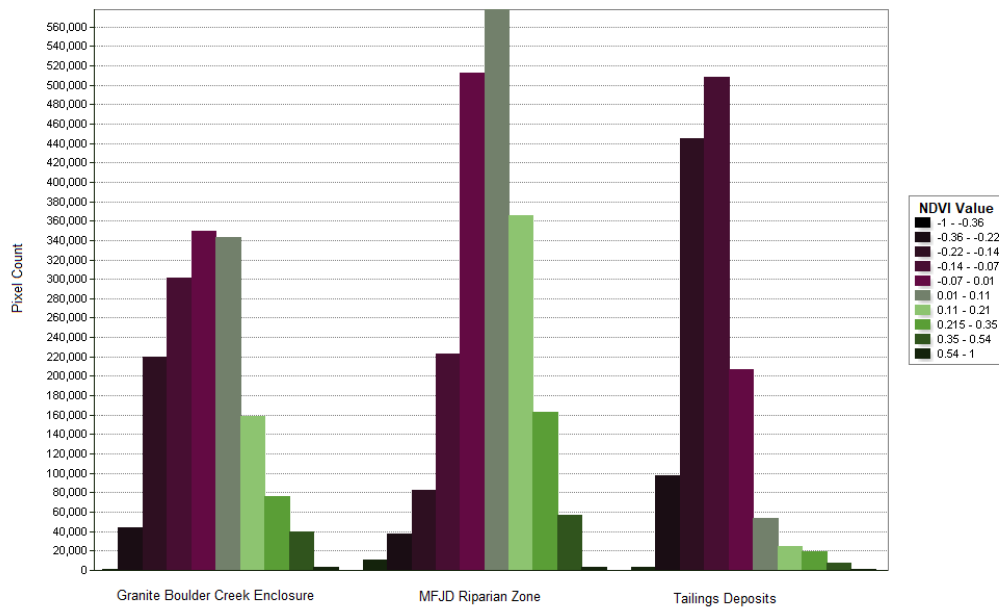
**Figure 19:** Histograms of NDVI values for contrasting areas of Oxbow CA

NDVI values calculated for Oxbow Conservation Area are summarized in Figure 19 and mapped in Figure 20. Because there are no calibrated measurements of NDVI prior to this imagery, these images can serve only as a point in time descriptions of vegetation vigor within the site and cannot indicate change without multitemporal imaging. The lowest NDVI values within both study sites correspond with areas of bare earth – at Oxbow, this primarily reflects the dredge tailings near the decommissioned north channel. The highest values correspond with near-channel *Alnus* and *Salix* clusters, as well as stands of *Pinus ponderosa* on the hillslopes near the southern extent of the site.

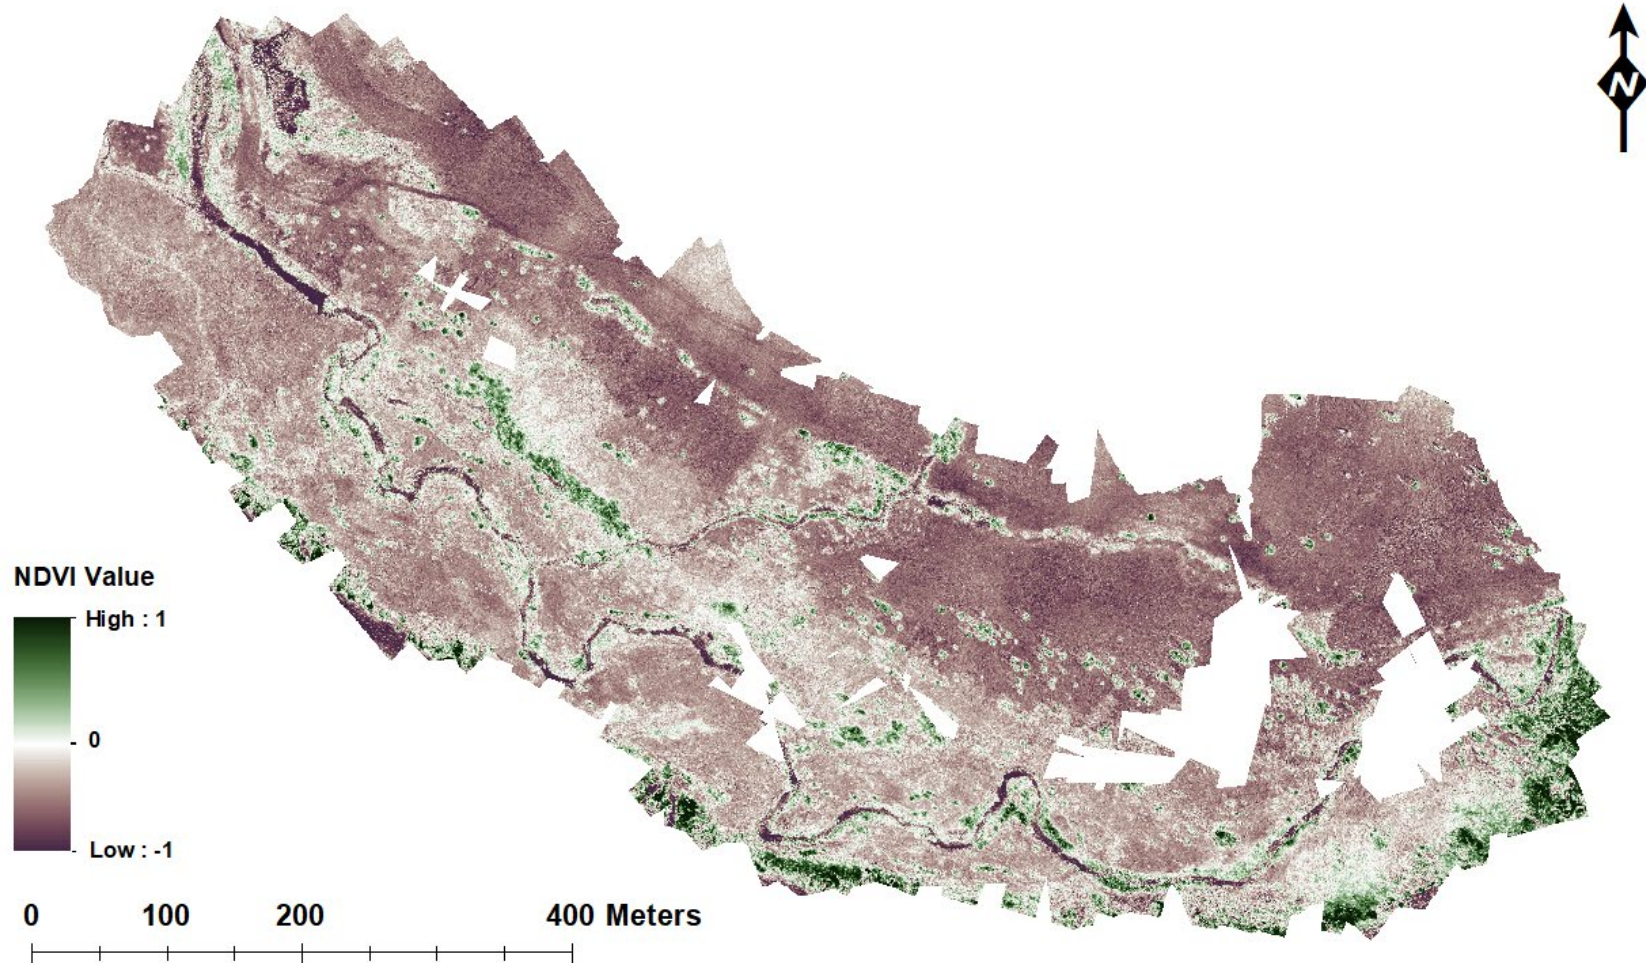
**Figure 20:** NDVI Map of Oxbow Conservation Area  
Spatial Resolution: 4.3cm/px

Most of the riparian zone within Oxbow CA has an NDVI value between 0.1 and 0.3, which is consistent with late summer conditions and drought stress in semi-arid floodplains. Remnant vegetation along the decommissioned north channel maintains a value similar to the riparian zone of the south channel, and the plantings within the restored portion of Granite Boulder Creek near the center of the map show notably higher values than the bare earth outside of the deer and elk browse exclosures (Figure 14, Chapter III shows a subset focusing on Granite Boulder Creek). Mid-channel *Carex nudata* islands are visible within the mainstem MFJD and maintain values between 0.2 and 0.3. Plantings within exclosures around old planting strips, particularly in the southwestern portion of the map, maintain some of the highest near-channel NDVI.

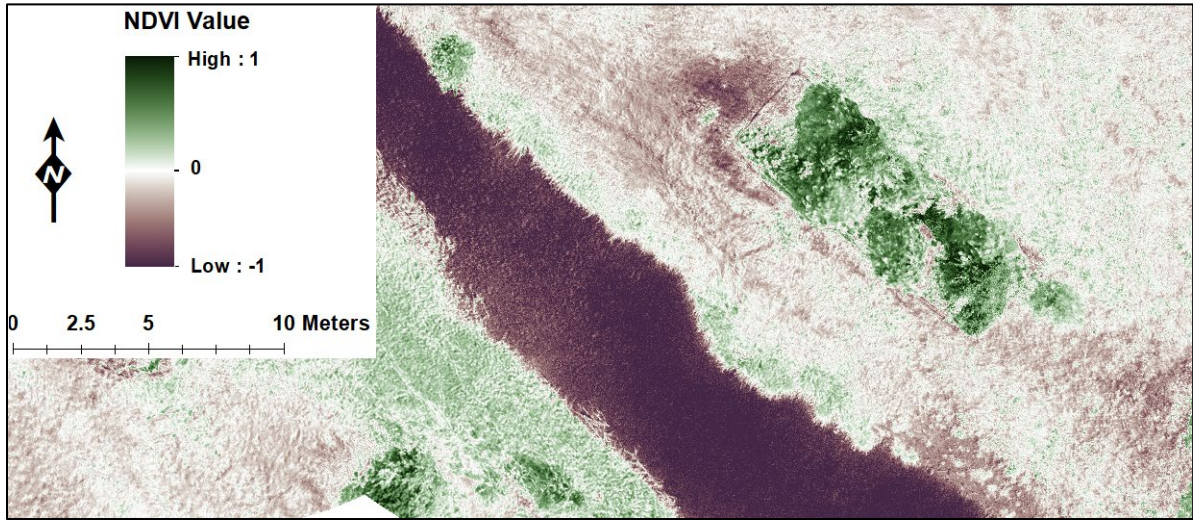
**Figure 21:** Subset of Forrester NDVI map, showing values at the individual plant scale  
Spatial Resolution: 1.5cm/px

Imagery with 1.5cm resolution taken at Forrest Conservation reveals variations at the scale of individual plants. Figure 21 shows a fenced area of plantings adjacent to the MFJD containing 6 planted trees. The highest NDVI values are near the center of the exclosure. The shrub near the water's edge near the top left of Figure 21 is an alder that has not been protected from browse, which may partially explain its lower NDVI values. These values, while fundamentally descriptive and observational in nature, help to paint a clearer picture of the success of riparian revegetation success within the study areas.

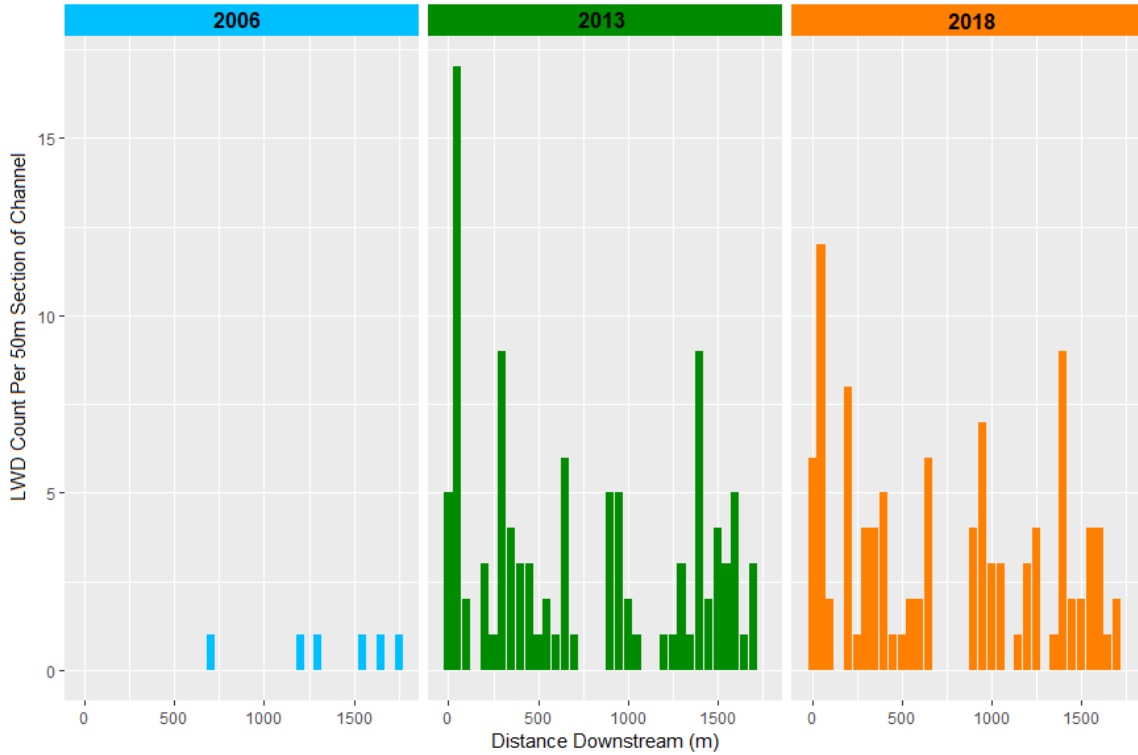
**Figure 22:** Downstream abundance of LWD organized by year

In 2006, there was virtually no large wood with a length >7m in the mainstem MFJD, for a total count of 6 pieces. In 2013, active construction of LWD structures made for a total count of 104 pieces – this total remained the same in 2018. Results from analysis of 2013 and 2018 imagery show that large wood within Oxbow Conservation is mostly stable. Figure 22 shows the downstream abundance of large wood plotted by 50m unit for each year of aerial imagery. Between 2013 and 2018, abundance has remained constant, but the distribution within Oxbow has become somewhat less clustered, with some downstream movement of wood (see Figure 23 for examples).

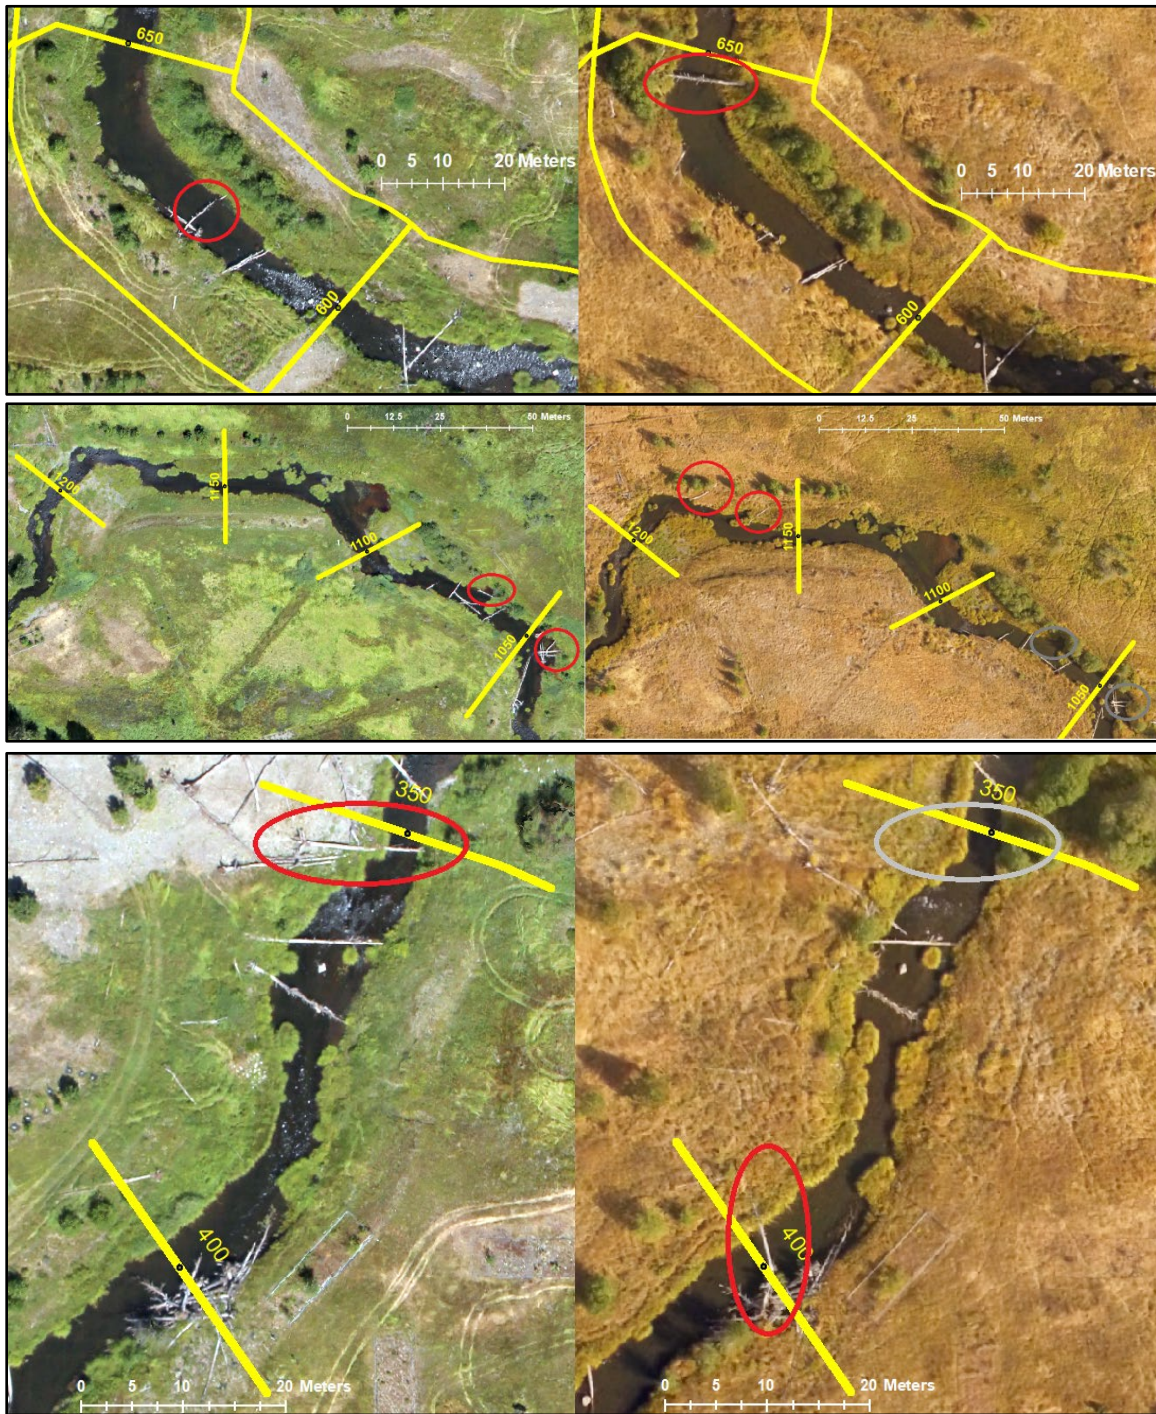
**Figure 23:** Examples of wood movement within the study area for June 2013 (left), and September 2018 (right). The yellow lines indicate distance downstream in meters from the beginning of the study site, and were used for unit breaks to bin LWD. Red circles show individual pieces of wood identifiable in both years of imagery.

The vast majority of wood structures within the study site have remained stable, keeping in line with the goals of restoration design. Loose pieces within the study reach have undergone some redistributing and downstream movement. Figure 23 gives visual examples of wood movement within Oxbow CA. The first pair of images shows downstream movement of roughly 50 meters that remains within the same unit. The second image pair shows the movement of 2 loose pieces downstream into two different units. The bottom pair of images shows a stable logjam accumulating loose wood from upstream.
