MONITORING AQUATIC HABITAT RESTORATION  
USING MULTISPECTRAL HIGH-RESOLUTION REMOTE SENSING

Presented to the Department of Geography  
and the Graduate School of the University of Oregon  
in partial fulfillment of the requirements  
for the degree of  
Master of Science

June 2019

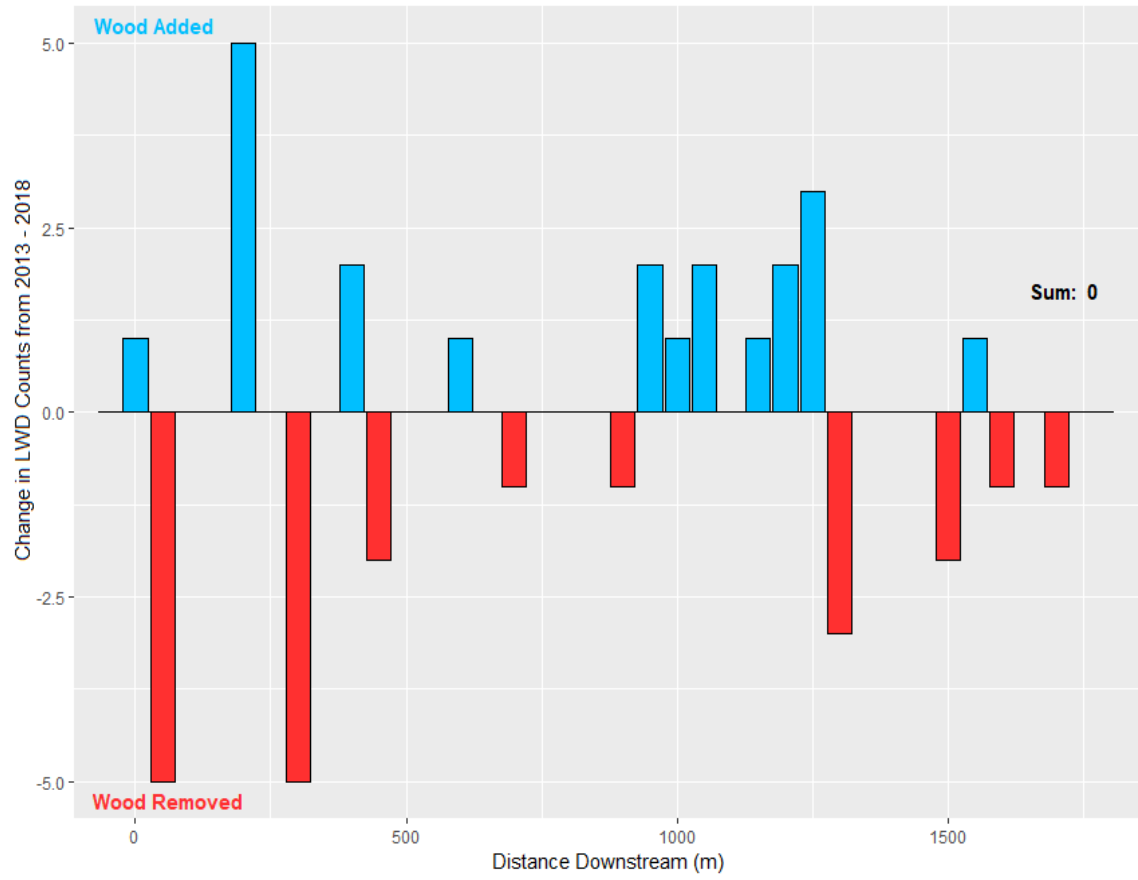
**Figure 24:** Change in LWD distribution between 2013 and 2018.

Reorganization of large wood is summarized in Figure 24, which shows the addition or removal of pieces from individual bins between 2013 and 2018. Note that the upstream-most bin has accumulated wood and the 2 bins farthest downstream have lost wood, indicating that wood has both entered and exited the system. Several large structures towards the upstream extent (distance <500) were only partially reinforced, and should expect some downstream movement of wood pieces. The largest change for any given unit within the study area is 5 pieces of wood.

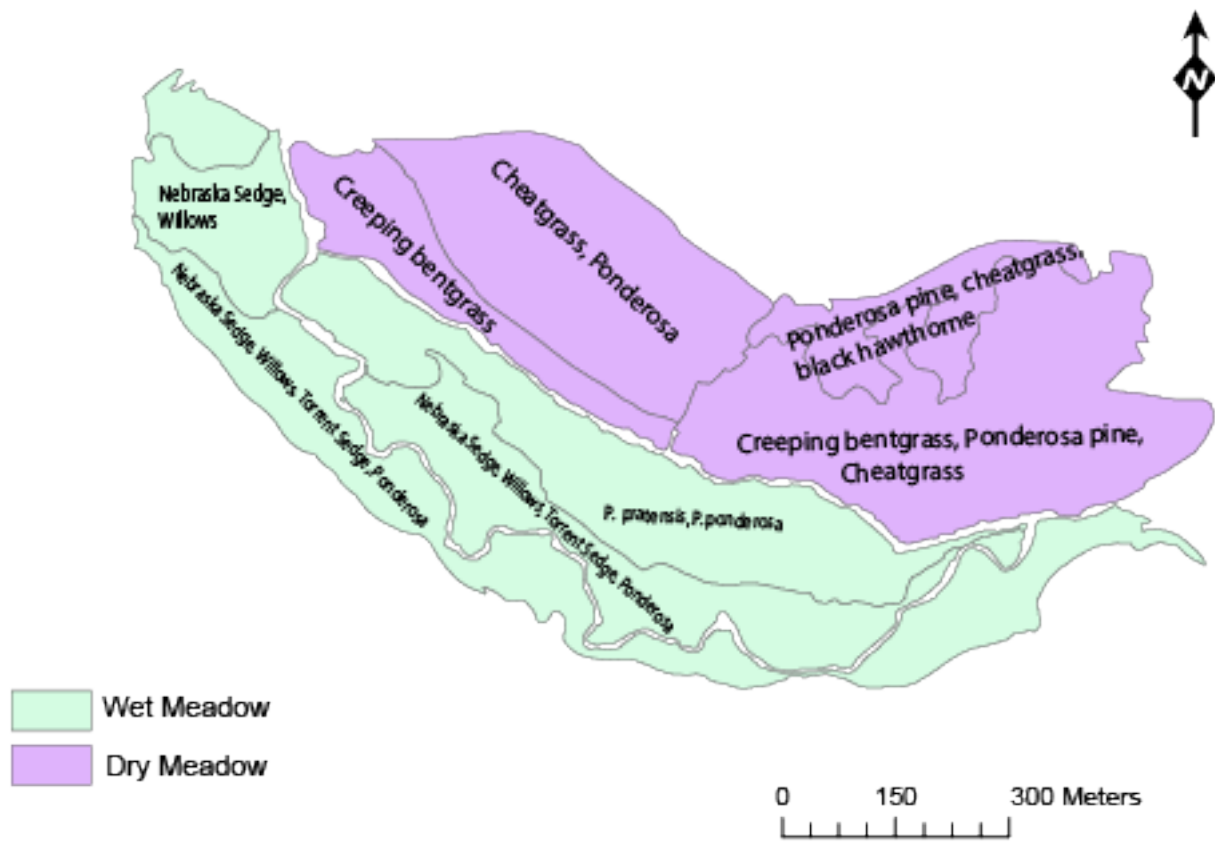
Figure 25: Vector floodplain map generated from field surveys showing dominant species

In addition to this research, mapping done by walking the extent of the MFJD floodplain and digitizing vector community extents by tablet was completed in summer 2018 by Ellsworth et al (2018). This provides an opportunity to compare map results of two methods. Results of 2018 field mapping are shown below in Figure 25. A comparison of the two maps fundamentally reveals the tension between spatial extent and resolution present in any geographic study. Vector floodplain mapping lists the dominant species of a given area of floodplain, with the areas of each polygon determined by the mapper in the field. The vector map provides valuable information about dominant species that is independent of scale. For example, it successfully captures the presence of cheatgrass (*Bromus tectorum*) in the north floodplain and Nebraska sedge (*Carex nebrascensis*) near the channel that are small, non-clumping species outside the realm of feasible identification achievable with drone imagery. This species level identification and mapping is made practically feasible only by generalizing spatial variation across larger areas.

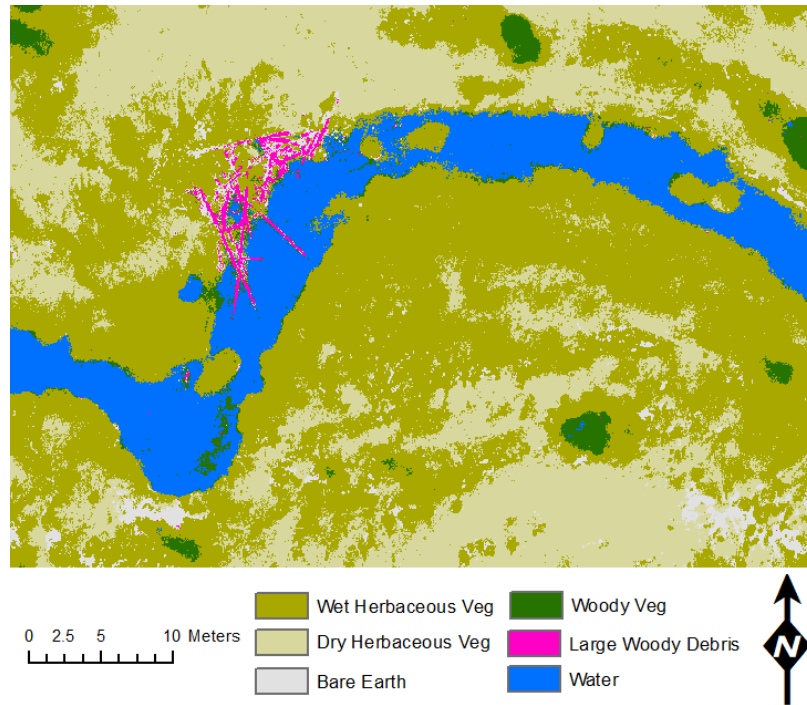
**Figure 26:** Example of supervised classification outputs from drone imagery

well in this study (Figure 26). This is likely a result of the spectral conditions at the time of flying – mixed pixels of dormant grasses and bare earth scattered through the floodplain give them a slight red tint that helped distinguish bright bare earth from large wood.

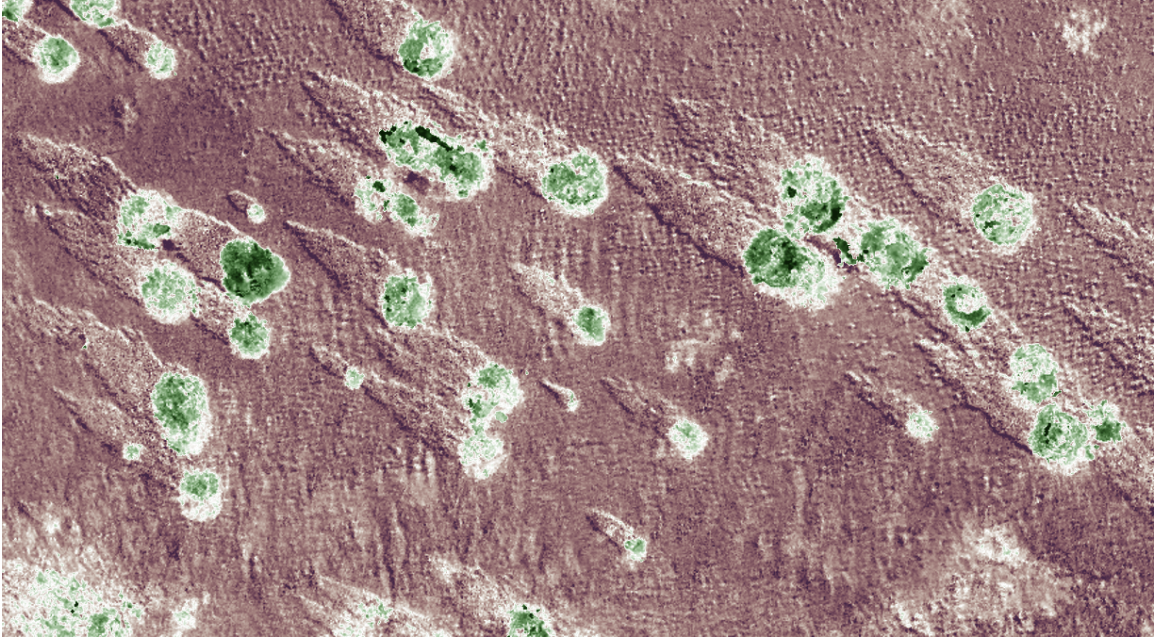
**Figure 27:** Example of shadow effects from tall Ponderosa pine trees in NDVI map. Green areas correspond to individual trees.
