A TERMINAL PROJECT

Presented to the Historic Preservation Program at the University of Oregon  
in partial fulfillment of the requirements for the degree of  
Masters of Science

ALL ALONG THE WATCHTOWER: IDENTIFYING TRENDS IN HISTORIC FIRE  
LOOKOUT PRESERVATION THROUGH SELECTED CASE STUDIES AND A  
STATISTICAL ANALYSIS

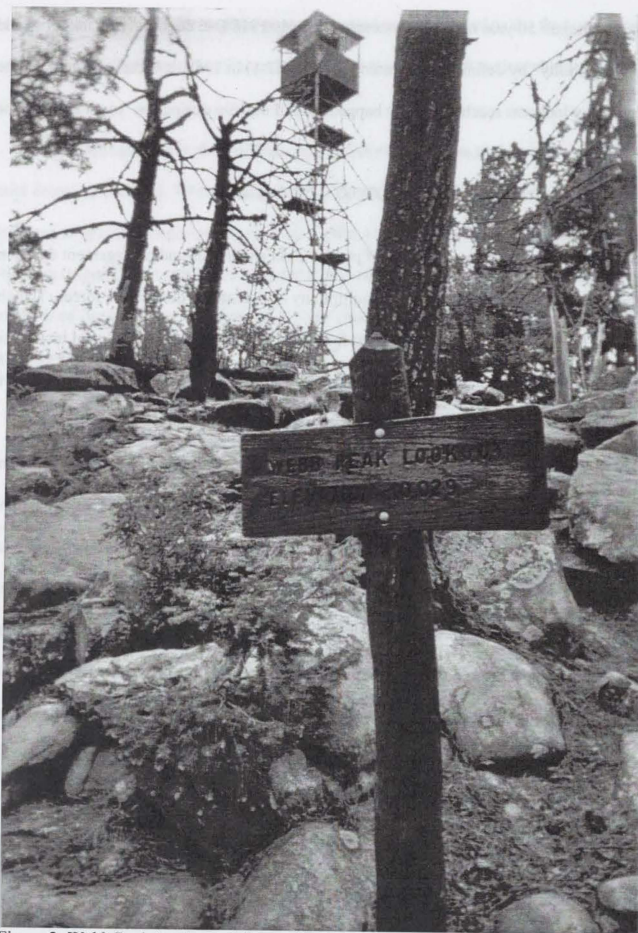
Figure 2. Webb Peak Lookout, Arizona. Photo taken by John Hill. June 2008.

Often fire managers will construct fire line and protect fire lookout structures when possible. During a series of fires in 2004 on the Coronado National Forest, Arizona, Webb Peak Lookout (an extant Aermotor lookout) was in the path of a fire, but through quick action (and much needed dozer line by fire suppression crews) the structure was saved.<sup>45</sup> Even though the lookout was constructed of steel, the extraordinary heat and destructiveness generated by a wildfire would have presumably irreversibly damaged the lookout. The author visited the lookout while on assignment during the 2008 fire season, and was pleased to find the lookout in great condition due to the efforts of other fire suppression personnel. Webb Peak Lookout thus illustrates the ideal outcome in safeguarding lookouts from wildfire. (Figure 2)

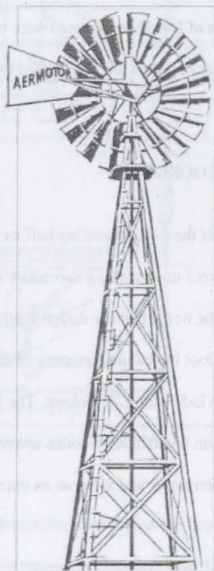
During the 1930s and the CCC era, new observation only lookouts became popular on a national level. Due to the national standardization process of lookout forms, "In the 1930s, the towers were no longer designed and constructed at the local level."<sup>72</sup> Commonly, these observation only lookouts were built by the Aermotor Company from Chicago Illinois (Figure 7).

INSTALLATION  
INSTRUCTIONS

### 4-POST STANDARD TOWERS

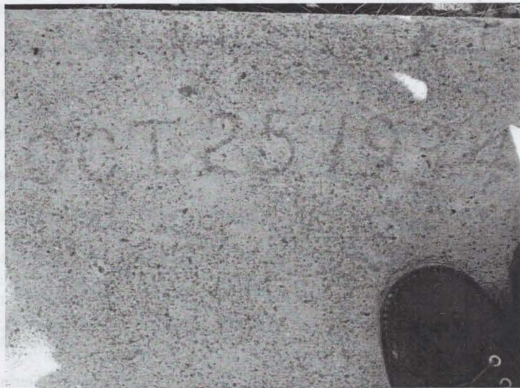
anchored. Often a construction date can be found etched into the once soft concrete; understandably, this date is greatly helpful to lookout researchers (Figure 9).

Figure 9. Blue Ridge Lookout, California. Foundation Construction Date. (Photo by Author, 2009).

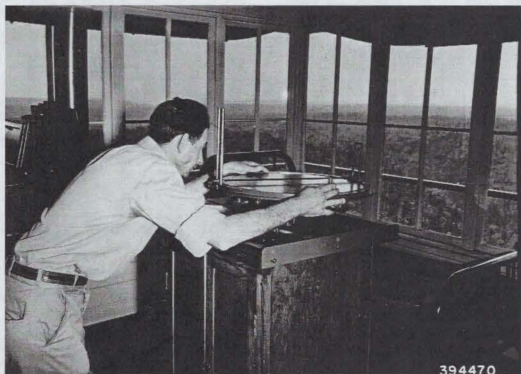
Figure 11. A lookout sights a distant smoke.<sup>91</sup>

The Osborne Fire Finder would be located in the center of the lookout cab or platform on an elevated stand where it was free to rotate 360 degrees in order for a lookout to establish a directional bearing. In conjunction with the Fire Finder, a map was located below the instrument

Osborne's instrument was initially developed as early as 1911, though much like fire lookouts, many renditions of this instrument were later produced with a significant new version introduced in 1934.<sup>90</sup> It is interesting that the device was called a "firefinder" as it simply plotted an unknown smoke or fire location on a topographical map. The actual "fire finding" was up to the lookout, who then would use the firefinder to pinpoint an exact location in order to aid in suppression activities (Figure 11).

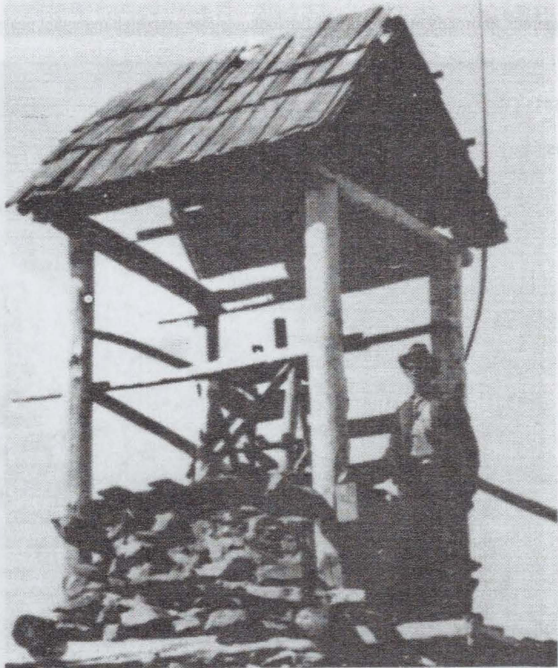
Figure 13. Historic open-sided Fire Finder shelter on Carpenter Mountain.<sup>101</sup>

This simple structure held an Osborne Fire Finder, and had a shingled gabled roof supported by four rough hewn poles. This early lookout shelter provided only limited protection from rain storms and inclement weather (Figure 13).

Carpenter Mountain Lookout site is located on the Willamette National Forest, in Section 7, Township 15S, Range 6E.<sup>98</sup> The lookout site stands at 5349 feet above sea level, and is a complex site lookout.<sup>99</sup> The site was established in 1915 when an alidade was placed on the "summit of the basalt plug."<sup>100</sup> In 1917 an open-sided shelter was constructed on top of the steep rock scree (Figure 13).

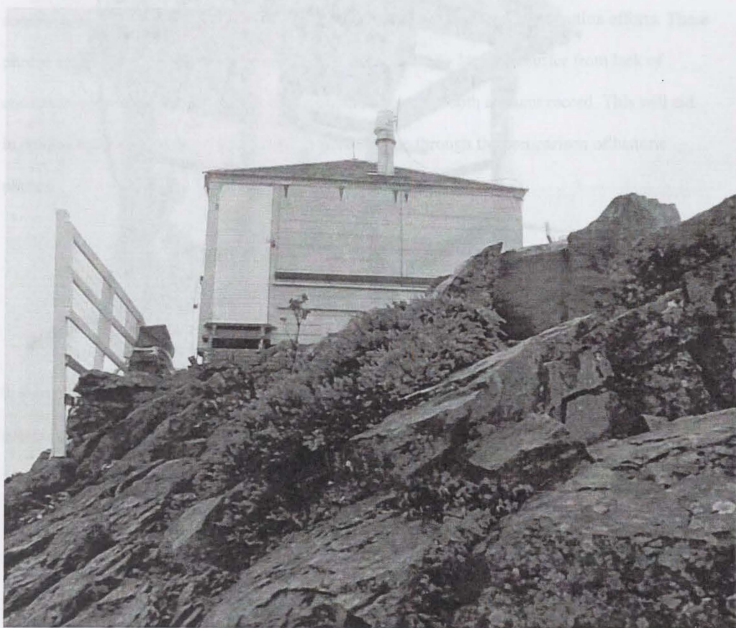
For 14 years after the dramatic destruction of the shelter the site remained undeveloped. In 1935 a new structure was erected on the peak.<sup>102</sup> The new structure on the Carpenter Mountain site was a ground L-4 cab style lookout which still stands today (Figure 14).

Figure 14. Carpenter Mountain Lookout, north side (photo by author, November 7, 2012).

This lookout has a hipped roof, and essentially occupies the entire space available on the peak.  
The structure remains seasonally staffed by Willamette National Forest personnel. (Figure 15).

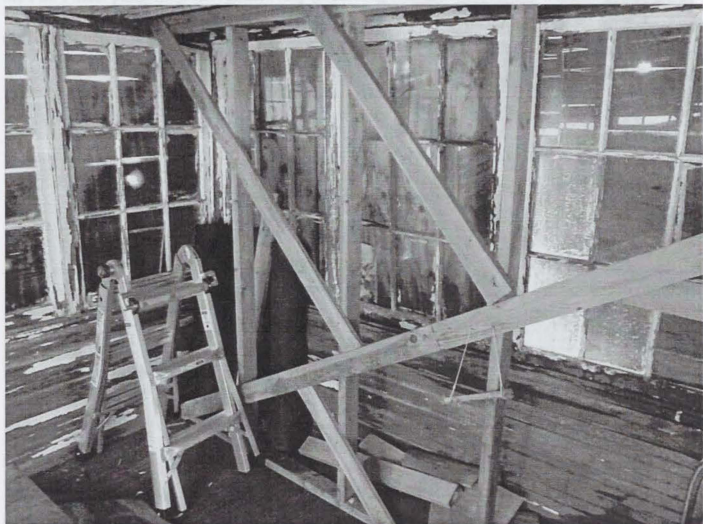
Recent private preservation/stabilization efforts have begun to slow this process by adding an internally framed support system to the lookout in order to give more integrity to the roof structure. This recent framing system braces the entire distance of the interior west wall, and spans from the floor to the ceiling (Figure 22).

Figure 22. Olallie Mountain Lookout interior bracing work, (photo by author, October 20, 2012).

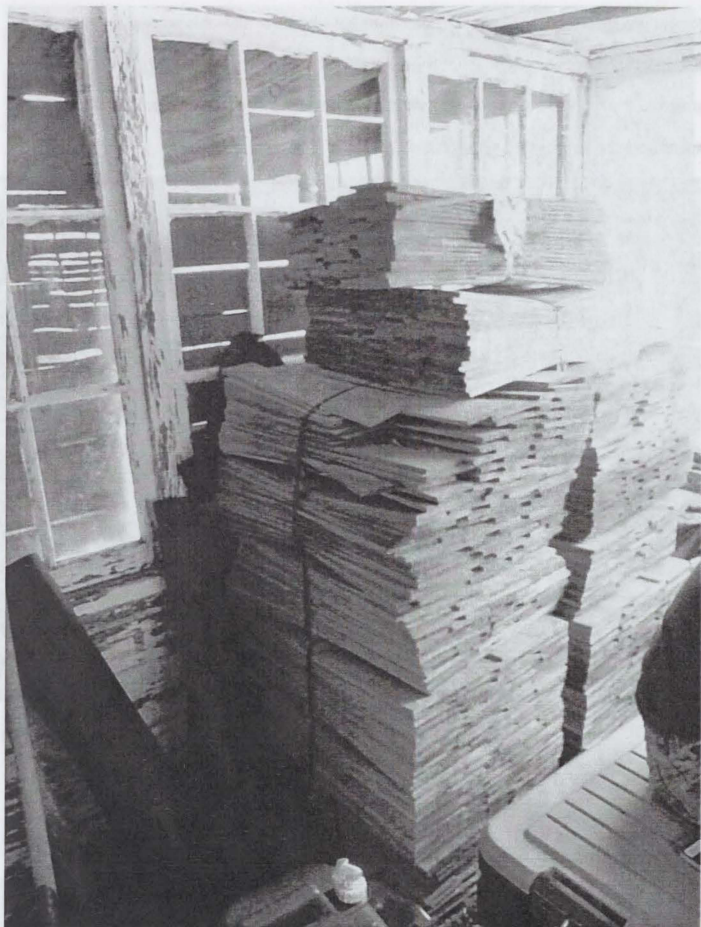
The interior of the lookout retains the original Fire Finder platform, but a high degree of water penetration was observed at the time of the visit. To address the problem of water leakage in the structure, private conservation groups have planned restoration efforts for the roof. Construction materials consisting of tar paper, and a large amount of wooden roofing shingles, were present at the site at the time of the authors visit in October of 2012 (Figure 23).

Figure 23: Olallie Mountain Lookout. Shingles and tar paper, (photo by author, October 20, 2012).

Both the expected roof construction and the internal framing are steps in the right direction, though it is evident that these measures alone will not fully stabilize Olallie Mountain Lookout. The popularity of Olallie Mountain Lookout was highlighted by the weathered sign-in book on the Fire Finder platform. Many hikers and visitors have written in the book indicating a high degree of interest in the site, even in months of poor weather (Figure 24).

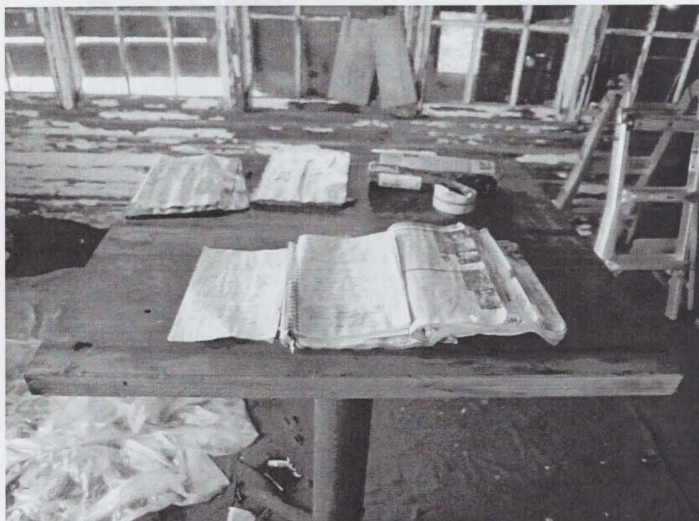
Figure 24. Olallie Mountain Lookout Fire Finder platform and sign in book, (photo by author, October 20, 2012).

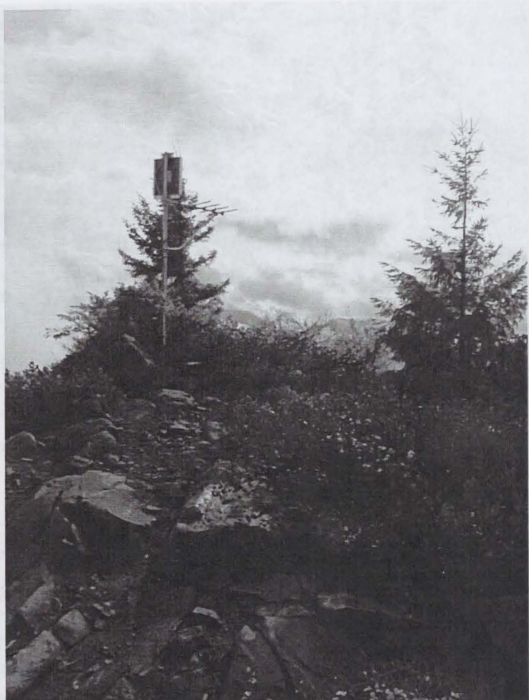
Figure 25. Frissell Point Lookout site, facing south (photo by author, November 3, 2012.)

The site is littered with debris associated with the structure including melted window glass, nails, and charred wood. (Figure 26).

The author visited the site of Frissell Point Lookout during November of 2012, and found a variety of interesting evidence associated with the former lookout. (Figure 25)

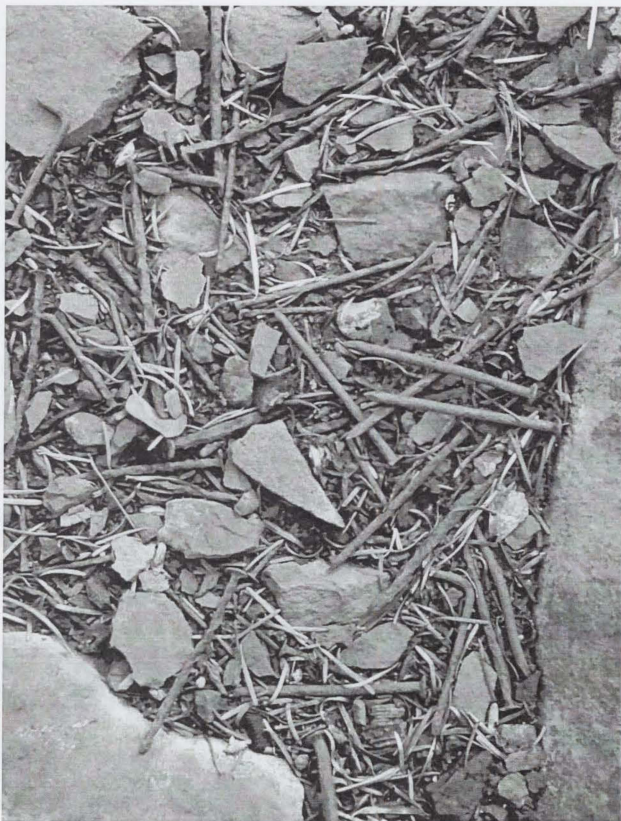
Figure 26. Structural remains at Frissell Point Lookout site (photo by author, November 3, 2012).

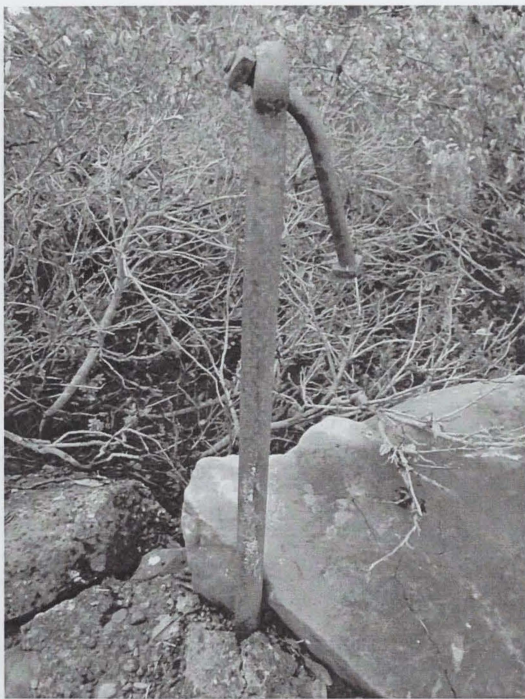
Four steel guy wire anchors indicate the four corners and orientation of the D-6 cupola lookout structure. These steel guy wire anchors were placed in both rock and earth and offer the greatest tangible evidence of the former existence of this historic structure (Figure 27).

Figure 27. Steel guy wire anchor at Frissell Point Lookout site (photo by author, November 3, 2012).

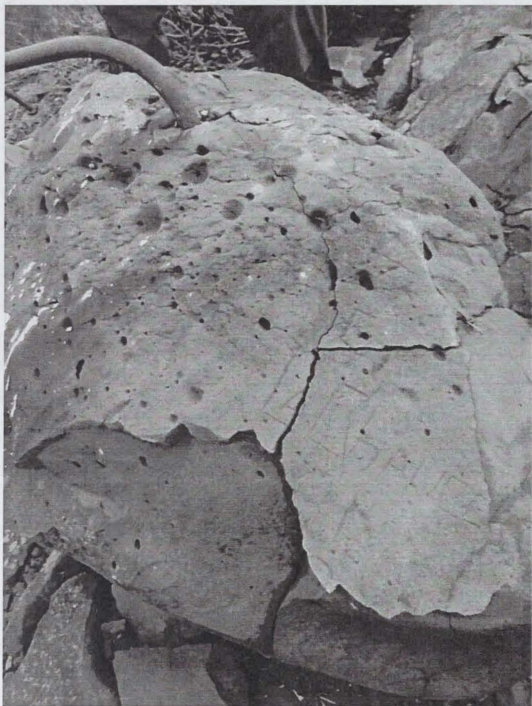
However, other more tacit evidence also can be found on the site. The northeast guy wire anchor is placed in a large boulder and exhibits an array of characteristics that reflect the structure that once presided on the site (Figure 28).

Figure 28. Northeast guy wire anchor at Frissell Point Lookout site; note paint, graffiti, and fire-damaged rock (photo by author, November 3, 2012).

This rock has both blue and white paint adhered to its surface, presumably from decades of repeated lookout maintenance and painting. The northeast guy wire rock is also heavily fire damaged and cracked from the fast and intense fire that consumed the historic D-6 lookout. Upon close examination of this rock, historic graffiti was also observed.

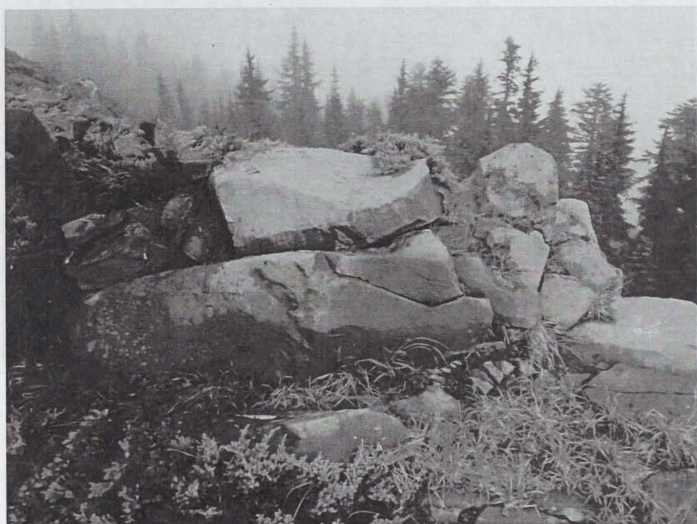
Figure 29. View to north of "Graffiti Rock" at Frissell Point Lookout site (photo by author, November 3, 2012).

The presence of graffiti at this site is noteworthy, as the largest boulder on the north east corner of the site contains decades of well preserved graffiti in the form of rock carvings (Figure 29).

The majority of this graffiti is most likely from hikers making their mark (though the author frowns upon such behavior, however historic). Such graffiti is now something of a curiosity as it exists today without the context of the historic fire lookout. The earliest inscription reads, "Survey 1933" (Figure 30).

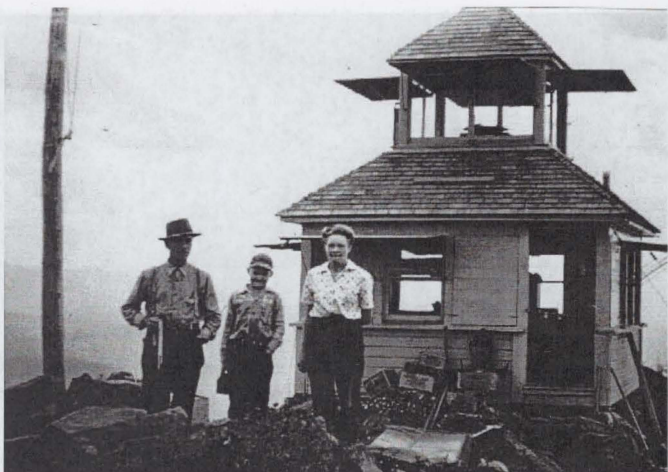
Figure 32. Historic Photo (date unknown) of Frissell Point Lookout.<sup>114</sup>

This graffiti alone may not have much meaning, but when coupled with a compelling historic photograph, a new and untold narrative emerges. Doug Newman's excellent book titled *Finding Fire: A Personal History of Fire Lookouts in Lane County, Oregon* chronicles the fire lookouts of Lane County, and contains the only known historic photo of the D-6 Frissell Point Lookout (Figure 32).

In this undated black and white photograph, a man and woman stand in front of the lookout with their small boy. Though purely speculative, the man and woman in this photograph may be Mr. and Mrs. Ertel. As a lookout operator often had large amounts of "free time," one could imagine that the intricate carving was done by such a person. Attempted research on Mr. and Mrs. Ertel revealed no data, though as many have noted about lookout operators, their service went largely undocumented.

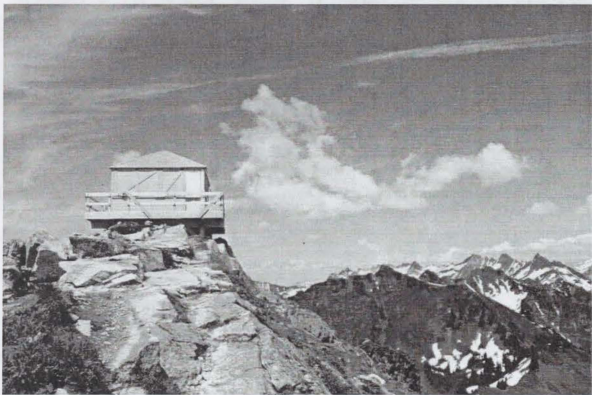
Figure 33. Green Mountain Lookout.<sup>119</sup>

Green Mountain Lookout is a hipped roof L-4 lookout situated on the Mount Baker-Snoqualmie National Forest, Washington, at Section 3, T32N. R12E.<sup>115</sup> The site has been an active lookout location since 1919, though the current lookout structure was not erected until 1933.<sup>116,117</sup> At the western boundary of Glacier Peak Wilderness (created in 1984), the lookout rests on a small wood platform foundation anchored to a rock outcropping, and overlooks grand views at an elevation of 6,500 feet above sea level.<sup>118</sup> (Figure 33).

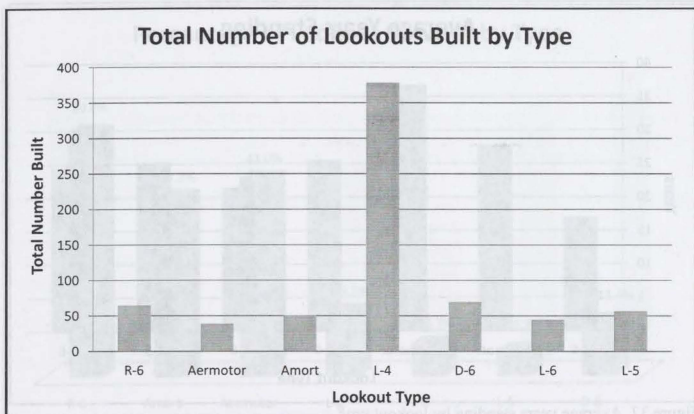
Through the statistical analysis of the seven selected lookout types in Oregon, a great deal of previously unknown information was discovered. The most popular and numerically predominant lookout type in Oregon is the L-4 type lookout. A total of 378 L-4 lookouts were built in Oregon, a reflection of the extent to which this lookout type was found across the nation. (Figure 36).

Figure 36. Total number of lookouts built by type in Oregon.

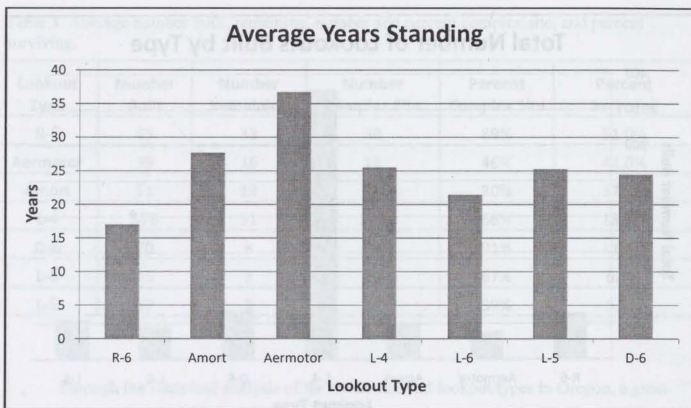
Conversely, the least common lookout type built in Oregon is the L-6 type lookout with only 45 examples constructed in the state. The average building period for these uniform and standardized lookout types in Oregon ranges from 1924 to 1963 (a span of 39 years). The average year that the D-6 type lookout was constructed was 1924, where 1963 represents the average year that the R-6 type lookout was constructed. (Table 2). The average removal period of standardized lookout types ranges from 1947 to 1981, (a span of 34 years). The first standardized lookout type to be removed was the D-6 lookout with 1947 the average year of removal. Aermotor type lookouts remained extant longer when compared to other lookout types with an average years standing of 36.75. The R-6 type lookout has the shortest average years standing at 17 years. The other lookout types experienced very similar average years standing dates, ranging from 21 to 27 years. Among all lookout types, the average years standing is 25.45 years. (Figure 37).

Figure 37. Average years standing by lookout type.

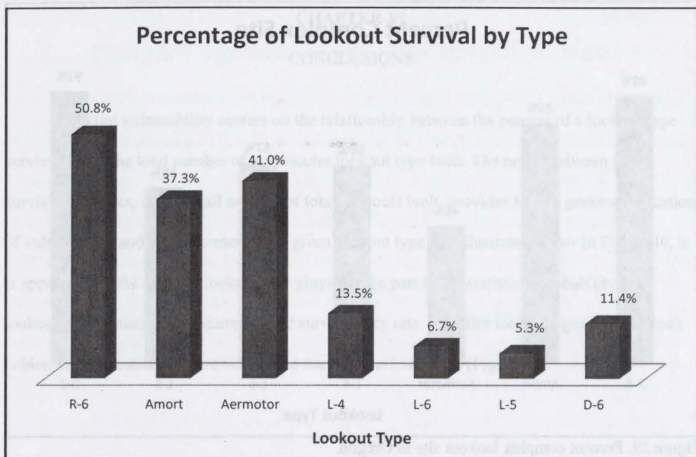
The R-6 type lookout has the best survivability percentage of all lookout types in Oregon, at a rate just over 50 percent (Figure 38 and Table 3).

Figure 38. Percentage of lookout survival by type in Oregon.

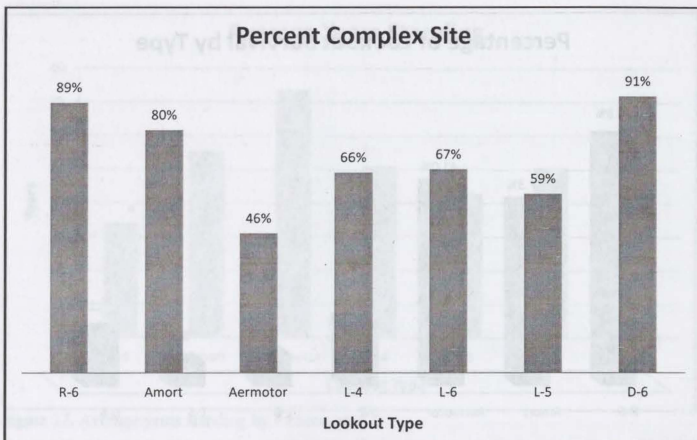
The L-5 lookout type has the poorest overall survivability percentage; only 3 L-5s (5.3 percent of the original 57 L-5's) built in Oregon remain extant. Though few examples of the Aermotor type lookout were constructed in Oregon, (the type was more popular in Regions 5 [California] and 3 [Arizona and New Mexico]), the Aermotor type lookout has a surprisingly high survival rate at 41 percent. Though the L-4 lookout type was the most constructed lookout type in Oregon, only 13.5 percent of the 378 L-4s stand today. The L-4 remains the most popular extant lookout type in Oregon, but it does not adequately reflect the total number of L-4 lookouts that were constructed as it has a relatively meager survivability rate. The D-6 lookout most commonly occurs at complex lookout sites at a rate of 91 percent. Aermotor type lookouts were the least likely to occur at complex sites. 46 percent of Aermotor type lookouts reflect the complex lookout site component (Figure 39).

Figure 39. Percent complex lookout site in Oregon.

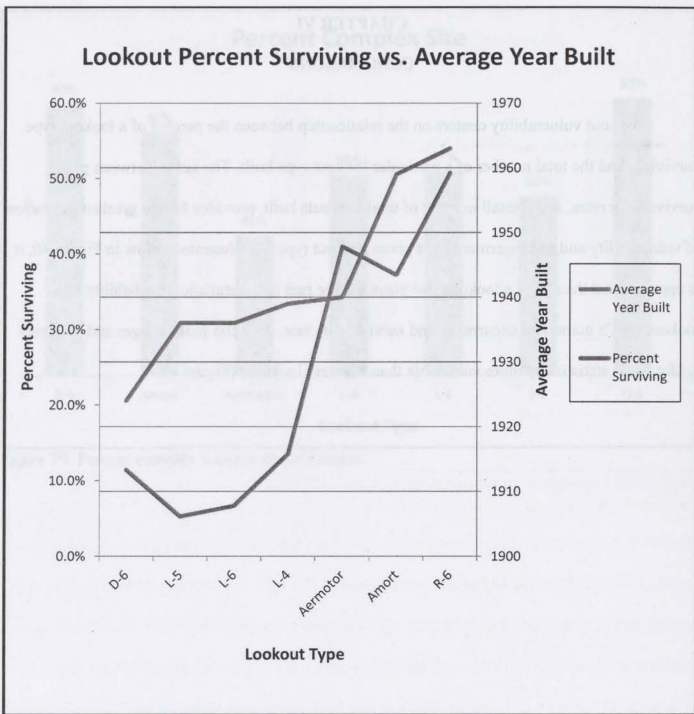
Lookout vulnerability centers on the relationship between the percent of a lookout type surviving, and the total number of a particular lookout type built. The nexus between poor survivability rates, and a small number of total lookouts built, provides for the greatest indication of vulnerability and endangerment for a given lookout type. As illustrated below in Figure 40, it is apparent that the age of a lookout also plays a large part in the statistical probability of a lookout type's numerical occurrence and survivability rate. As a fire lookout ages and becomes "older," it is statistically more vulnerable than "newer" lookouts (Figure 40).

Figure 40. Lookout percent surviving vs. average year built in Oregon.

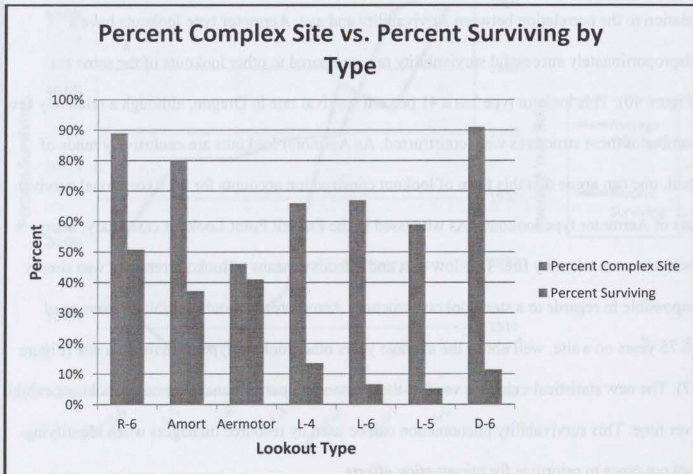
lookouts having previous and/or future lookout types on the site. These data indicate that it was more common for the Aermotor lookout type to occupy a site with no other previous and future lookouts built. It was hoped that a direct correlation between complex lookout sites and survivability rates could be identified, but identifying a trend proved unsuccessful. (Figure 41).

Figure 41. Percent complex site vs. percent surviving by type in Oregon.
