An Energy Reduction Strategy & Retrofit Guidebook for Owners of Historic Brick Buildings: Weighing the Values & Implications of Energy Efficiency & Historic Integrity

Evanne St. Charles
Master's Candidate, Historic Preservation, 2013
University of Oregon

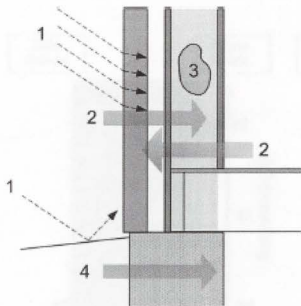
Figure One: Ways a building enclosure can dry (listed above). From: *Internal Insulation of Masonry Walls: Final Measure Guideline*, 15.

1. Evaporation to the inside or outside surfaces
2. Vapor transport by air leakages (through cracks and holes) and/or diffusion (through pores in the material) to the interior or exterior of the building
3. Drainage through cracks and openings
4. Ventilation¹¹⁰

Solid masonry walls (including solid brick wall assemblies as well as brick veneer backed by load-bearing concrete) are typically limited to the first two drying processes (unless retrofitted to accommodate drainage or ventilation). Brick cavity walls may utilize all four methods to dry.

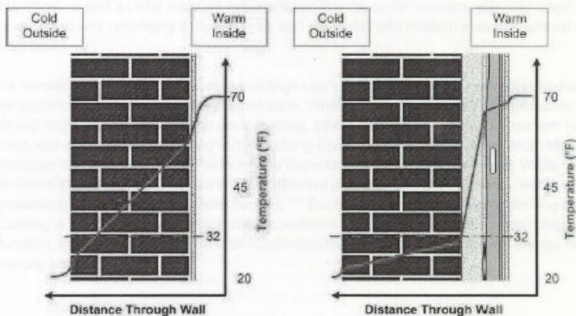
Figure Two: The addition of insulation causes the interior surface of the brick wall to become colder, and there is a greater potential for condensation and freeze-thaw damage to occur. From: *Internal Insulation of Masonry Walls: Final Measure Guideline*, 17.

Insulation also causes the interior surface of the brick wall to become colder because less heat escapes from the interior of the building (see Figure Two). When temperature decreases, the relative humidity and potential for reaching a point of saturation becomes greater (temperature and relative humidity are inversely related). This decrease in temperature (and increase in relative humidity) can result in condensation and, if conditions are cold enough, frost. Hence, the type and thickness of the insulation needs to be considered in order to reduce the possibility of condensation and freeze-thaw damage.

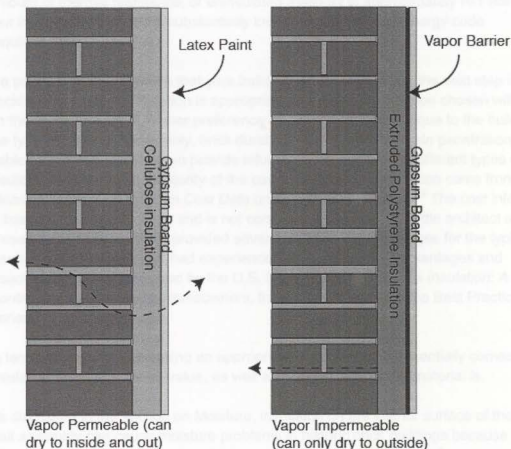
Figure Three: The left assembly can dry both to the interior and exterior because the materials are permeable, whereas the assembly on the right can only dry to the exterior because impermeable materials are used.

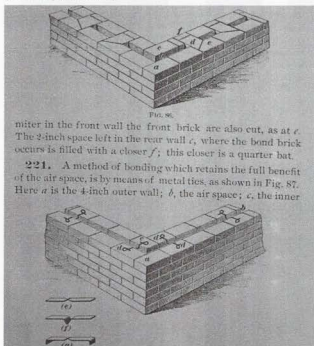
Figure Four: Examples of historic cavity walls. From: *Masonry, Carpentry, Joinery: The Art of Architecture, Engineering and Construction in 1899.*

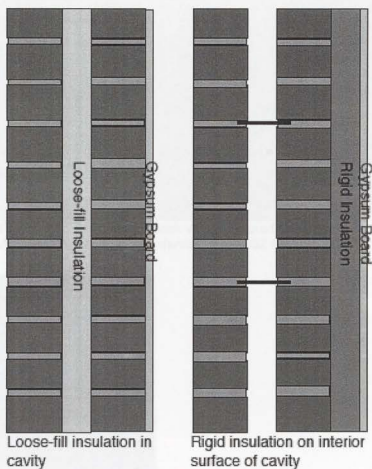
Figure Five: Two methods of insulating brick cavity walls.

Insulating brick cavity wall assemblies held together by metal ties can be done two ways – insulating in the cavity itself or insulating in the interior as you would a solid brick wall (see Figure Five).

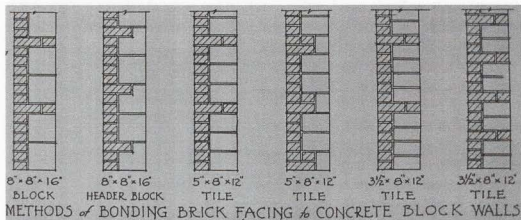
Figure Six: Examples of brick veneer backed by concrete walls. From: *Architectural Graphic Standards*, 1932-1952 editions.

Although brick and concrete do not have identical moisture and heat transfer properties, they are typically similar enough that a solid wall with brick veneer and concrete backing can be treated like a solid brick wall assembly (see Figure Seven). It is also worth noting that in all of the works cited regarding the treatment of insulating masonry wall assemblies, the term "masonry" applies to a variety of materials, including brick and concrete, and the materials are not treated differently.

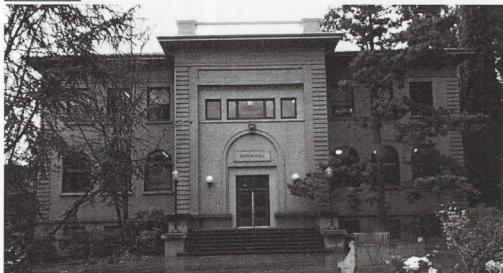
Figure Nine: Fenton Hall. Photo by author.

Fenton Hall was built in 1906 on the University of Oregon campus. The building was originally constructed for library purposes, and was designed by architect Yousa D. Hensill. The building is approximately 20,000 square feet, and now houses the Math Department. The majority of Fenton is composed of an unreinforced, solid brick wall assembly, three-wythes thick (see Figure Ten). However, reports indicated that in some areas, such as the entrance to the first floor, the brick wall has a cavity 4.5 inches thick between the first and second wythe of brick. During its 2011 renovation, a 4.5-inch air space followed by steel-backed gypsum board (for the seismic upgrade) was constructed on the interior.¹⁷¹

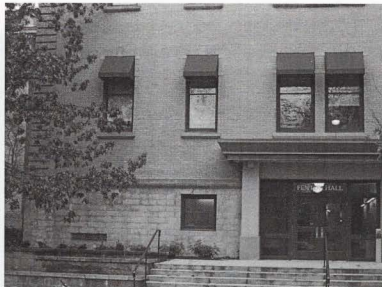
Figure Eleven: Fenton Hall historically appropriate awnings. Photo by author.

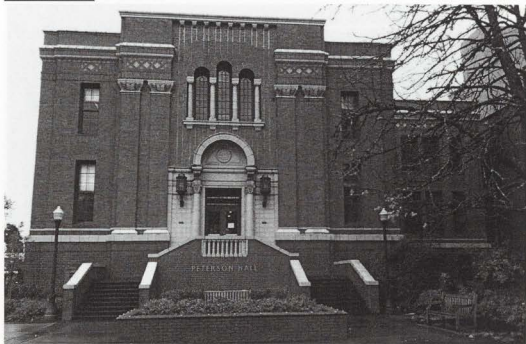
Figure Twelve: Peterson Hall. Photo by author.

Peterson Hall was constructed in 1916 on the University of Oregon campus, and is approximately 19,000 square feet. The building was originally built to accommodate the School of Education, and was the first building on campus designed by architect, Ellis F. Lawrence. It is now part of the Lillis Business Complex, housing offices, classroom space, and the Oregon MBA program. Peterson maintains an unreinforced, load-bearing brick wall assembly, which is four-wythes thick on the first floor and three-wythes thick on the second and third floors. During its 2007 renovation, rigid polystyrene insulation was added to the interior of the brick assembly on the first floor, and fiberglass batts were installed on the second and third floors.¹⁷³

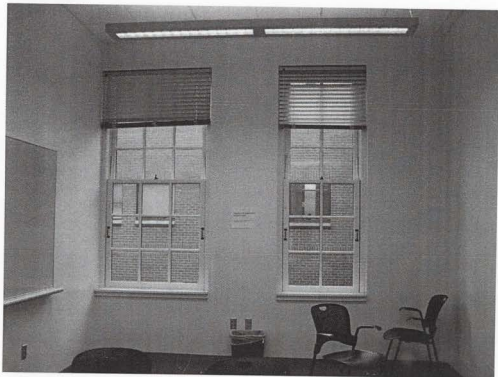
Figure Thirteen: Peterson Hall new insulated glazing. Photo by author.

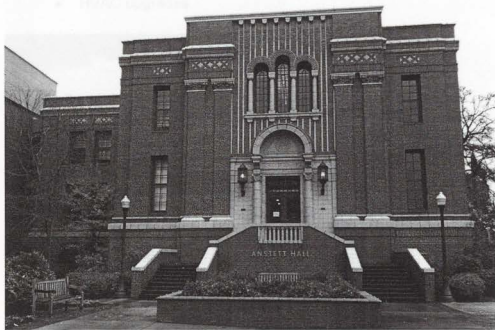
Figure Fourteen: Anstett Hall. Photo by author.

Anstett Hall, first known as Commerce Hall and then as Gilbert Hall, was constructed in 1921 on the University of Oregon campus. The building, roughly 19,000 square feet, originally housed the School of Business, and was designed by Ellis F. Lawrence. Anstett is now part of the Lillis Business Complex, composed of PhD student offices and tutoring rooms. Anstett has an unreinforced, load-bearing brick wall assembly, which is four-wythes thick on the first floor and three-wythes thick on the second and third floors. During its 2010 renovation, rigid polystyrene insulation was added to the interior of the brick assembly on the first floor, and fiberglass batts were installed on the second and third floors.¹⁷⁵

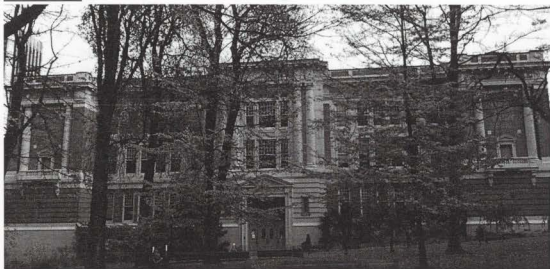
Figure Sixteen: Lincoln Hall. Photo by author.

Lincoln Hall was built in 1911 as the Portland School District's Lincoln High School. The 145,000-square-foot space is now occupied by Portland State University, and houses the college's Performing Arts Program. Lincoln was renovated in 2011, and is the first LEED Platinum building on the university campus. The building is composed of an unreinforced, solid brick wall assembly, which is approximately three-wythes thick (see Figure Seventeen). The exterior walls remain uninsulated.¹⁷⁷

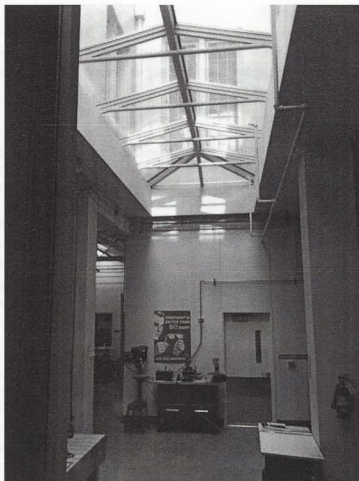
Figure Twenty-Two: Shattuck Hall restored light wells. Photo by author.

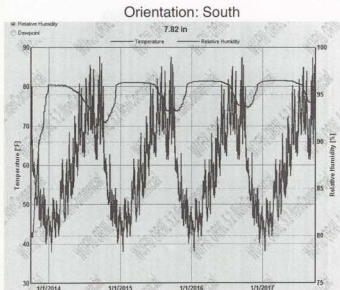
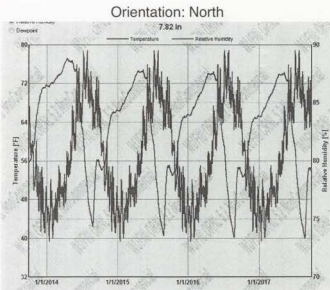
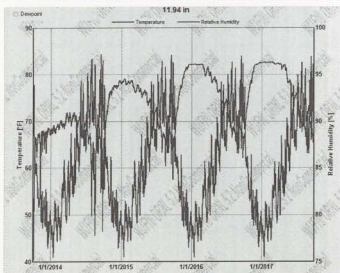
11.94": Although the surface of the brick (between insulation and brick) is drying out to some extent in the **south-facing** model, the RH is between 90% and 95% throughout most of the year, and it is rising as time goes on. This indicates that even if moisture accumulation is not a problem now, it may be in the future. High RH levels are also more problematic with cellulose because of the potential for mold growth. The RH level in the **north-facing** model ranges between 75% and 85% for most of the year. Although mold growth could occur on the cellulose, the materials are drying out and the RH levels should be acceptable at this location.

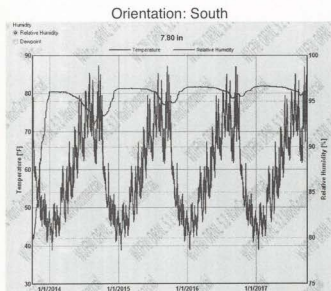
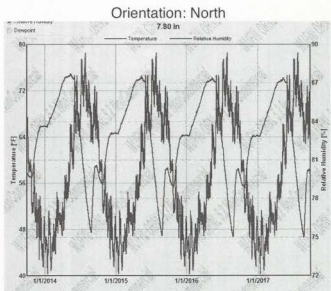
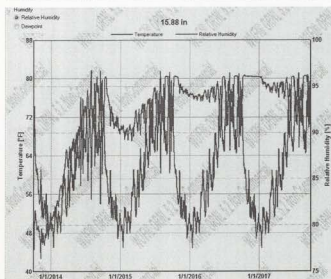
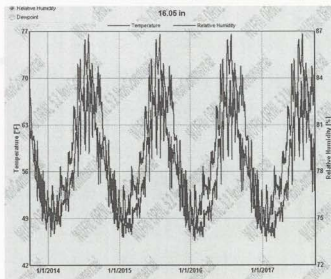
15.88"/16.05": Although the surface of the brick (between insulation and brick) is drying out to some extent in the south-facing model, the RH is above 90% throughout most of the year, and the RH is slightly rising over the time period. This indicates that even if moisture accumulation is not a problem now, it could be in the future. The RH never goes above 85% in the north-facing model, and there is a significant amount of drying occurring. Because mold growth does not occur on fiberglass and condensation does not appear to be present, the conditions at this location should be acceptable.

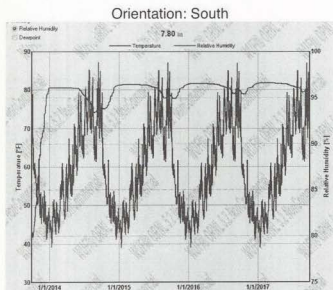
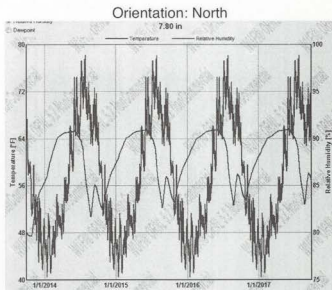
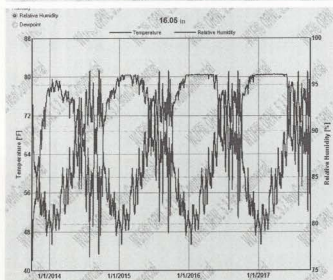
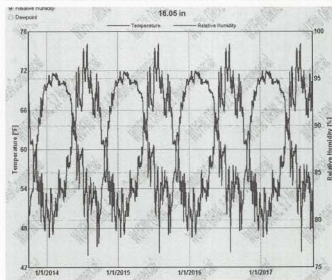
16.05": Although the surface of the brick (between insulation and brick) is drying out to some extent in the **south-facing** model (indicated by the sharp dips in the RH line during the spring and summer months), the RH is approximately 96% throughout most of the year, and the line flattens out. This indicates that moisture accumulation and condensation is possible. Although the RH is above 80% for most of the year in the **north-facing** model, there is a significant amount of drying occurring. Because mold growth does not occur on fiberglass and condensation does not appear to be present, the conditions at this location should be acceptable.

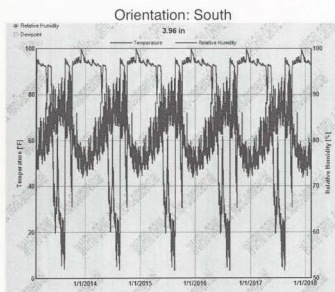
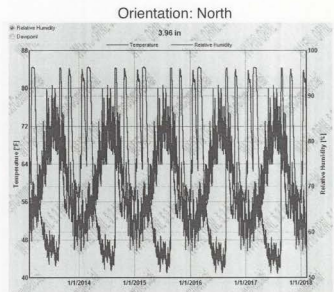
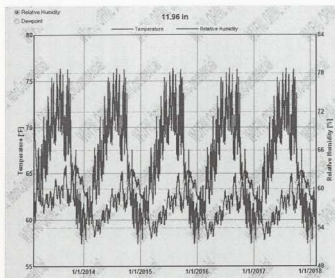
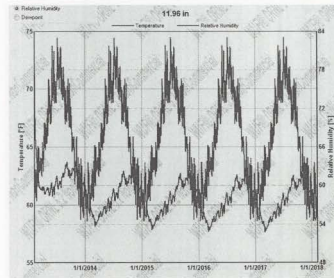
11.96": The RH never reaches above 65% in the **south-facing** and **north-facing** models. Moisture accumulation should not be a problem at this location.

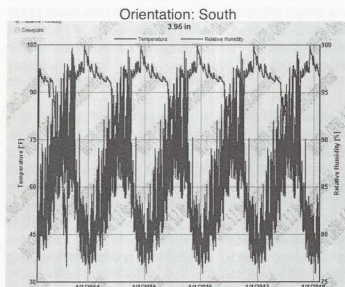
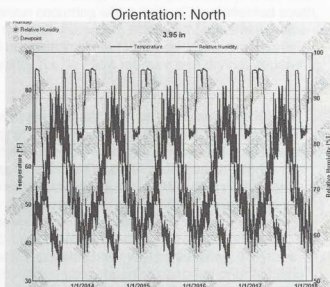
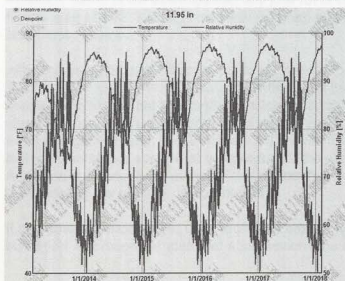
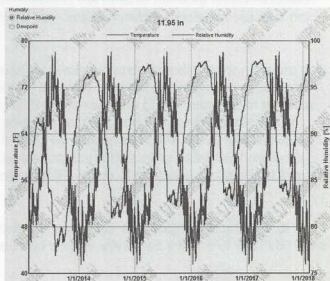
11.94": Although the RH is above 90% for about half the year in the **south-facing** and **north-facing** models, drying is still occurring, and the materials are not reaching saturation levels. Because closed cell spray foam does not grow mold, higher humidity levels at this location should be acceptable.

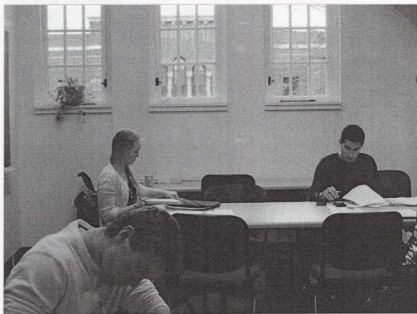
2/13/2013 2:52:13 PM

Measurements °F

Ar1	Max	73.5
	Min	69.2
	Average	72.5
Ar2	Max	73.0
	Min	70.6
	Average	72.2
Ar3	Max	73.6
	Min	71.4
	Average	72.6
Ar4	Max	73.5
	Min	70.1
	Average	72.5
Ar5	Max	73.8
	Min	71.0
	Average	73.0
Ar6	Max	73.4
	Min	70.9
	Average	72.1
Ar7	Max	73.7
	Min	71.0
	Average	72.5
Ar8	Max	72.3
	Min	71.9
	Average	72.1
Ar9	Max	72.1
	Min	70.4
	Average	71.2
Ar10	Max	73.3
	Min	70.9
	Average	72.6

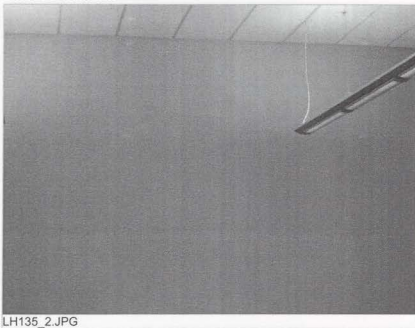
2/6/2013 3:58:09 PM

Parameters

Emissivity	0.95
Refl. temp.	68 °F
Distance	15 ft
Atmospheric temp.	68 °F
Ext. optics temp.	68 °F
Ext. optics trans.	1
Relative humidity	45 %

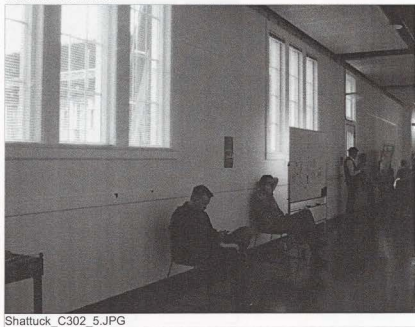
2/6/2013 4:22:42 PM

Measurements °F

Ar1	Max	68.1
	Min	67.0
	Average	67.6
Ar2	Max	67.9
	Min	67.3
	Average	67.6
Ar3	Max	68.0
	Min	67.4
	Average	67.7
Ar4	Max	68.2
	Min	67.5
	Average	67.8
Ar5	Max	67.9
	Min	67.1
	Average	67.5
Ar6	Max	67.8
	Min	67.1
	Average	67.5
Ar7	Max	67.5
	Min	66.8
	Average	67.3
Ar8	Max	68.9
	Min	67.7
	Average	68.3
Ar9	Max	68.3
	Min	67.0
	Average	67.7
Ar10	Max	67.9
	Min	67.3
	Average	67.6
Ar11	Max	68.2
	Min	67.5
	Average	67.9
Sp1		65.8
Sp2		66.0
Sp3		66.3
Sp4		66.1
Sp5		66.4
