CONTEMPORARY ARCHITECTURE IN A HISTORIC CONTEXT:
USING PRESENT-DAY CONSTRUCTION TECHNIQUES TO
MITIGATE THE EFFECTS OF SINKING IN
VENICE, ITALY

A THESIS

Presented to the Department of Architecture
and the Robert D. Clark Honors College
in partial fulfillment of the requirements for the degree of
Bachelor of Architecture

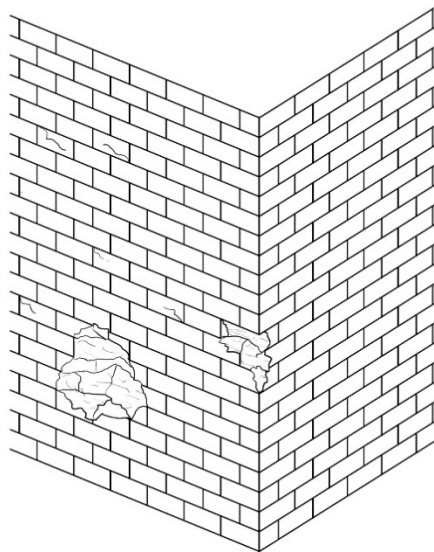
Figure 2: Venetian Wall Diagram

Diagram of the same Venetian brick wall depicted above, with signs of no maintenance, including some bricks chipping away.

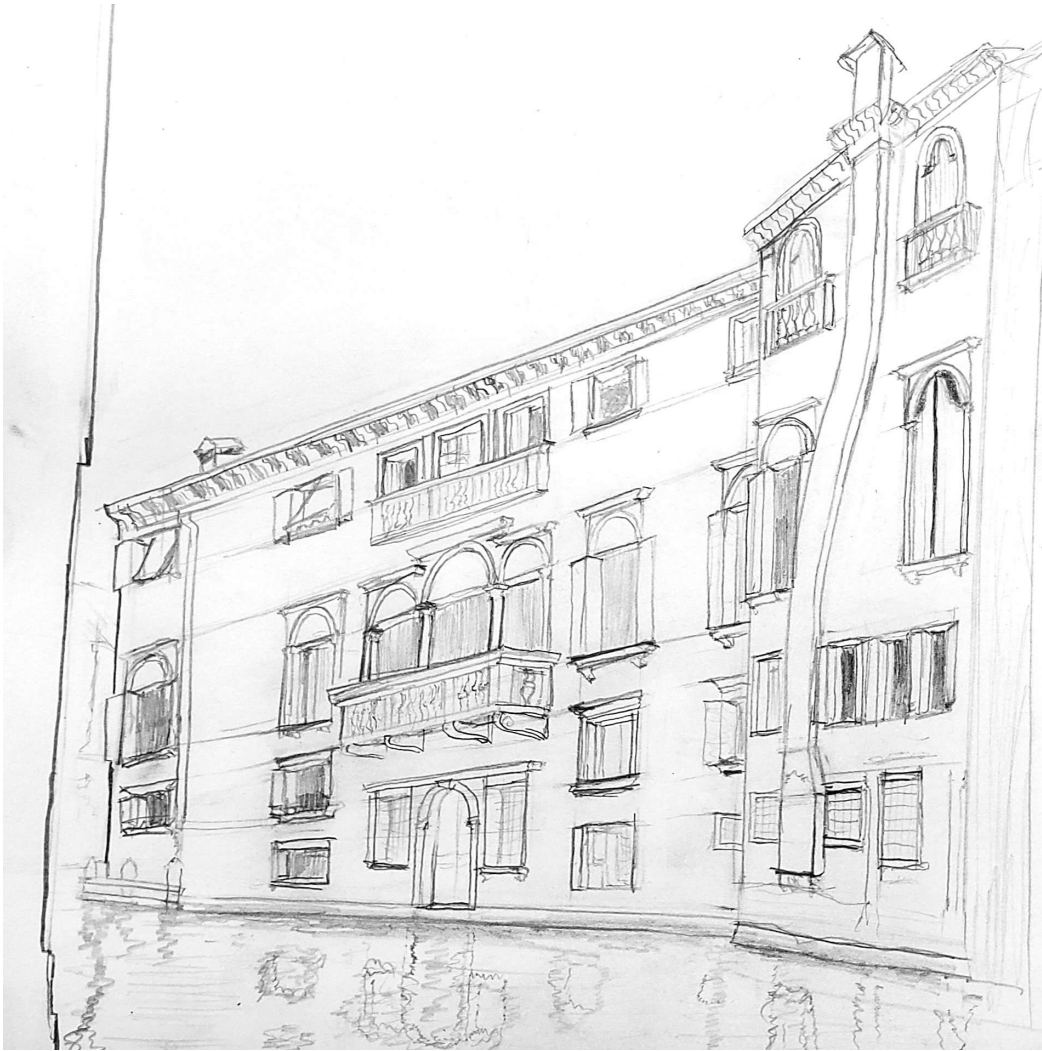
Figure 4: Drawing of the Palazzo Celsi-Donà

Drawing of the Palazzo Celsi-Donà done by the author in May 2023.

Palazzo Celsi-Donà was built in a vernacular Baroque style with no particularly special ornamentation. At the canal level, it contains a large, arched door flanked by two windows, with smaller windows on either side. A floor exists between this canal-side door and the piano nobile. The piano nobile provides the most visual interest, containing a balcony accessed by a door of three arches, the middle arch being larger than the two on the sides. These arches are supported by simple columns. At some point, most of the arches had their top, round parts bricked up to fit a more conventional square window. The top floor contains another set of three windows, which are square, unlike the ones on the piano nobile. There are balusters against the bottoms of these windows. On every floor, there are two windows extending from each side of these sets of three windows. The interior contains some woodwork, but it is unknown if there are frescoes inside.

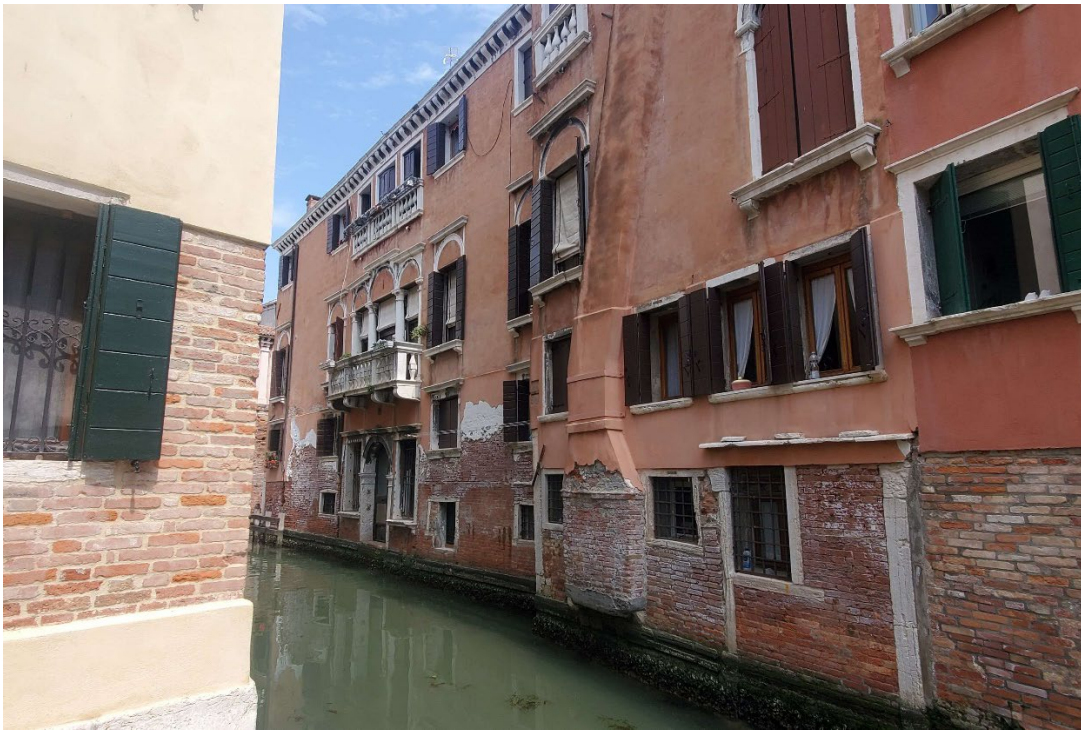
Figure 5: Palazzo Celsi-Donà

A photograph by the author of the Palazzo Celsi-Donà, taken in May 2023. Note the large iron bracket to the left of the chimney above the lowest window; this is something that needs discussion.

The building is in a state of mild decay; bricks and plaster continue to erode off the building, and no significant work is being done to maintain it. The doors and windows on the ground floor do not seem to be well-sealed, leaving the lower floor prone to flooding. The building sits in a precarious position; it is historically significant enough to preserve, yet it is not something so valuable that it should be a museum. Yet, if no action is taken to maintain it, the building will continue to rot from water damage. The building is actively decaying; Google Street View images from 2013 compared to the author's photographs in 2023 show consistencies

in the decomposition of bricks, plaster, and the failure of a downspout, which has caused even more water damage. An intervention or reconstruction of the exterior wall would aid in the preservation of the building as a whole.

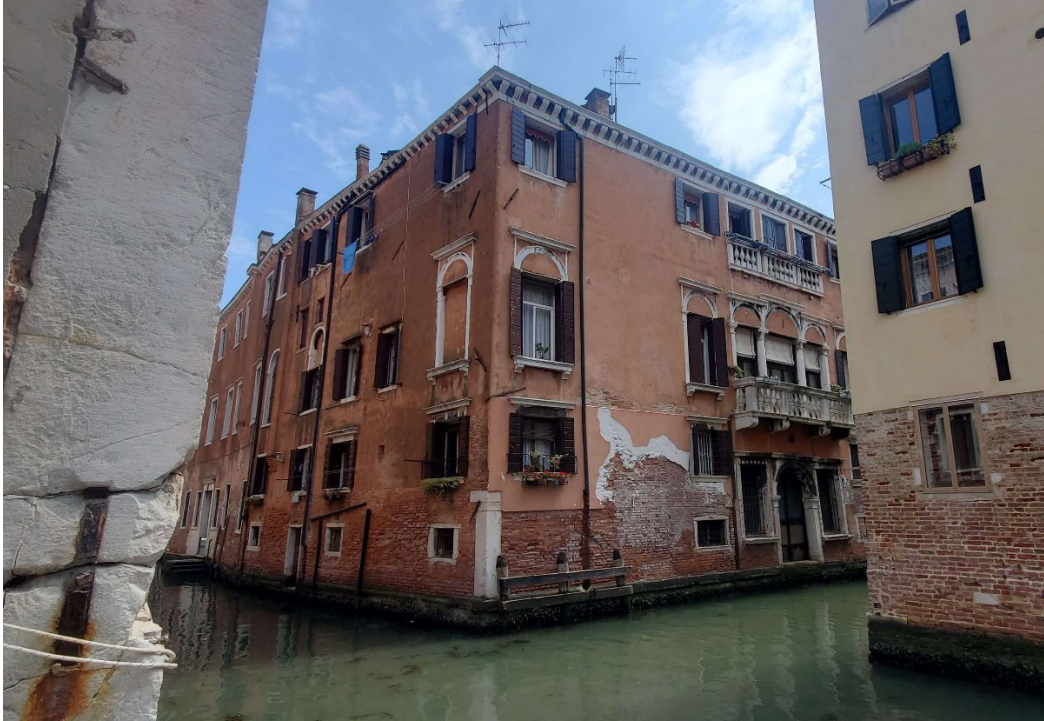
Figure 6: Palazzo Celsi-Donà

Another photograph by the author of the Palazzo Celsi-Donà, from a different view. Deterioration of plaster and brick is visible, and brick has especially worn away around the base of a downspout, which failed at some point in time. More iron brackets are visible.
