Creswell Historic Buildings Survey Final Report

Prepared for the Lane Council of Governments by

Historic Preservation Northwest

July 2, 2007

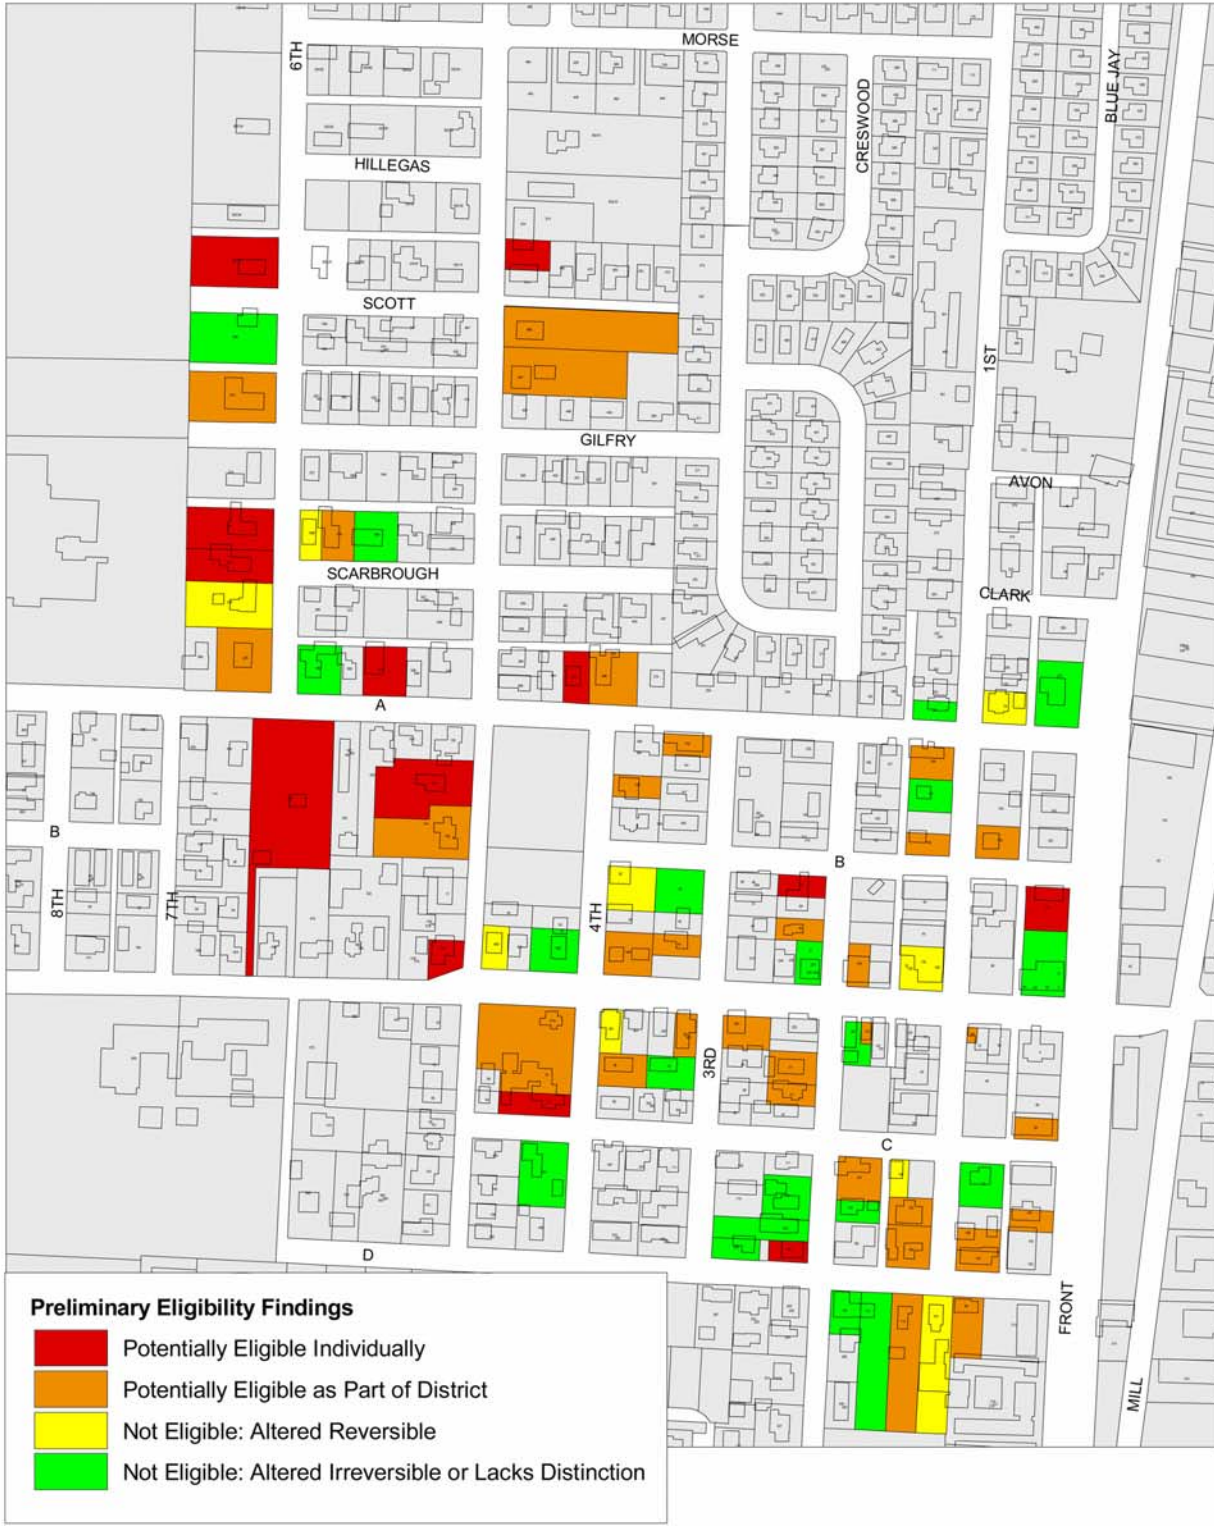
City of Creswell
 Historic Resource Survey Findings - DRAFT
 Determination of Eligibility
 Prepared by Historic Preservation Northwest, 6/28/07

Below is a “spectrum of integrity” used to apply the preliminary National Register findings to apply to each resource. The spectrum is based on buildings in Oregon City. On the following page is a map that plots the findings.
