Eugene Masonic Cemetery

Condition Assessment and Treatment of the Historic Grave Markers and Mausoleum

October 2013 – May 2014

David Espinosa – Master of Science in Historic Preservation Candidate

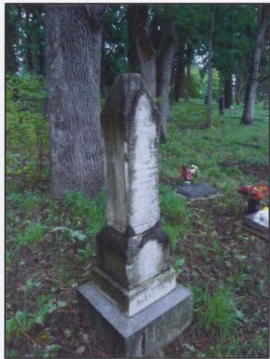
Northwest corner pre-treatment

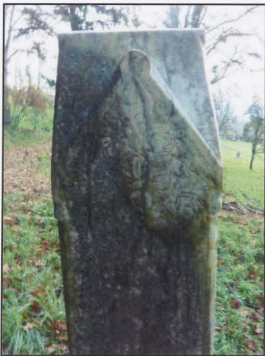
Cleaning in progress

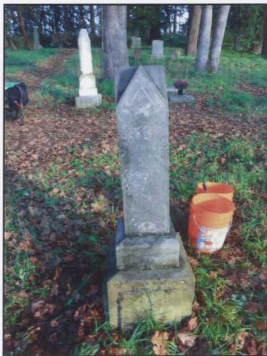
West face post-treatment

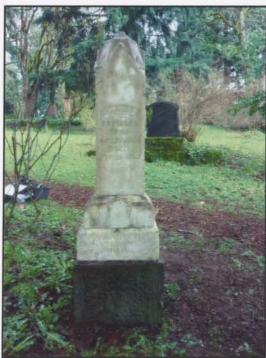
West face post-treatment

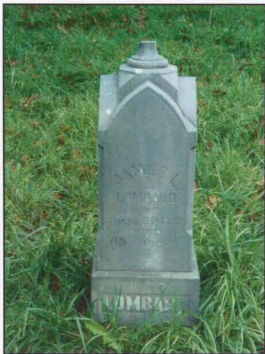
West face post-treatment

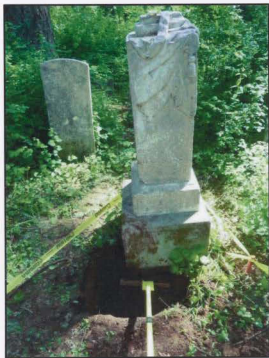
Pry-bar in use as gravel infill is inserted

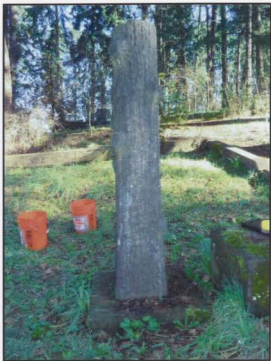
West (rear) façade pre-treatment

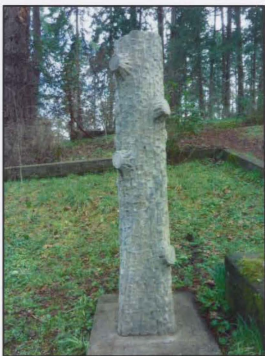
A small amount of sugaring was noticed on the top of the marker. This phenomena occurs when rainwater attacks the spaces between calcite grains in marble resulting in a loose granular texture similar to sugar. This is likely occurring on the WOW monument due to the fact that the top of the monument is sculpted to resemble a tree stump. The flat top has channels carved into it to give the appearance of trunk growth rings. These channels allow rainwater to gather and deteriorate the stone. The deterioration does appear slight at this point and still allows for the carved detail to be visible.

Detail of loose calcite granules on top of monument post-treatment

As a highlighted site within the cemetery it is recommended that the WOW monument receive an annual or biannual cleaning with Orvus WA Paste and clean water.
