REHABILITATION OF THE STARR HOUSE  
MONROE, OREGON

by  
TADA SUTTITUM

A TERMINAL PROJECT

Presented to the Historic Preservation Program:  
School of Architecture and Allied Arts  
and the Graduate School of the University of Oregon  
for the degree of  
Master of Science  
December 1985

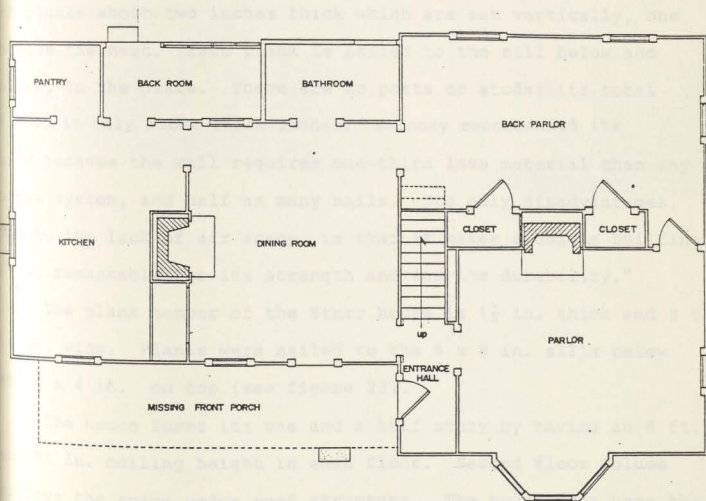
Even though the original plan fo the house did not have any bathroom, the bathroom was necessary to the house. During the 1940s alteration to the back porch a bathroom was added. But by putting the bathroom into the back porch, the original flow of space and function were destroyed (see figure 22). The transitional space between the house and landscape was blocked. The Gothic concept of relating the house to the landscape was diminished. The noticable change affects the exterior appearance and is not compatible with the original style.

Fig. 22.. First floor plan

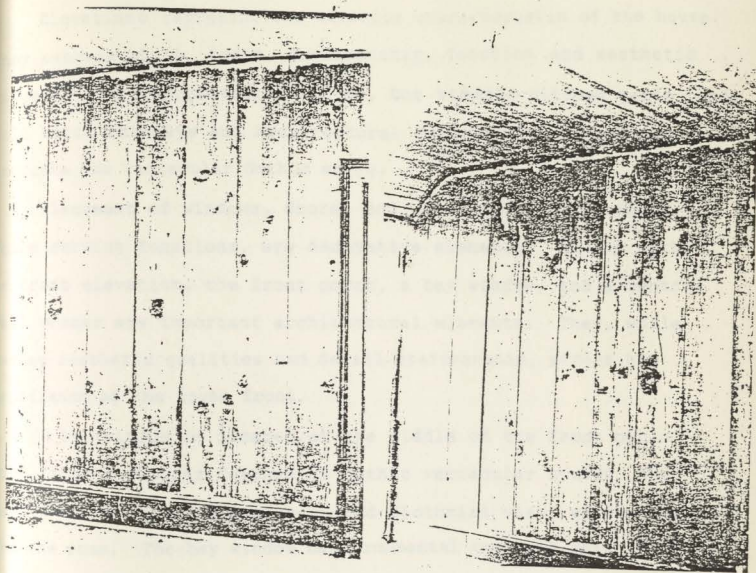
The plank member of the Starr house is  $1\frac{1}{2}$  in. thick and 8 to 10 in. wide. Planks were nailed to the 8 x 8 in. sills below and 2 x 4 in. on top (see figure 23).

Fig. 23. Walls on the second floor show the method of "box construction".

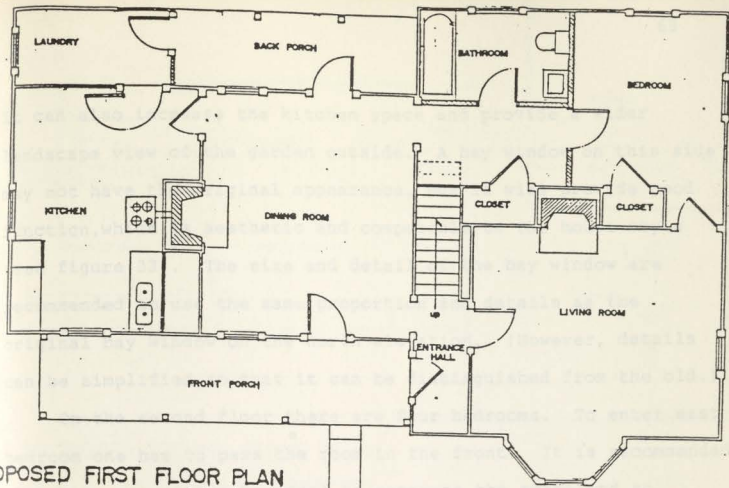
PROPOSED FIRST FLOOR PLAN

The pantry room is a small room, measuring 5 ft. by 6 ft. 5 in.. It was originally used for food storage. It is proposed to be a laundry room which is functionally associated with the service area of kitchen and the back porch. The expansion of the pantry is possible in order to provide larger space for laundry facilities (see figure 32 for proposed first floor plan). This proposed alteration has little effect upon the appearance of the south elevation because the original function and elevation still maintain their significant characteristics.

Fig. 32. The laundry room is possibly expanded in order to provide larger space for laundry facilities.

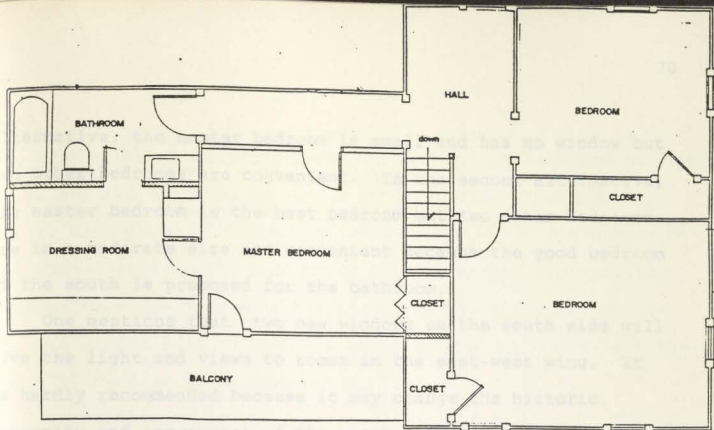
PROPOSED SECOND FLOOR PLAN

On the second floor there are four bedrooms. To enter east bedroom one has to pass the room in the front. It is recommended that a new partition be added to separate the space and to create privacy for the room in front. Part of a bedroom could give space for a bathroom. This will provide convenience to occupants. Next, the location of the upstairs bathroom is considered. Two possible locations of the bathroom are suggested. The first location is at the room to the east of east-west wing. The room will be filled in with a bathroom and a dressing room which is connected to the next room by a new door. The next room will be a master bedroom which has a balcony in front with a glazed door but no window (see figure 34).

Fig. 34. The location of the bathroom in the east bedroom is one of the alternatives of providing a bathroom on the second floor.

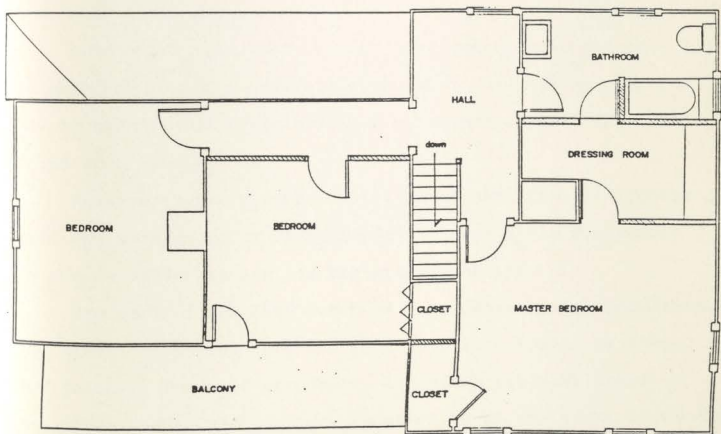
PROPOSED SECOND FLOOR PLAN

In the second possible bathroom location, east-west wing still contains two bedrooms, while north-south wing will have one bedroom to the front and the other will be converted to a bathroom and a dressing room (see figure 35). The master bedroom will be the biggest and most convenient bedroom in the house. Each alternative has advantages and disadvantages. In the first

Fig. 35. The location of the bathroom in the south bedroom is the other alternative.

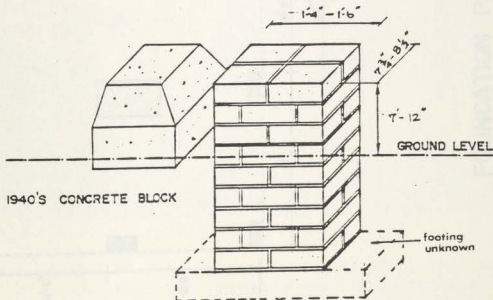
A foundation provides a level and uniformly distributed support for the house. The foundation must be strong enough to support and distribute the load of the house, and sufficiently level to prevent wall defects and to keep doors and windows from sticking. The foundation of the Starr house is modulare foundation formed by brick piers. The footing of the foundation may be brick or stone slab embedded in the ground or only brick piers sitting in the ground. By the time of the investigation, the footing has not yet been excavated. Except at the bay window, which is smaller, the typical size of the masonry piers is about 8" x 1'-4" (see figure 37). Piers are placed to support sills running around the house perimeter (see figure 38). The brick pier foundation of the house becomes significant because of the uniqueness of the foundation type and original.

Fig. 37. The masonry pier of the Starr house.

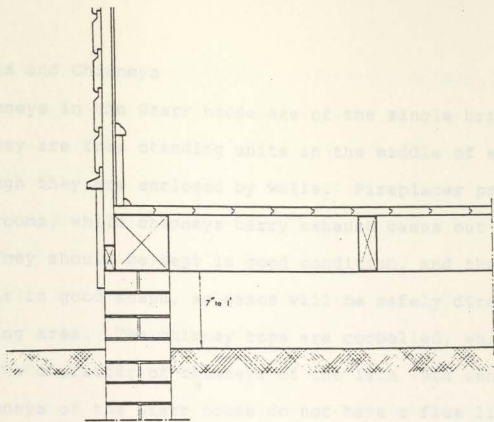
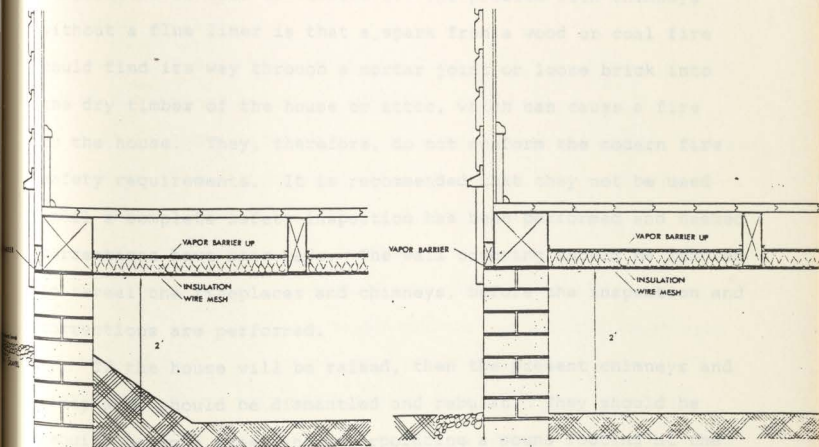
Fig. 43. Foundation and floor remodeling

Whatever the alternatives, proper drainage should be installed by the method mentioned earlier. Even though the house has drainage at the foundation area, damp may still be rising up from the foundation and damaging the wood structure. There is presently no moisture barrier between the masonry and the sills. To prevent future damage, the moisture barrier should be installed under the sills and under the floor, along with the insulation (the insulation material readily provides a vapor/moisture barrier on one side). Soil cover material is also recommended to be placed on the ground at the area underneath the house. Illustrations of foundation and floor remodelling see figure 43.

All temporary concrete blocks and wood cushions can be removed after the original foundation is repaired.

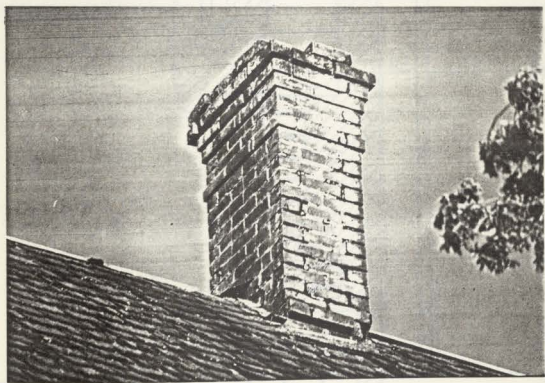
Fig. 44. The corbelled brick chimney of the Starr house.

Chimneys in the Starr house are of the single brick thick type. They are free standing units in the middle of each wing, even though they are enclosed by walls. Fireplaces provide heat to rooms, while chimneys carry exhaust gases out of the house. They should be kept in good condition, and their bricks and mortar in good shape, so gases will be safely directed from living area. The chimney tops are corbelled, which is a distinctive character of chimneys of the late 19th century.

Chimneys of the Starr house do not have a flue lining inside, thus they are unsuitable for handling the higher exhaust temperature of coal or woodstove. The problem with chimneys without a flue liner is that a spark from a wood or coal fire could find its way through a mortar joint or loose brick into the dry timber of the house or attic, which can cause a fire to the house. They, therefore, do not conform the modern fire safety requirements. It is recommended that they not be used until a complete safety inspection has been performed and needed corrections have been made. The wall covering should be removed to reveal the fireplaces and chimneys, before the inspection and corrections are performed.

the present size and character as possible. However, the fireplaces and chimneys of the Starr house at least need repairing, if they are not dismantled. The mortar and/or bricks may be loose, therefore, repointing and replacing bricks may be necessary. They can use the same method of repointing masonry mentioned in appendix B.

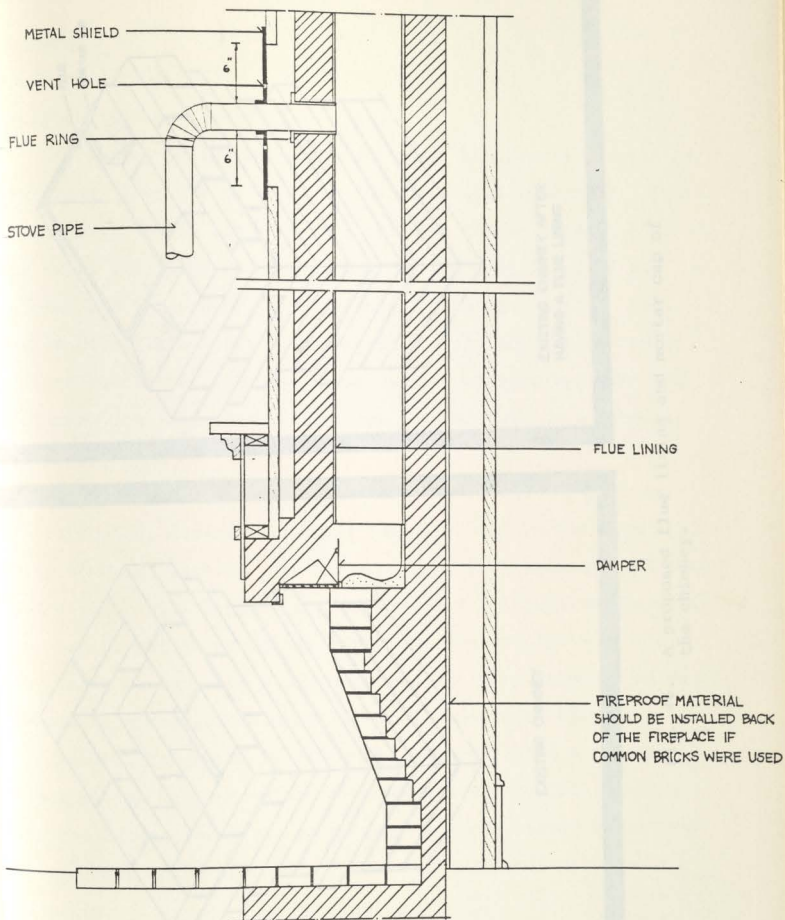
Fig. 45. The installation of a damper, a flue lining and a stove pipe in the fireplace of the Starr house.

From the evidence of the house, a woodstove outlet was added to each existing chimney. In the north-south wing, a thimble is located in the north bedroom. In the east-west wing chimney, a woodstove is connected to it from the kitchen. Woodstove may be used again once the chimneys are completely repaired. Non-combustible walls and floors should be installed behind and under stove.

Many of the fireplace bricks are deteriorated and

unservicable due to long periods of service. They are not fire bricks, Bricks at the fireplaces could be replaced by original bricks from hidden areas, such as underneath the roof, or by using new bricks matching in size and color with the old. Fire bricks may be used if they are specially produced similar in size and color to the old. If they are not available common bricks can be used, but fire proofing material should be installed in the back of the fireplaces.

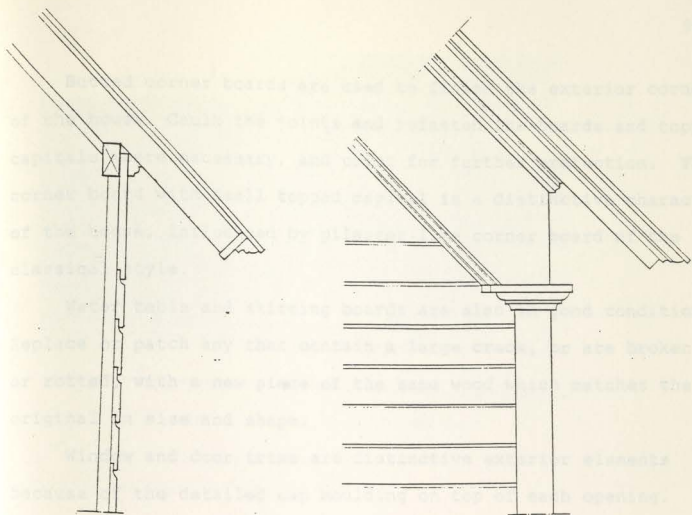
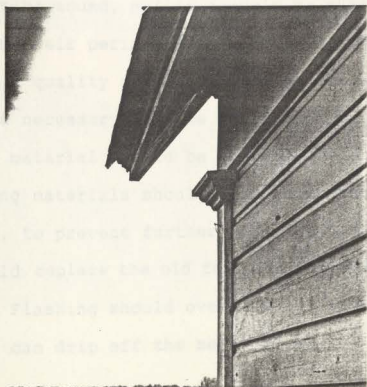
Fig. 50. The Exterior trim

The trim around the roof edges is intended to seal off the structural intersection of the rafters, top plates and wall planks. Moulding and wide frieze boards are used to trim the top wall and roof edges. These are in good condition and probably need only refastening at the loose spots, and repainting for longer service.

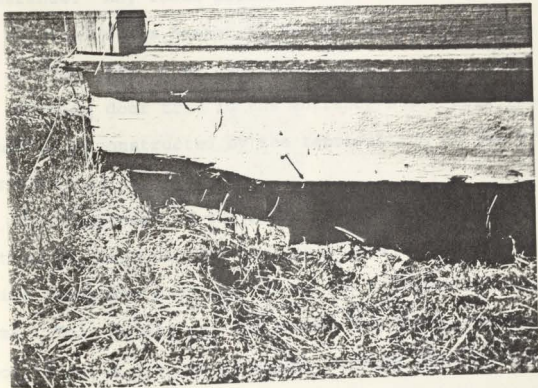
Fig. 52. Water table and skirting

Water table and skirting boards are also in good condition. Replace or patch any that contain a large crack, or are broken or rotted, with a new piece of the same wood which matches the original in size and shape.

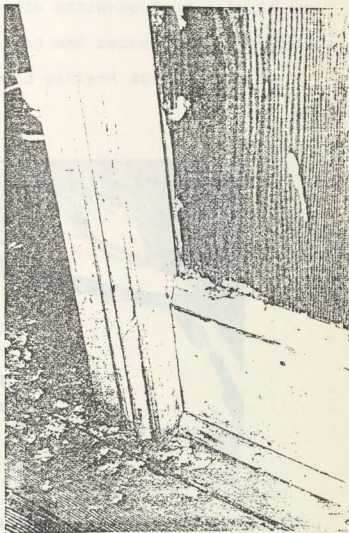
Fig. 55. The baseboard of the house

The baseboard of the house is composed of three parts; the flat board, base cap and base shoe (see figure 55). It is a wide baseboard proportional to the high ceiling height of the rooms. This detail carries around the house. Baseboards are important as a structural member because they secured plank walls in place. Baseboards are in good condition. Wherever some part of the baseboard is missing, it should be replaced by the new reproduction piece of wood which matches the style, size and material of the original baseboards.

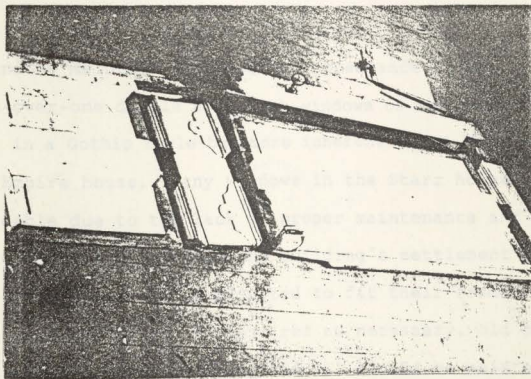
Fig. 56. The east entrance door

Four panel doors constitute the majority of the door types in the house. Most doors, except the east entrance door, are in this traditional pattern of the four panel type. The east entrance door is glazed above in four panes. Front entrance doors have fixed-glass-panel overhead transoms. The transoms and the panes of the east entrance door could use the same restoring methods as the glass windows. All doors, except the east entrance door, were removed and the openings are presently covered with plastic sheets. Many of the removed doors are kept in the house, such as the north entrance door. It is in broken pieces, but could be repaired and reused at its original location. It has a decorative wood pattern applied to the surface (see figure 56 ).

All existing doors should be cleaned and repainted. They need repairing to make them fit properly. Missing doors should be reproduced to look like the original doors and installed at needed locations.

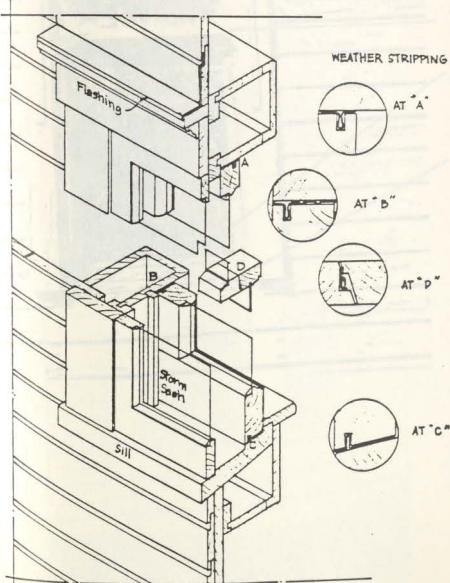
Fig. 57. Starr house's double-hung window, weatherstripped & storm window

Windows may lose heat through conduction and infiltration around the perimeter. To stop all the air infiltration around the windows, they may need caulking, weather-stripping, and reglazing. The wood frame storm window could be installed to prevent heat loss through the window (see figure 57).

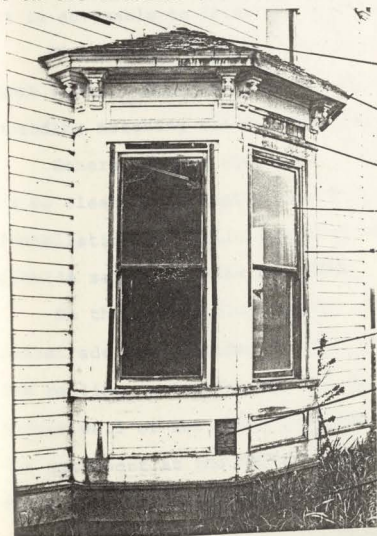
Fig. 59. Bay window

The bay window is located at the center of the front gable on the north elevation. It has semi-octagonal shape (see figure 59). Its location, shape and villa style brackets along the eaves represent an important characteristic of vernacular Gothic style which has to be maintained. Generally the bay window is structurally in fair condition, but it needs repairing due to exterior deterioration. The shingle roof over the bay window needs reroofing (see section about roof). The windows need fixing and adjusting to be servicable. Missing and cracking boards on the bay window need to be replaced with new boards to match the original. Both exterior and interior sides of the bay window should be cleaned and painted using the method of applying paint on the exterior and interior.

- flashing where roof meets a wall
- reroofing with wood shingles
- clean and repaint
- fix windows
- caulking around bay window perimeter as necessary
- renail loose board if found
- treat exposed wood with a wood preservative before new wood applied to match the old
- level and consolidate foundation

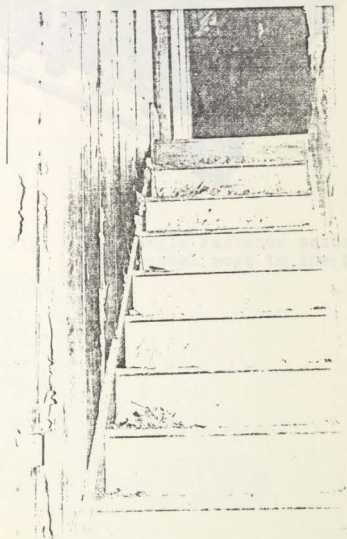
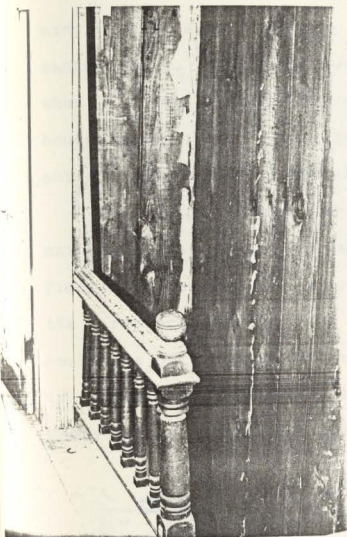
Fig. 61. The stair balustrade of the Starr house

is wider than the space available where it is connected at the north wall (see figure 61), it may be the original due to its style and craftsmanship. Like door jamb and window trim, the stair railing could be ready made from the local mill and was installed after the wall structure was finished.

The stair balustrade should be cleaned and varnish applied to retain its original appearance. It is recommended that a drift pin be inserted in the middle of the newel post connecting it to the floor and to secure it to the floor joist if possible. The former angle fasteners should, therefore, be removed.

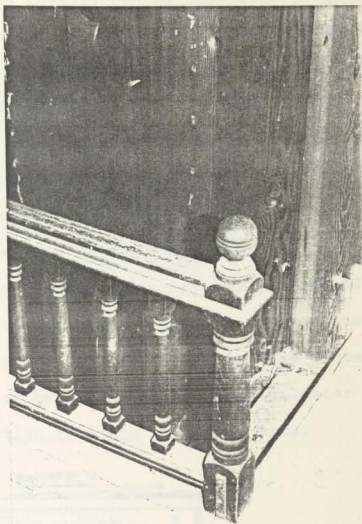
Fig. 62. An angle fastener secures the newel post to the floor

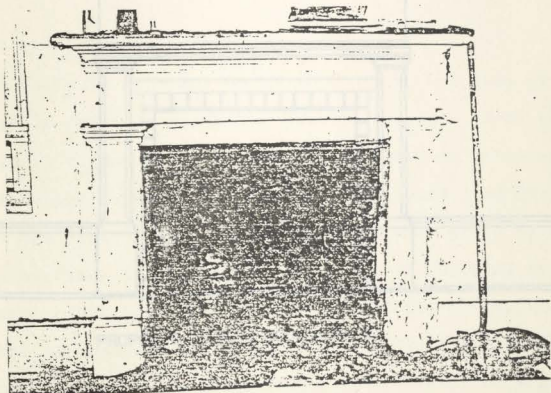
Fig. 63. Dining room fireplace and mantel

The fireplace mantel in the dining room of the Starr house maintains its original appearance. The wood mantel faces the fireplace, leaving only a narrow edge of masonry showing around the fireplace opening. The pilasters are rather simple but the mouldings on the mantelpiece are carefully detailed. The mantel is in fair condition. A missing baseboard at the left pilaster needs replacing with reproduction to match the other side.

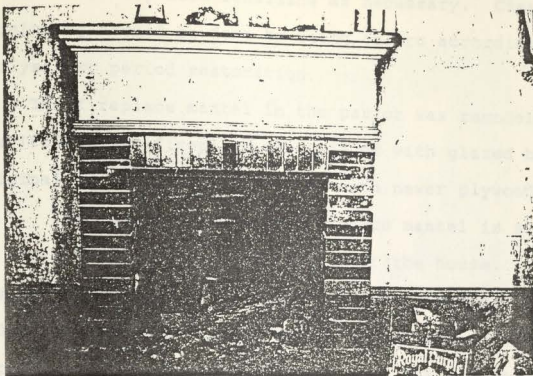
Fig. 64. Parlor room fireplace and mantel

The fireplace mantel in the parlor was remodeled around the 1950s. The fireplace was refaced with glazed bricks. The original mantelpiece was covered with newer plywood (see figure 64). The appearance of the fireplace mantel is significant to the historic interior integrity of the house. The mantel in the parlor should be refinished. Glazed bricks should be removed and replaced by wood pilasters in compatible design to the significant period of the house, since the original detail is not available. The new plywood should be removed so that the old may be examined. If the old one is usable, it should be restored and used. A suggestive design for parlor mantel is shown in figure 65 .

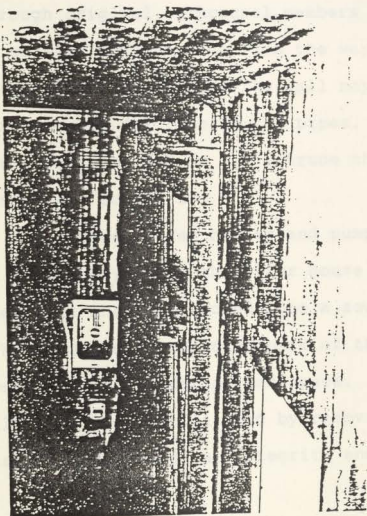
Fig. 84. The service panel is located on the wall in the entrance wall.

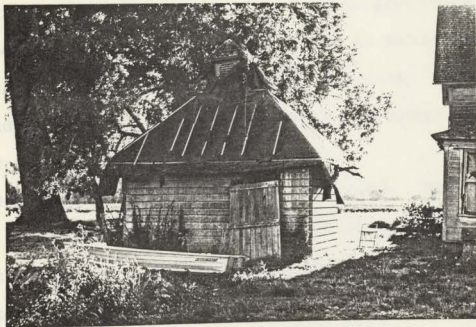
Fig. 85. The dairy building

The serious problem of the building is the roof. Shingles were removed and the roof is covered with a plastic sheet while waiting for repair. Shingles should be reinstalled as well as missing roof structural members. Rotten structural members should be repaired by splicing new wood to match the old. The cupola should be fixed in its proper position. Wood shingles are recommended for roof covering to match the house and recover historic appearance.

Loose siding boards should be renailed. Deteriorated, missing and large cracked board should be replaced by new boards that match the old. Missing corner boards and door trim should be reinstalled by new boards and trim with compatible design and proportion. Simple panel doors can be used to replace the missing ones. The existing window is in good condition, but may need to be properly adjusted as needed.

The evidence at the bottom of the west wall shows an inactive insect infestation. Bottom edges should be treated by insecticide as needed and attacked wood must be removed and replaced by new material to match.

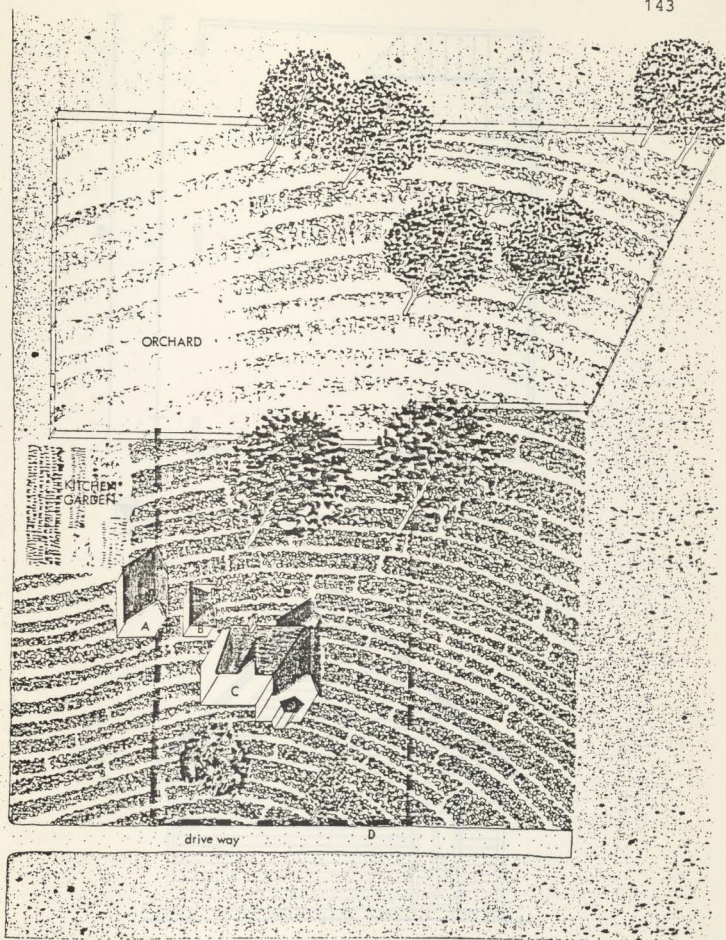
Fig. 86. A suggestive location for the garage

Therefore, the recommended location of the garage is on the southeast of the house, where it can be accessed from the driveway (see figure 86). By placing the garage at this location, it will retain the visual perspective of the historic building group; the house and the dairy building. Also, the garage will be integrated in the group arrangement of the farm which former buildings (which have been torn down) were located in the core area.

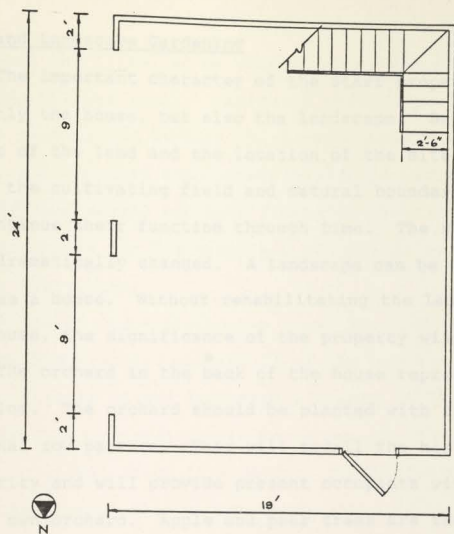
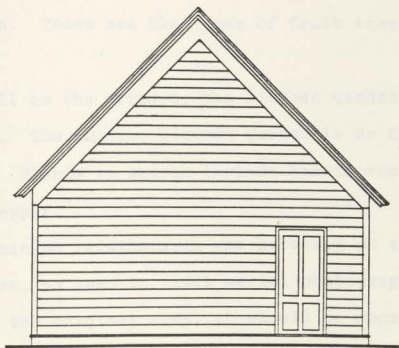
Fig. 87. A suggestive design for the garage.

The appearance of the garage should not be predominant to the house so that the house can be recognized as an important element on the landscape (see figure 87).

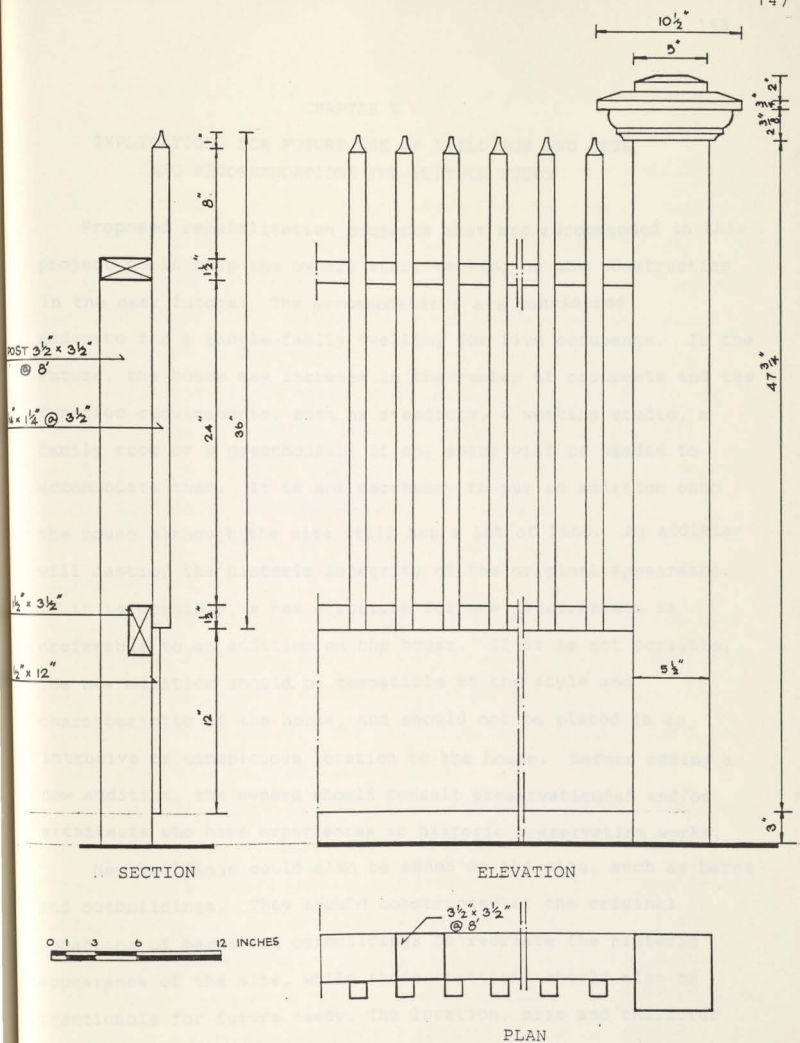
Fig. 88. The proposed picket fence

A picket fence around the house is recommended. It will enhance the historic appearance of the house. It is a strong characteristic of the landscape elements of the late 19th century. A suggested picket fence design is based on the historic picket fence in a nearby location; about a mile from the Starr farm. This picket fence dated from the early 20th century remains from an old house which has been demolished. It is compatible to the style of the house. It is recommended because that existing fence is also in poor condition and will be lost without repair. If it is possible, the Starr house's owners should buy the old picket fence from that nearby farm and use it as a part of the rehabilitation. This will be a way to help maintaining a historical heritage (see figure 88).
