ANALYSIS AND REHABILITATION
OF THE COZINE HOUSE
McMINNVILLE, OREGON

A TERMINAL PROJECT

| CHAPTER III. ANALYSIS OF EXISTING CONDITIONS AND RECOMMENDATIONS FOR REHABILITATION/RESTORATION | 20 |

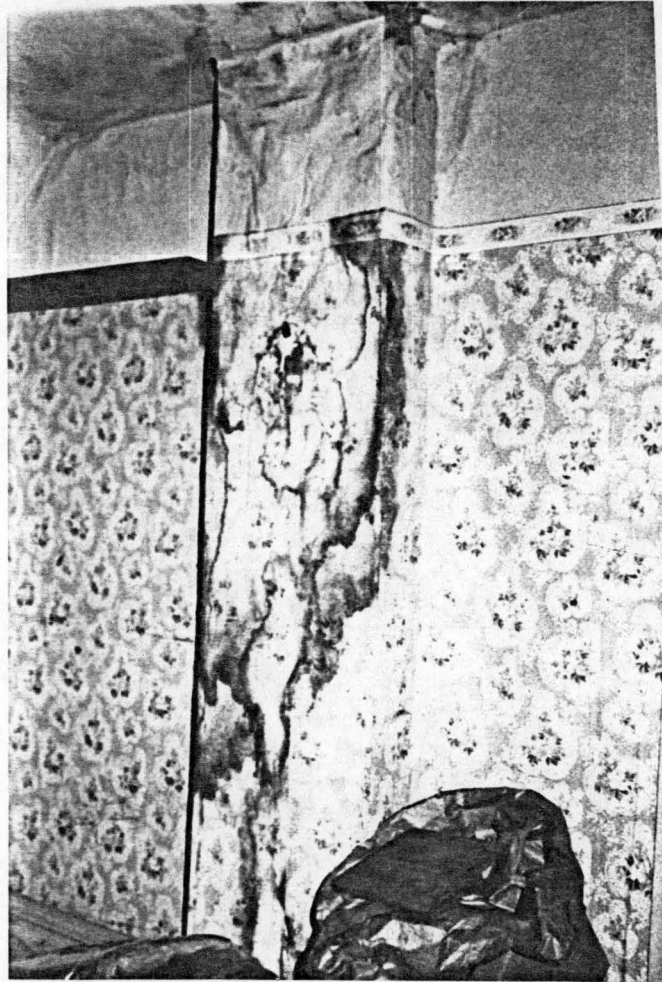
Fig. 49

second floor - south bedroom
chimney detail

When the wallpaper is stripped off the walls, the brickwork on the chimneys should be repointed. It is not necessary to return the chimneys to functioning chimneys. Instead, they can be repaired so as not to leak and sealed inside so as to be inoperable. The presence of the chimneys on the exterior is very significant. Therefore, unless the chimneys present a serious problem on the interior, they should remain in place. If it were desirable to make the chimneys operable, a new liner could be inserted and fireproof walls installed for the wood stoves. The local building inspector must be consulted regarding regulations.

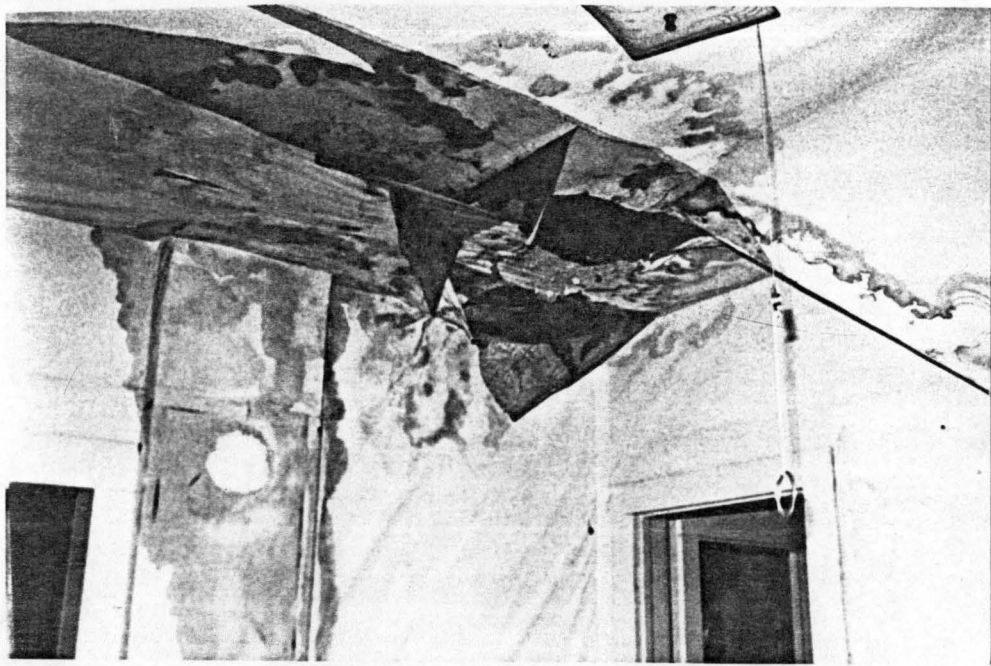
second floor - east bedroom - ceiling detail
