Eugene Masonic Cemetery

Condition Assessment and Treatment of the Historic Grave Markers and Mausoleum

October 2013 – May 2014

David Espinosa – Master of Science in Historic Preservation Candidate

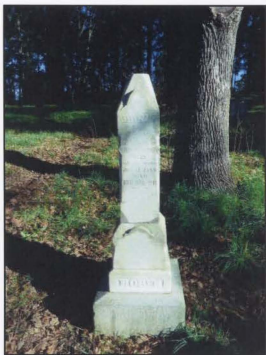
Boren marker post-treatment

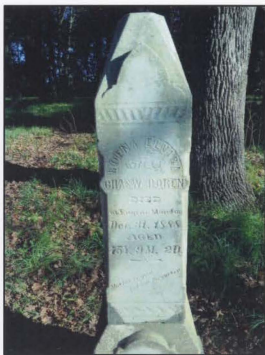
Inscription detail post-treatment

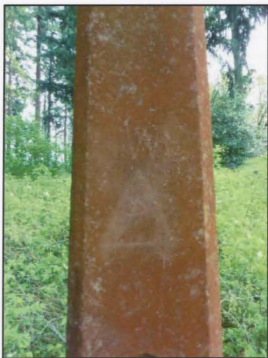
(Above) Inscription detail pre-treatment
(Below) Brownlee marker post-treatment

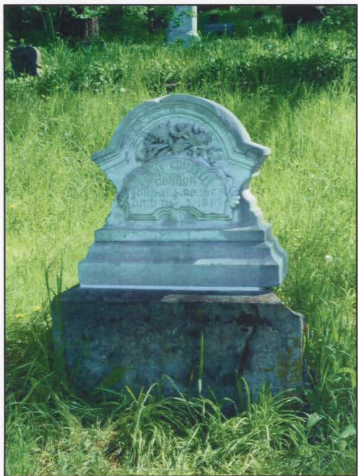
Condon marker post-treatment

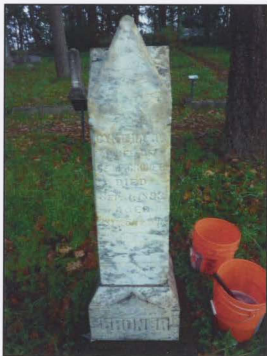
West face post-treatment

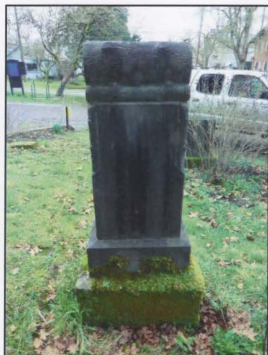
East face pre-treatment

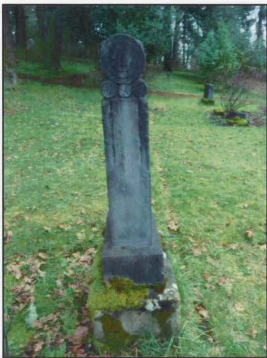
North face pre-treatment

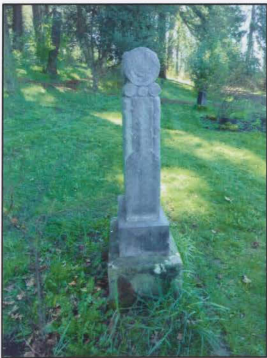
North face post-treatment

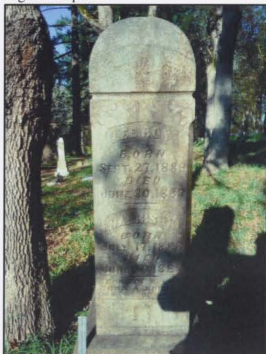
South face inscription detail

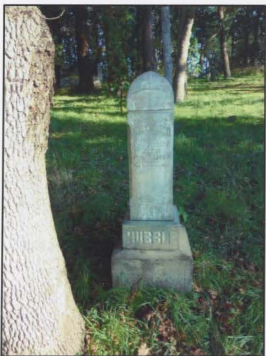
West face post-treatment

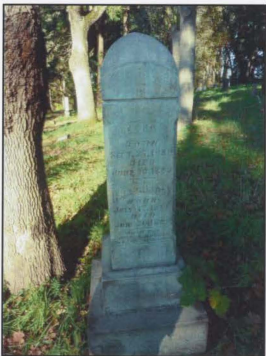
South face post-treatment

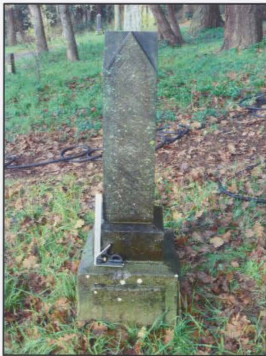
South face pre-treatment

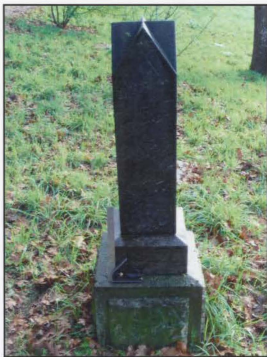
North face pre-treatment

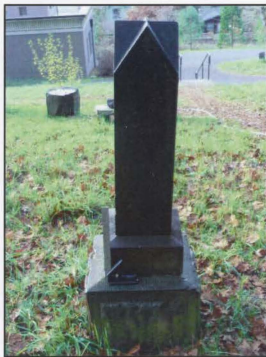
East face pre-treatment

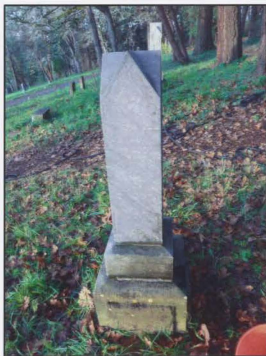
South face post-treatment

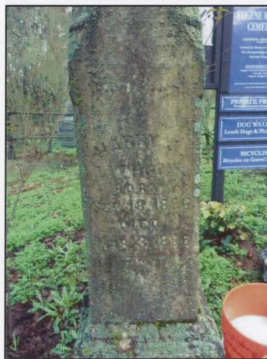
West face pre-treatment

present an image of upkeep and respect for the deceased to the general public. No glaring issues, other than the extent of soiling and growth on the marker, are immediately visible.

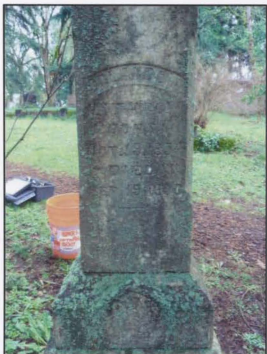
West face inscription detail

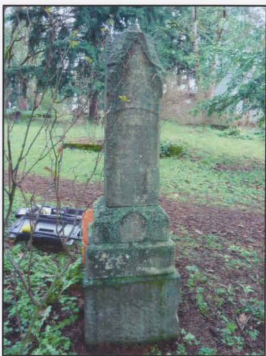
South face inscription detail

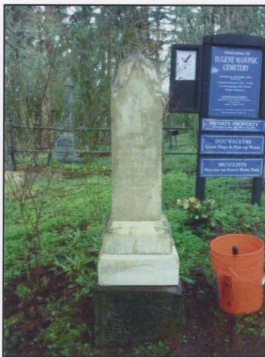
South face post-treatment

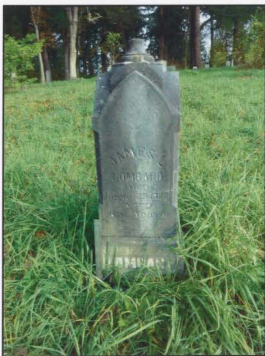
West face pre-treatment

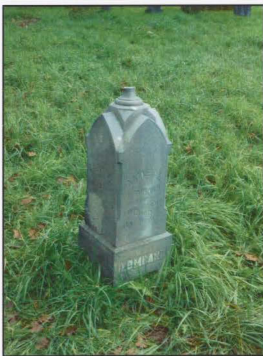
North and West faces post-treatment

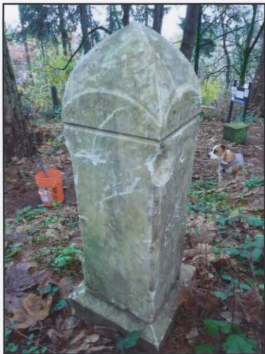
South corner of marker pre-treatment. Note material loss and conservation dog

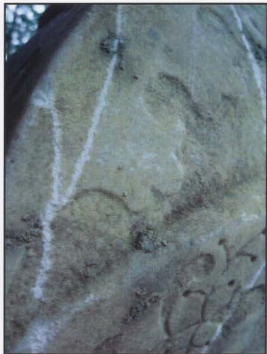
Detail of gouging, and natural accretions

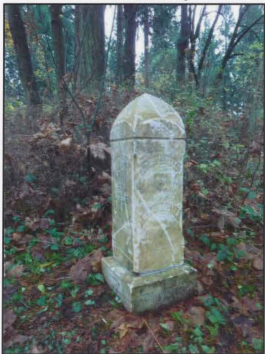
(Left) McAlister marker post-treatment

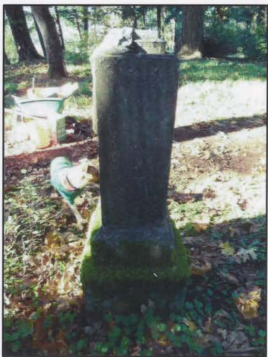
East face pre-treatment, pitbull terrier assistant.

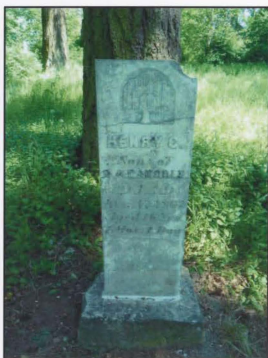
Noble post-treatment

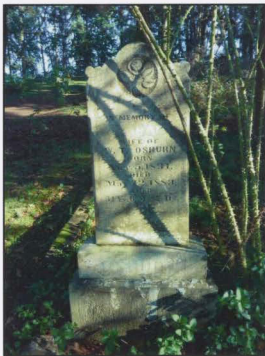
West face of Osburn marker post-treatment

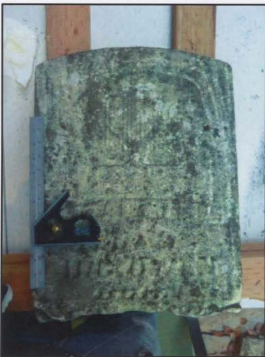
Upper fragment pre-treatment

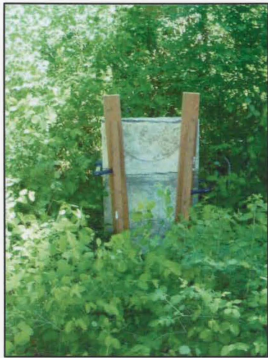
Bonding of the middle and lower fragments

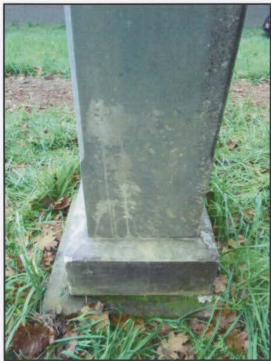
Blotch detail post-treatment

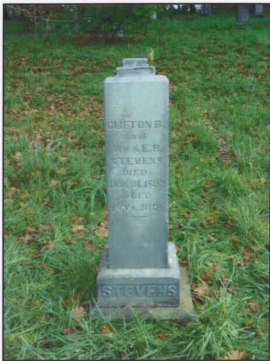
Clifton Stevens marker post-treatment

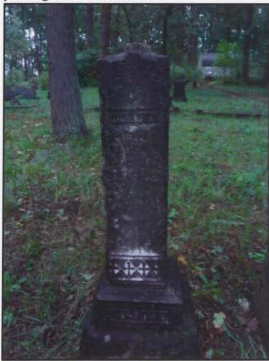
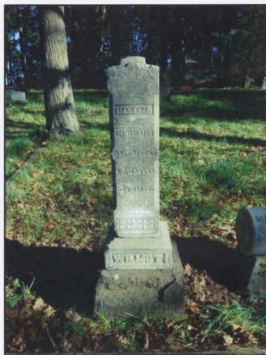
History of Repairs	Resetting of primary element on lower marble element apparent	N/A	N/A	N/A	N/A
Condition of Repairs	The joint is open and deteriorating. The resetting was off-set by approximately ¼"

Comments: The Wilmot marker was heavily stained due to biological growth. There is evidence that the primary marble element was reset. This is deduced by the off-center placement of the piece and the presence of a mortar that would not be typical of the marker's era of origin. An ornamental element is missing from the top of the primary marble element, likely a casualty of vandalism. The sandstone base is spalling on all surfaces.

Recommendations: This marker sits in a location that is under constant shade rendering it vulnerable to damage from moisture and biological growth. Regular cleaning with Orvus WA Paste and water will do much to preserve the condition and integrity of the marble elements. Although still structurally sound, the sandstone base must be monitored as it is spalling on every exposed surface. Regular cleaning and application of D2 Biological Solution will greatly prolong the life of the base.

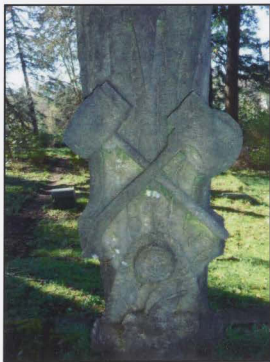
Ornament detail pre-treatment

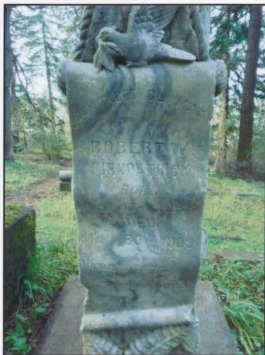
Inscription detail post-treatment
